# Investment Evaluation Summary (IES)

<b>Project Name:</b>	Replacement of HV Ground Mounted Distribution Substations - Oil-filled Switchgear
<b>Project ID:</b>	00702
<b>Thread:</b>	Ground Mounted Substations
<b>CAPEX/OPEX:</b>	CAPEX
<b>Service Classification:</b>	Standard Control
<b>Scope Type:</b>	A
<b>Work Category Code:</b>	REGMS
<b>Work Category Description:</b>	Replace Ground Mtd Sub
<b>Preferred Option Description:</b>	Increased replacement that will reduce the age profile below 50 years of age
<b>Preferred Option Estimate (Nominal Dollars):</b>	\$21,805,000

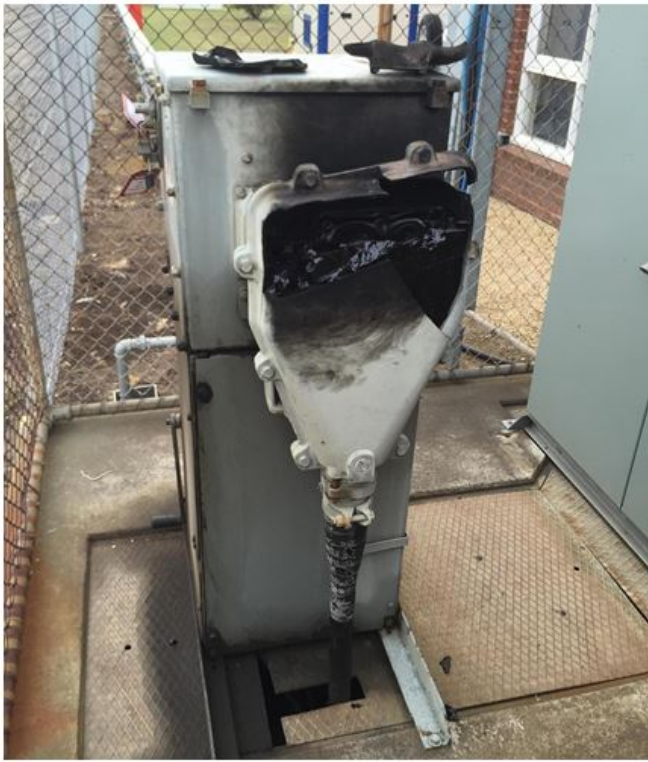
Figure 1 shows the consequences of a switchgear termination failure. The cable terminations are made from cast iron and the insulation medium is pitch/tar. The failed components, which was disseminated throughout the chain fence enclosure due to an internal fault.

**Figure 1 - Recent Reyrolle JKSS switchgear with cast iron pitch filled cable terminations failure - 2014**

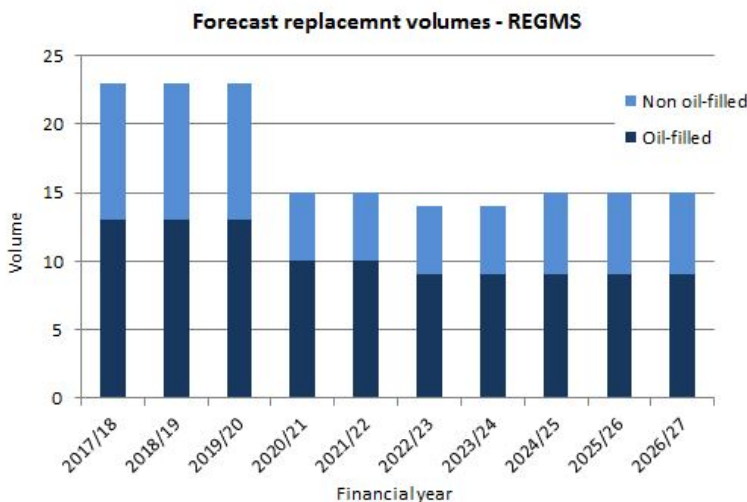
**Figure 3 - Forecasted replacement volumes for REGMS split between oil and non-oil filled switchgear**

Figure 3 shows the recommended REGMS replacement volumes for the 10 year period starting in 2017/18.

The rate of replacement has been developed with target of removing high voltage switchgear from service prior to it reaching 50 years of age because the risk of failures greatly increase above this age..
