Investment Evaluation Summary (IES)

Project Name:	Replacement of HV Ground Mounted Distribution Substations - Non Oil-Filled
Project ID:	00703
Thread:	Ground Mounted Substations
CAPEX/OPEX:	CAPEX
Service Classification:	Standard Control
Scope Type:	A
Work Category Code:	REGMS
Work Category Description:	Replace Ground Mtd Sub
Preferred Option Description:	Consistent replacement strategy
Preferred Option Estimate (Nominal Dollars):	\$14,300,000

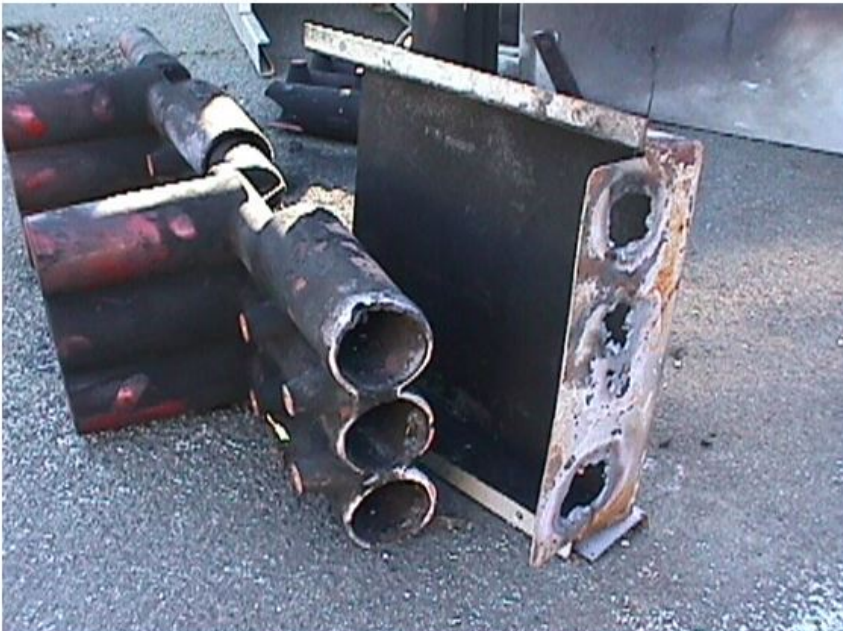
Figure 1 shows the consequences of a HV switchgear failure that had the potential to cause harm.

Figure 1 - Epoxy spouts contained inside of RGB switchgear that has failed due to moisture and dust ingress

The design of these units allows dirt and moisture to build up in the epoxy spout at the rear of them, which over causes the failure of the insulation in the switchgear resulting in an flashover and failure of the unit. . As of April 2014 there were three recorded cases of this type of failure. There is also anecdotal evidence that there have been more that have failed in this manner. There are issues other than the ingress of moisture and dirt concerning these units and due to these faults an additional three incidents have occurred. The most recent being a cable failure inside the switchgear cubicle resulting in the loss of the switchgear.

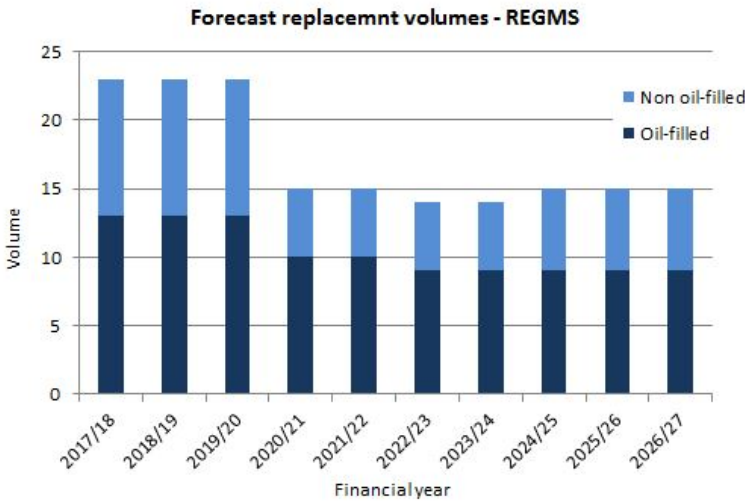
Figure 3 - Forecasted replacement volumes for REGMS split between oil and non-oil filled switchgear

Figure 3 shows the recommended REGMS replacement volumes for the 10 year period starting in 2017/18.

The rate at which replacement will occur will initially be ten units per year, for three years. The volume will be reduced to five units per year to provide for steady replacement rates in the REHSW program. This strategy is shown in figure 4. This approach will allow for strategic replacement, with critical units being replaced first, namely RGB24 and Hazemeyer.
