# Asset Management Plan

## Conductors and Hardware – Distribution

Info Zone Record Number: R260427

Date: October 2015

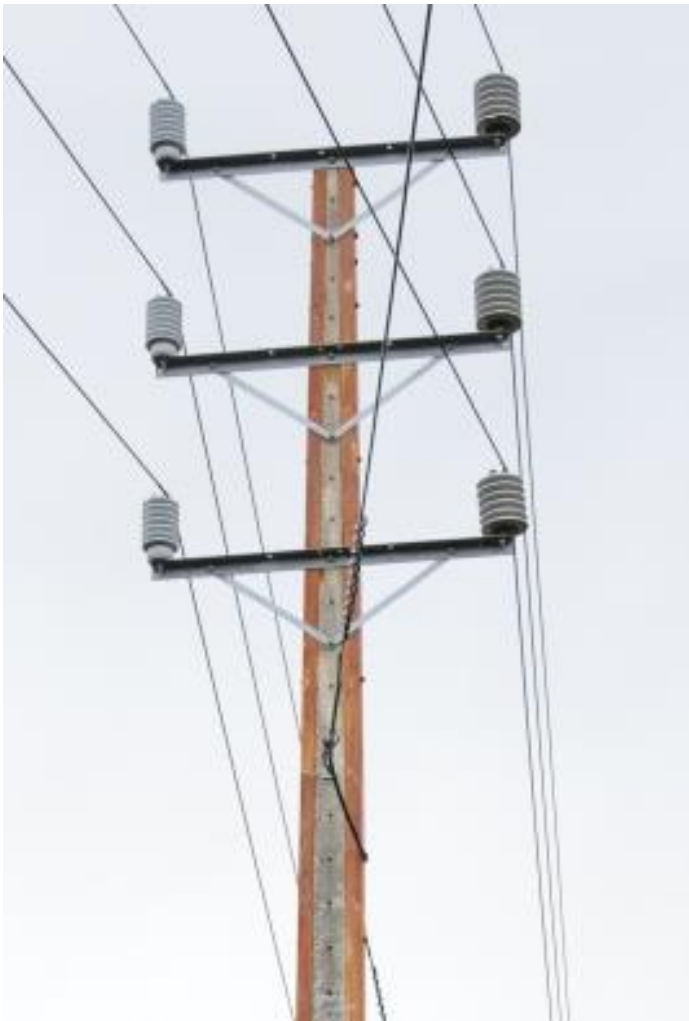
**Figure 3: Steel HV crossarms**

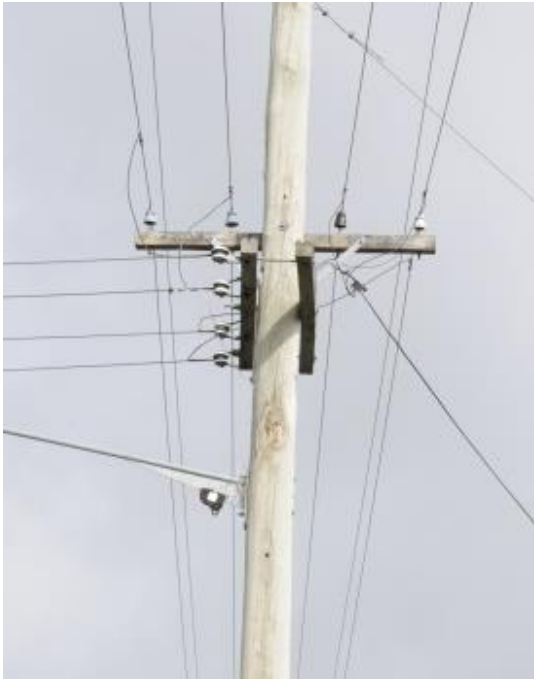
**Figure 4: Wooden LV crossarms**

LV cross arms are predominantly manufactured from timber as this medium is cost effective and offers insulation qualities to allow live line activities to be performed safely.

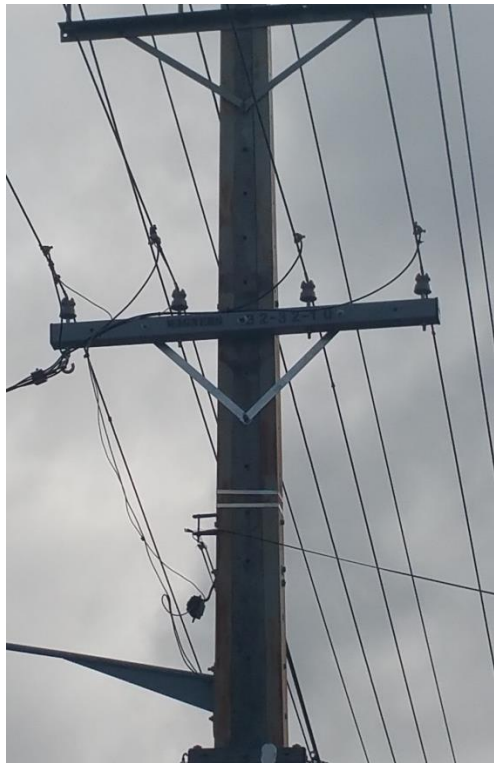
**Figure 5: Fibreglass LV crossarm**

Investigations of alternative crossarms have recently taken place and a fibreglass LV crossarm is currently being trialled in the Hobart area.

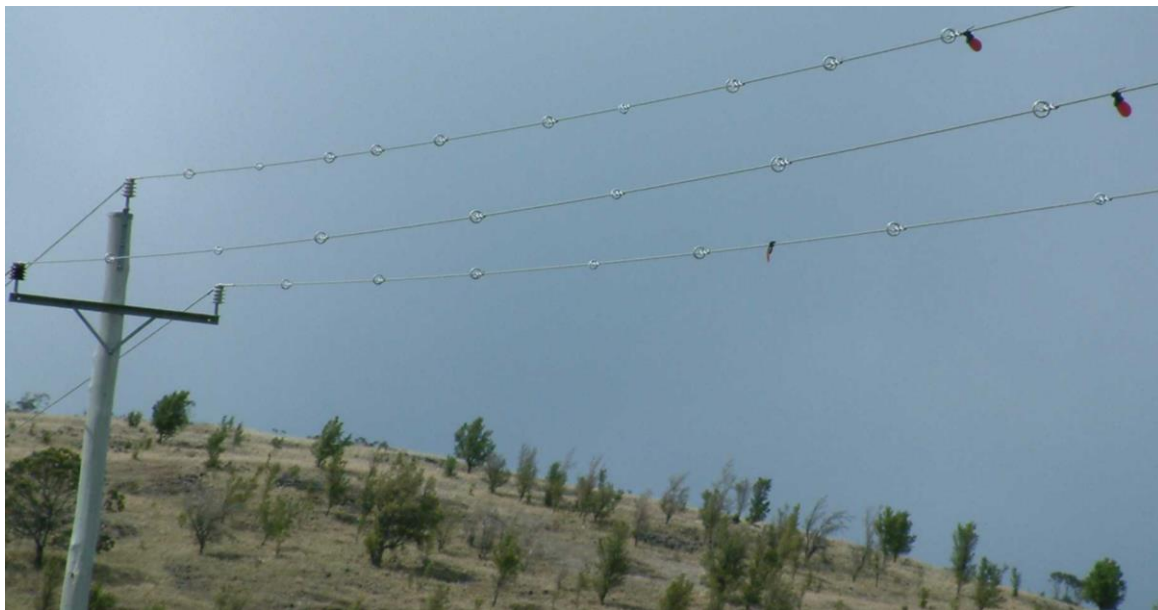
**Figure 6: Bird diverters installed on conductor**

Swans, geese, waterfowl and other large birds commonly collide with conductors. Bird diverters are installed to make conductors more visible to birds. Birds cause over 400 outages a year on TasNetworks' distribution system.

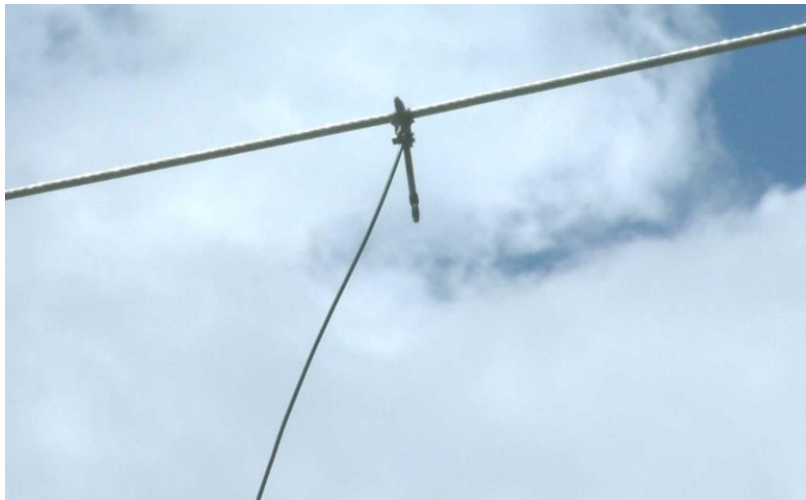
**Figure 7: Live line clamp directly connected**

In the past, live line clamps were used to connect new transformers directly to HV feeders without requiring an outage. This connection was intended to be a temporary connection and to be changed to a 'D-clamp' at the next planned outage. However, records were not well kept of installations connected using live line clamps and many were not changed to D-clamps and it is estimated that there are approximately 10,000 live line clamps still connected (according to the WASP defect pool).

The connection of a live line clamp directly onto a live tensioned conductor can result in arcing, eroding individual strands of the conductor and greatly reducing its strength. The risk is greater for Galvanised Iron (GI) conductor as this arcing can remove the galvanising, which exposes the iron to moisture build up underneath the clamp. This results in corrosion of the conductor, which will lead to conductor failure or the fusing of the conductor to the clamp.

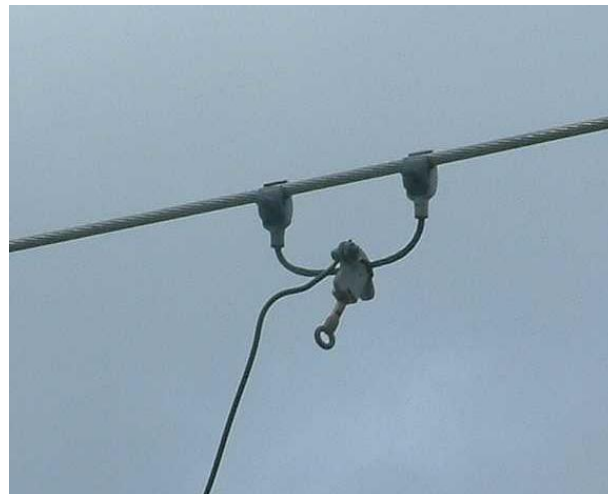
**Figure 8: Live line clamp connected via D-clamp**

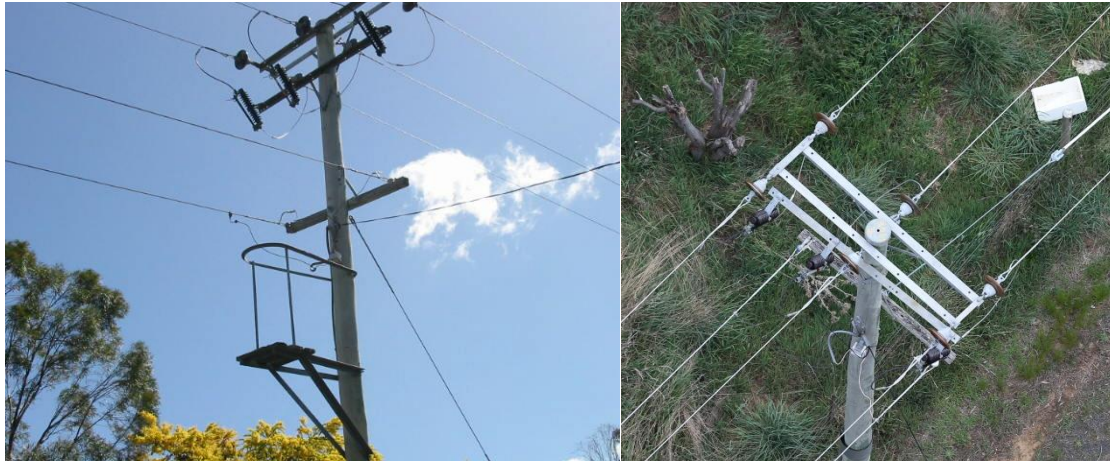
Figure 9: The same pole seen from the ground and from the air

A visual inspection from ground level limits the Asset Inspector from completing a full assessment of the pole top assets making the identification of critical asset failures such as broken tie wires and faulty cross-arms difficult. The RCM review identified that TasNetworks should visually inspect pole tops from above every five years as part of its new overhead system maintenance strategy.

The use of high definition imagery and remote sensing technologies for asset inspection is becoming commonplace throughout the utility sector across the world, and is gaining acceptance as standard industry best practice. A detailed trial in 2013 of various available technologies (including unmanned aerial vehicles and hi-mast) found that helicopters provided the most cost effective solution. Helicopters also have an added advantage of being able to assist with vegetation inspections due to their ability to efficiently patrol long stretches of feeder.

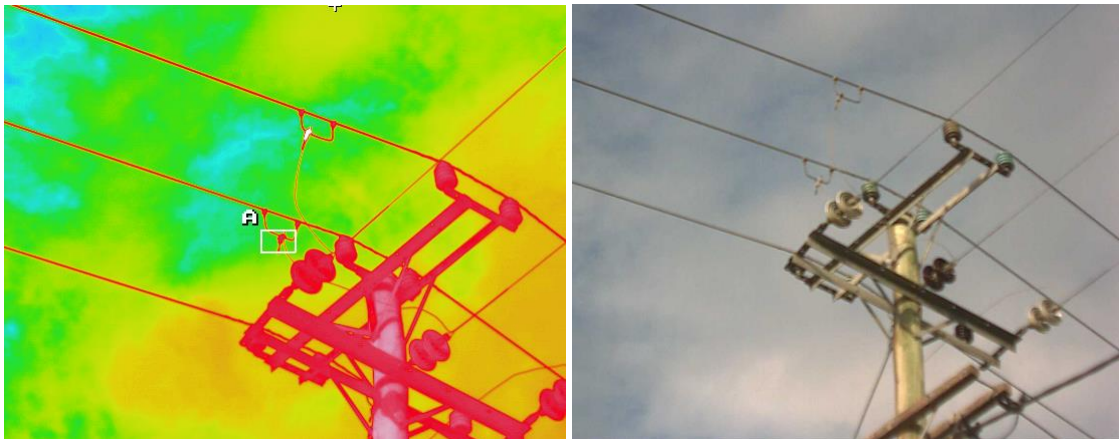
**Figure 11: A Live Line Clamp through a thermal imaging camera and a normal camera**

This program entails the use of a thermal imaging camera to identify joints or connections that are displaying signs of high resistance within the network. The results of a recent RCM analysis identified this work as being critical to the overhead strategy of no failures that matter. By identifying weak spots and defects prior to asset failure, reactive maintenance can be undertaken with less disruption to customers at lower cost, and potential fire starts can be avoided.
