Substation Renewal and Maintenance Strategy

This strategy guides the management of TransGrid's existing Substation assets.

Revision no:	4	HP TRIM No:	D2014/18645	Approval/ Review Date:	20 December 2016
Business function:	Strategic Asset Management			Document type:	Strategy
Process owner:	Manager / Asset Strategy				
Author:	Robert Li, Substations Asset Strategist Evan Lamplough , Substations Asset Strategist Timothy Blair, Substations Asset Strategist Tony Gray, Substations Asset Manager				
Reviewers:	Tony Gray, Substations Asset Manager Lance Wee, Manager / Asset Strategy				
Approver:	Tony Gray, Acting Manager/Asset Strategy

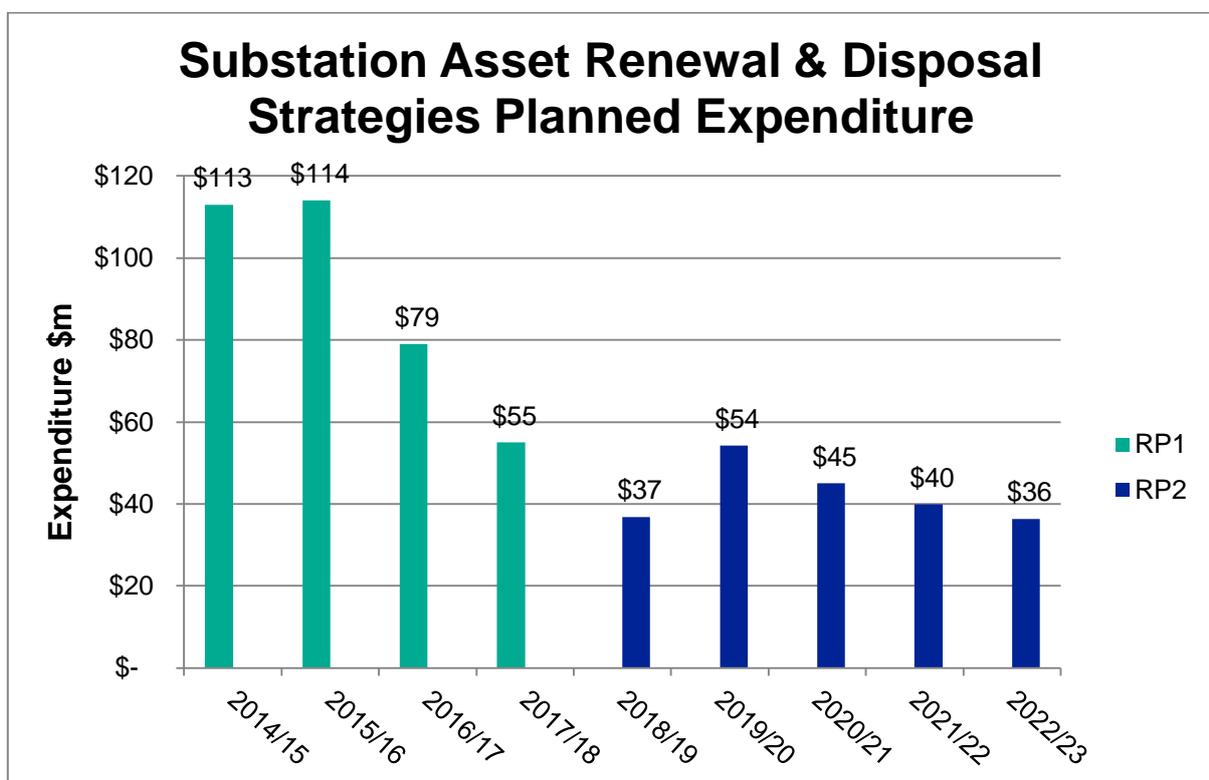
Figure 2 Substation Asset Renewal & Disposal Strategy Planned Expenditure (RP1 and RP2)

Figure 2 shows the current planned expenditure relating to the substation asset renewal and disposal strategies for the current regulatory period (RP1) and the next regulatory period (RP2).

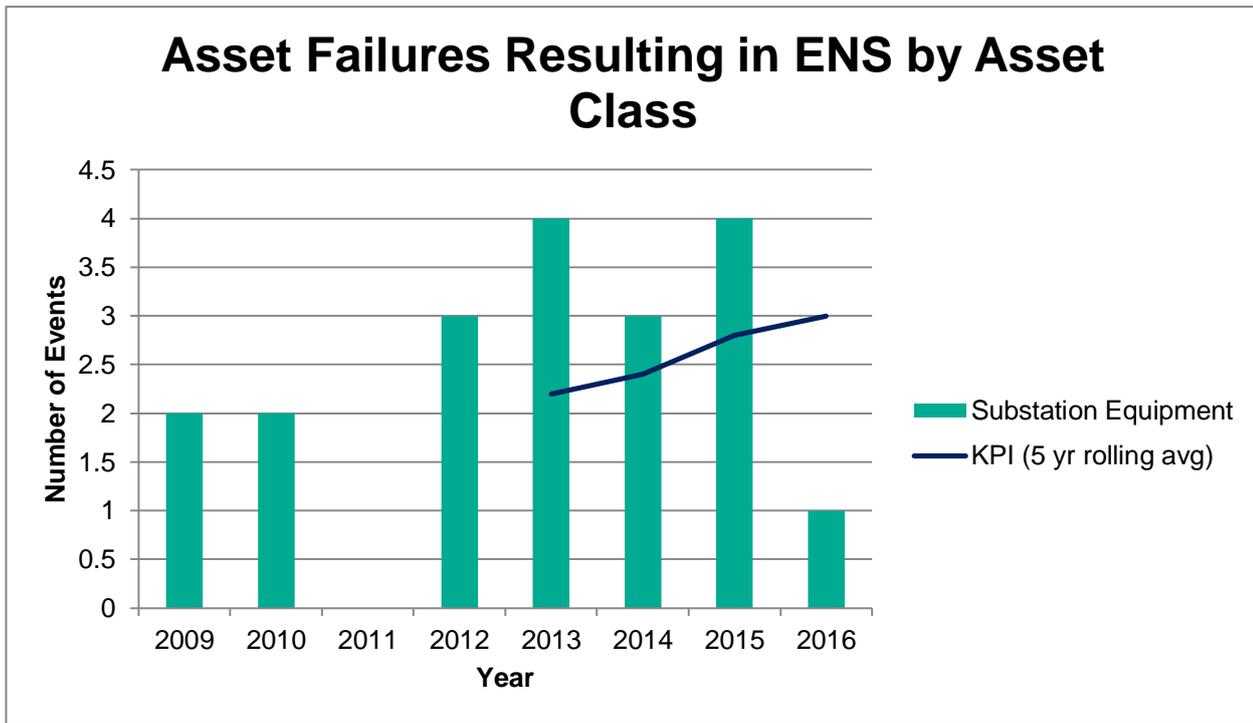
Figure 3: Asset Failures Resulting in ENS by Asset Class

ENS events due to substation faults in the 2015 calendar year were above the 5 year average. The 2016 year to date performance is trending favourably to be below the 5 year average.

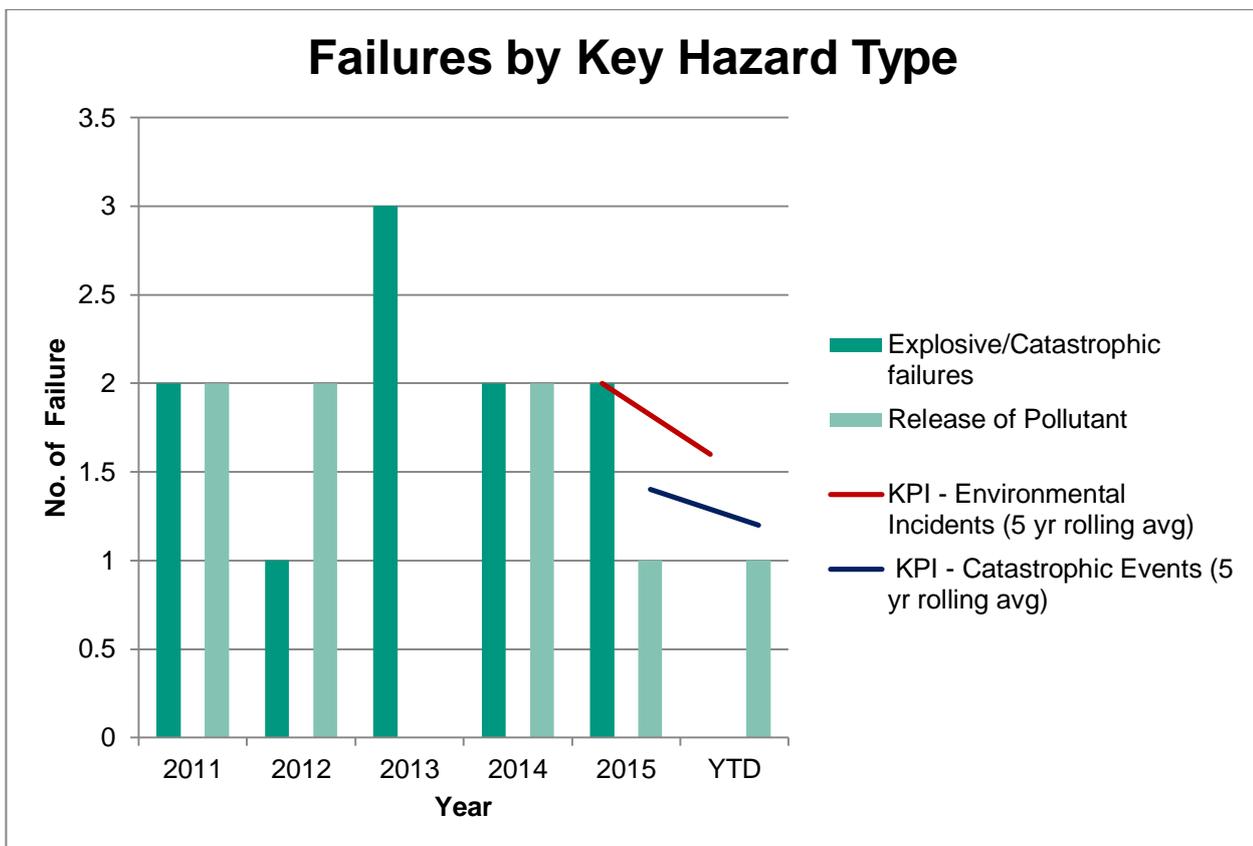
Figure 4: Failures by Key Hazard Type

Key Hazardous Events due to substation faults in the 2015 calendar year were in line with the 5 year average. The 2016 year to date performance is trending favourably to be below the 5 year average.

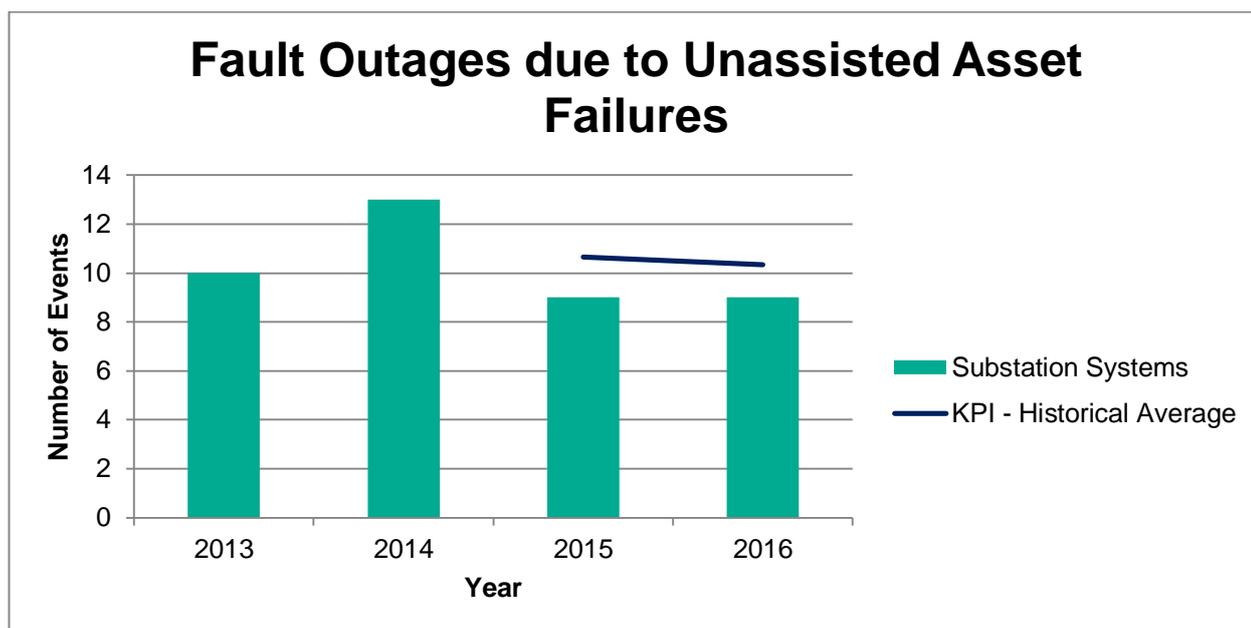
Figure 5: Fault Outages due to Unassisted Asset Failures

Fault Outages event data due to Unassisted Asset Failures in the 2015 calendar year were below the historical average. The 2016 year to date performance is nearing the average, however is presently below the historical average.

Historical data for Fault Outage and Forced Outage events is limited to 2013; this window is relatively small however performance over this period is consistent.

Note: Data is a subset of AER published RIN data.

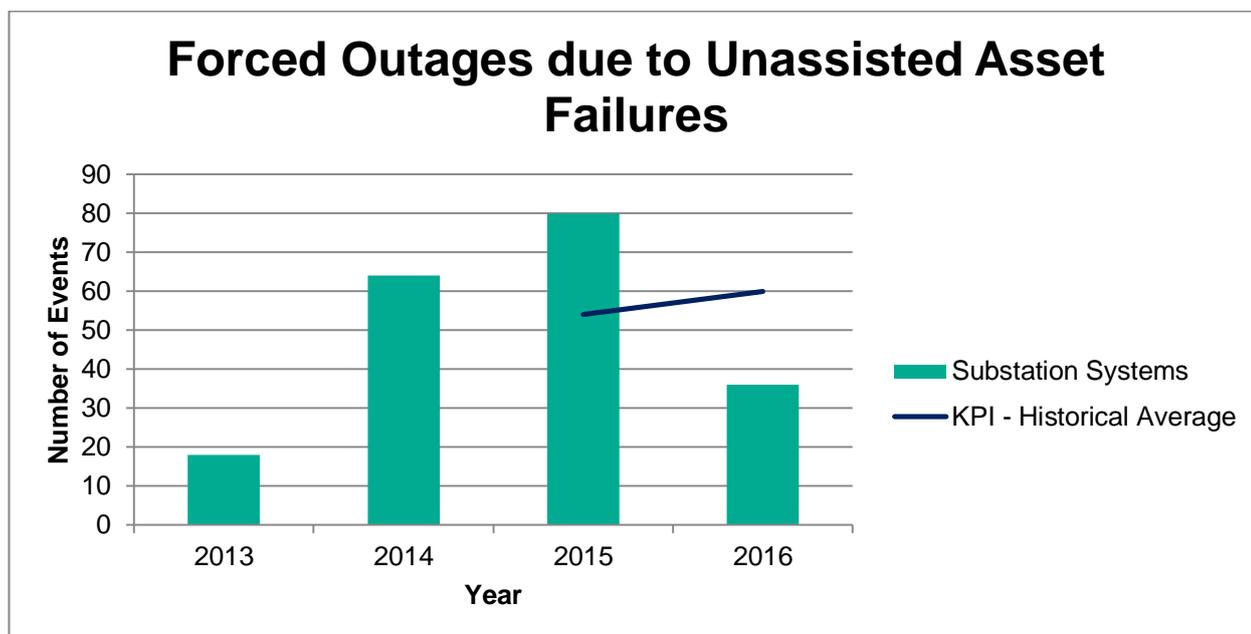
Figure 6: Forced Outages due to Unassisted Asset Failures

Forced Outages event data due to Unassisted Asset Failures in the 2015 calendar year were above the historical average.

Review of the contributing data shows a number of assets that are identified for replacement under existing and proposed renewal initiatives are targeted. As such ongoing implementation of the identified renewal initiatives is anticipated to progressively address the increasing Forced Outage event rate.

Note: Data is a subset of AER published RIN data.

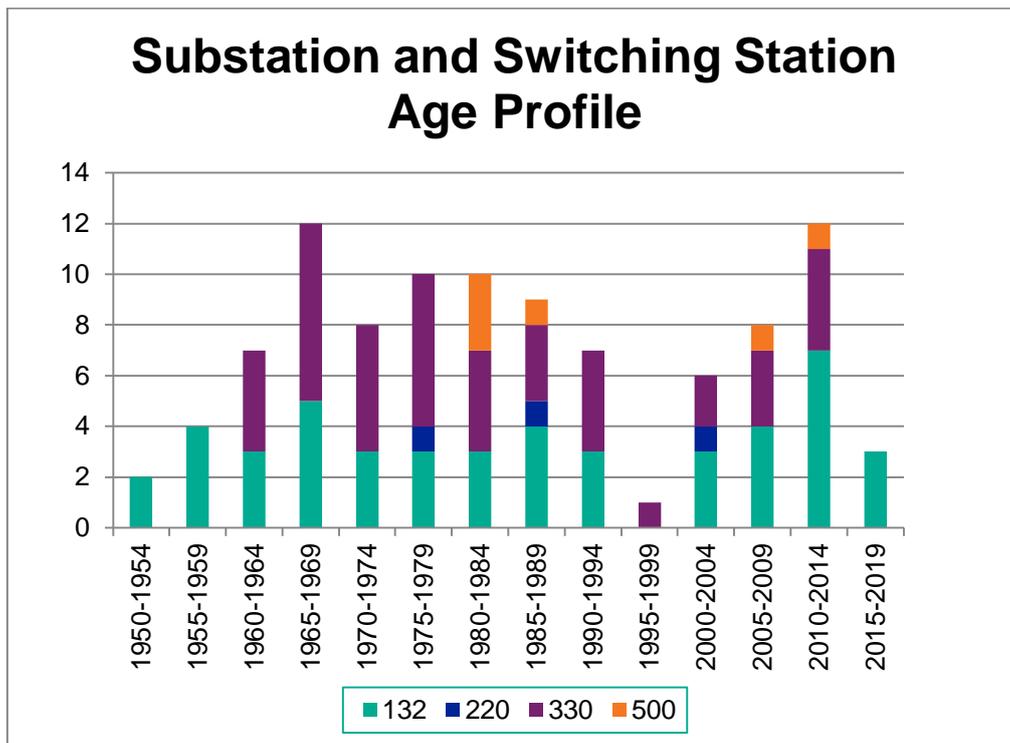
Figure 7: Substation and switching station age profile

The age profile of TransGrid’s substations is illustrated below – where substations are separated by their voltage ranges from 132kV through to 500kV. It can be seen that 25% of TransGrid’s substations and switching stations were commissioned before 1970, with the oldest commissioned in 1950 and the most recent in 2016.

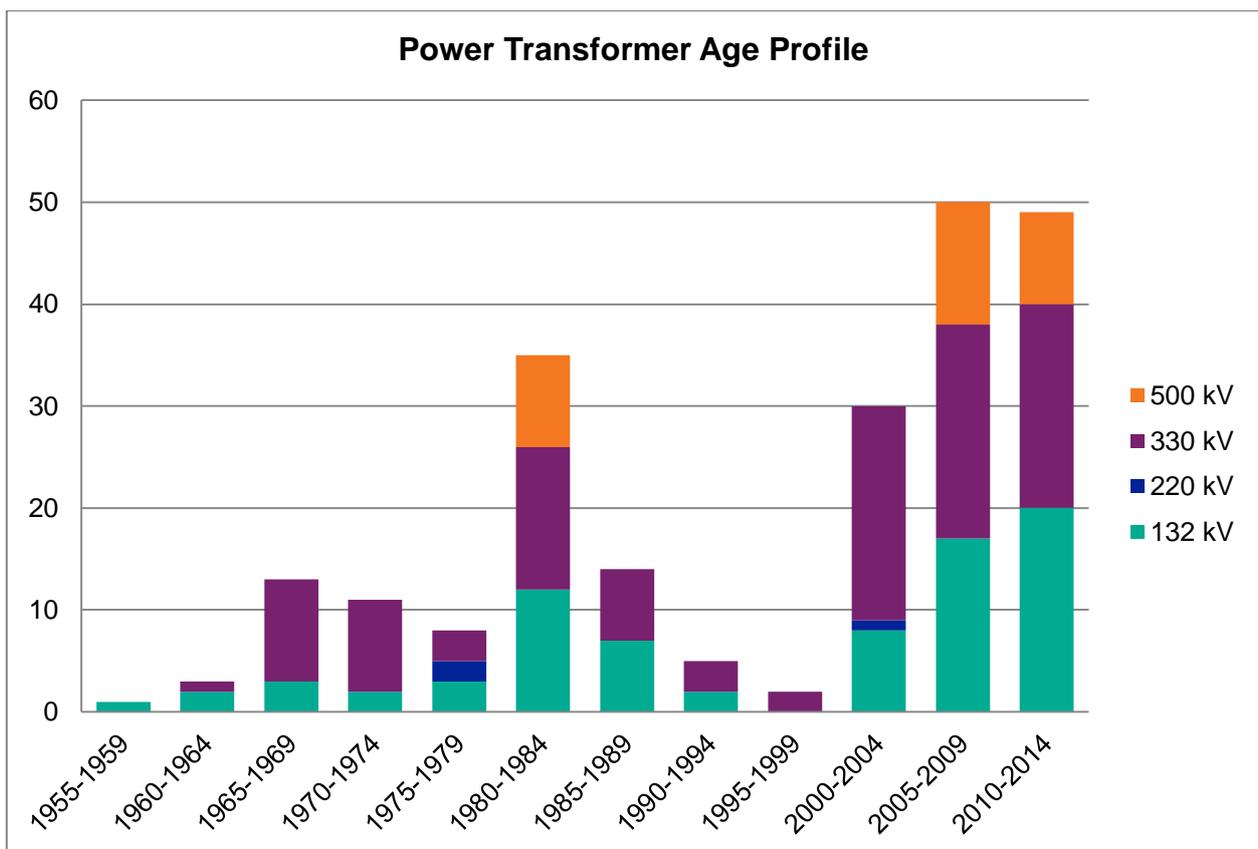
Figure 8: Power transformer – age profile

The power transformer age profile is shown in Figure 3. It shows that 9% were commissioned before 1971, and have thus exceeded their nominal lifespan of 45 years. Some of the oldest units were manufactured in 1955. The average age of TransGrid's transformer fleet is approximately 20 years.

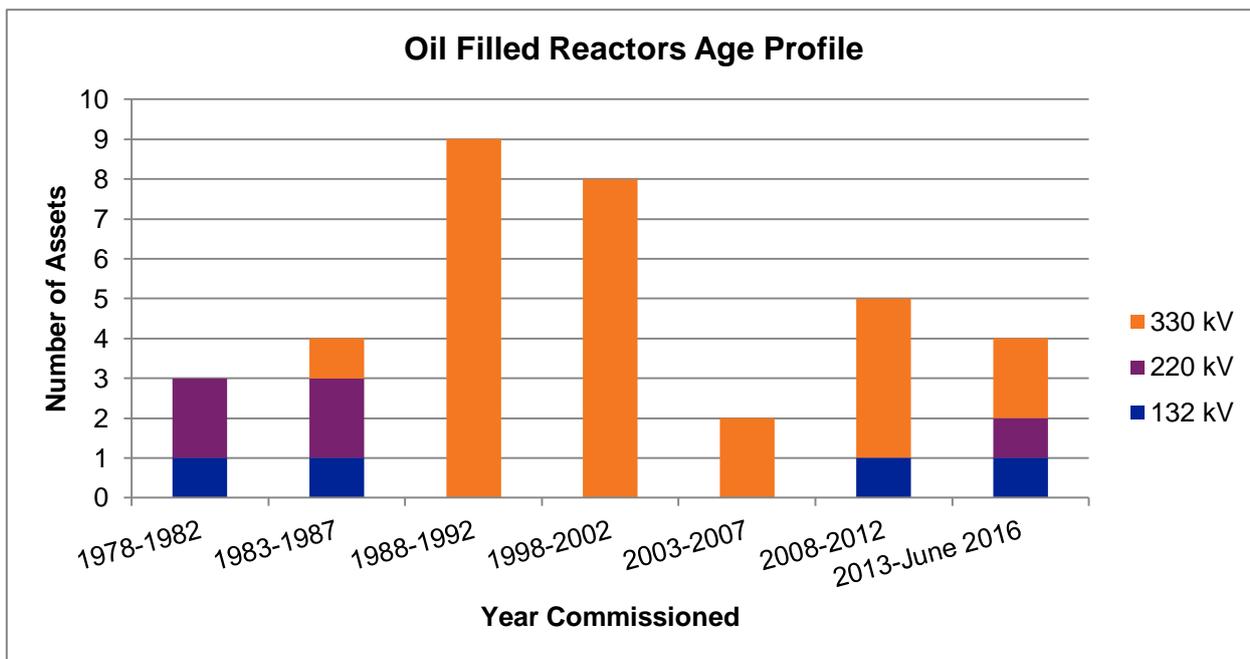
Figure 9: Oil Filled Reactors – age profile

The age profile for oil filled reactors is shown in Figure 8 below. However, given the small number of SF₆ insulated reactors and their relatively uniform operating life, graphical data regarding their age profile has not been included. Whilst the average age of the oil filled reactor population is approximately 17 years, 11% were commissioned before 1986 and have thus exceeded their nominal lifespan of 30 years, with the oldest units manufactured in 1978. Of the other reactors currently in service, the SF₆ reactors are installed in the Haymarket Indoor GIS Substation which was commissioned in 2004 and all are in an early stage of their life.

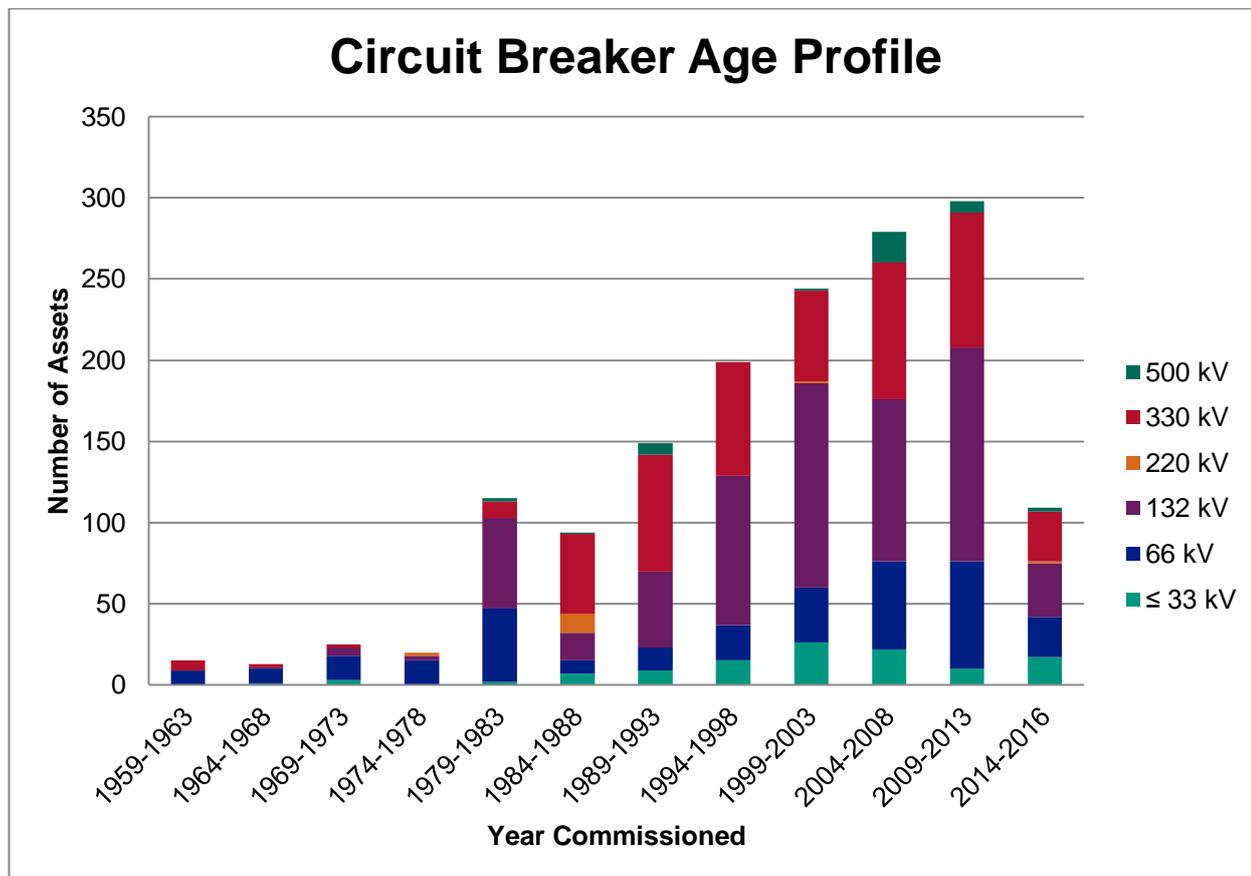
Figure 11: Circuit breaker – age profile

The CB age profile and population breakdown are shown in the Figure 7 and Figure 8. They show that 3.2% of the units were commissioned before 1976, and have thus exceeded their nominal lifespan of 40 years. The oldest units were manufactured in 1959. The CBs have an average age of approximately 16.5 years.

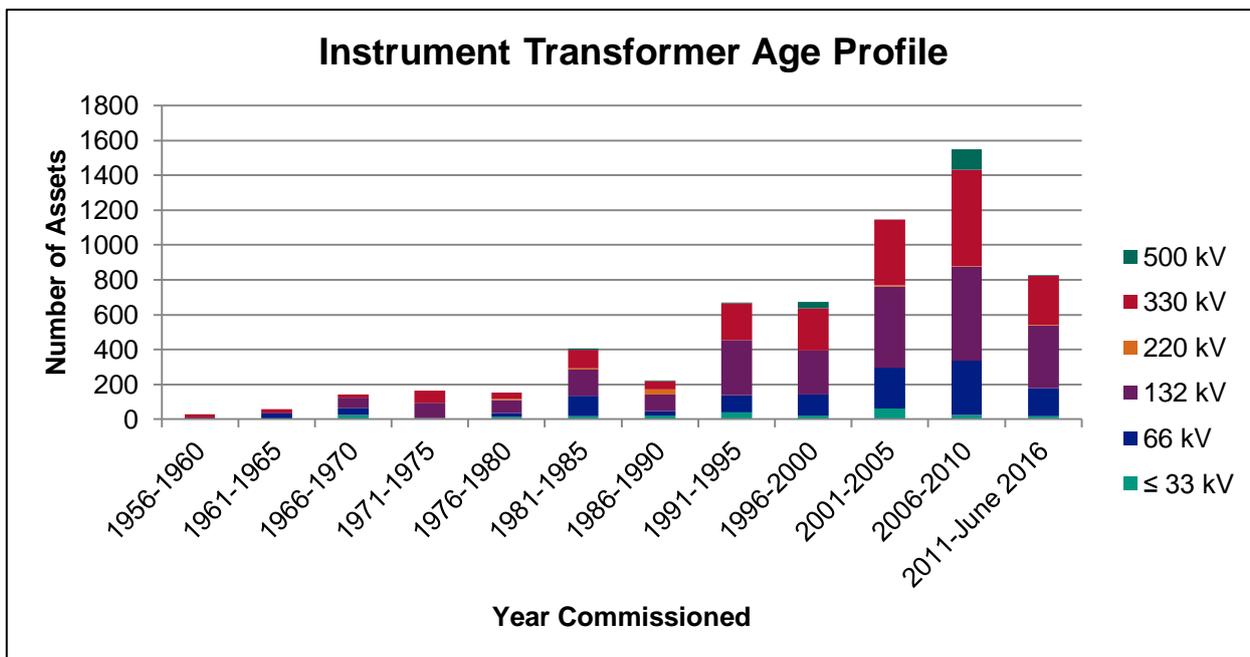
Figure 14: Instrument transformer – age profile

The instrument transformer age profile is shown in the Figure 15. It shows that approximately 7% of the units were commissioned before 1976, and have thus exceeded their nominal lifespan of 40 years. The oldest units were manufactured in 1956. The instrument transformers have an average age of approximately 17 years.

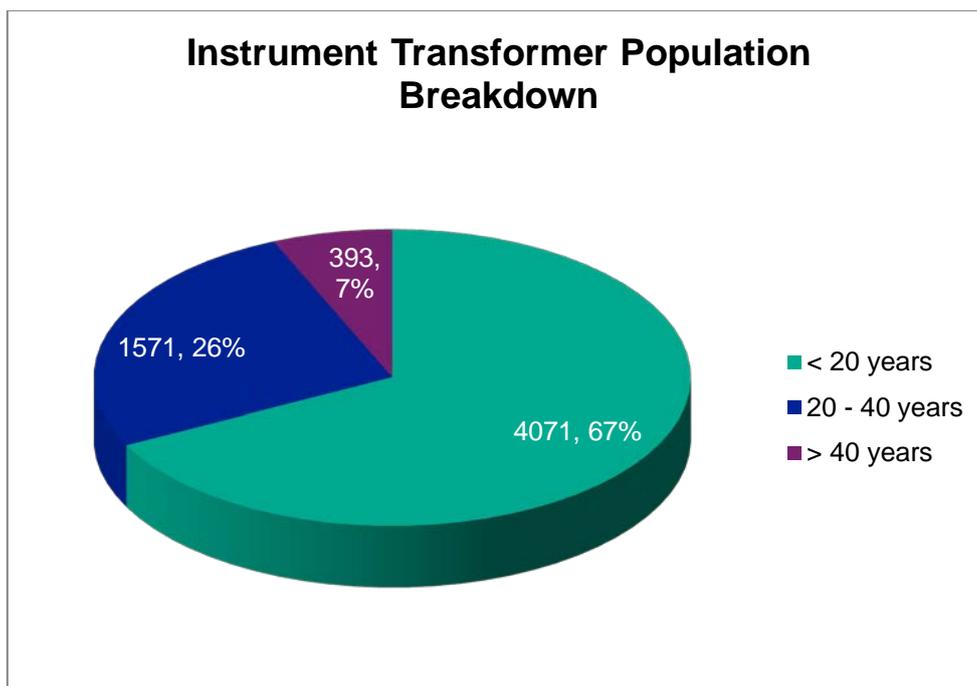
Figure 15: Instrument transformer – population age breakdown

The following Figure 16 shows the division of instrument transformers by age groups.

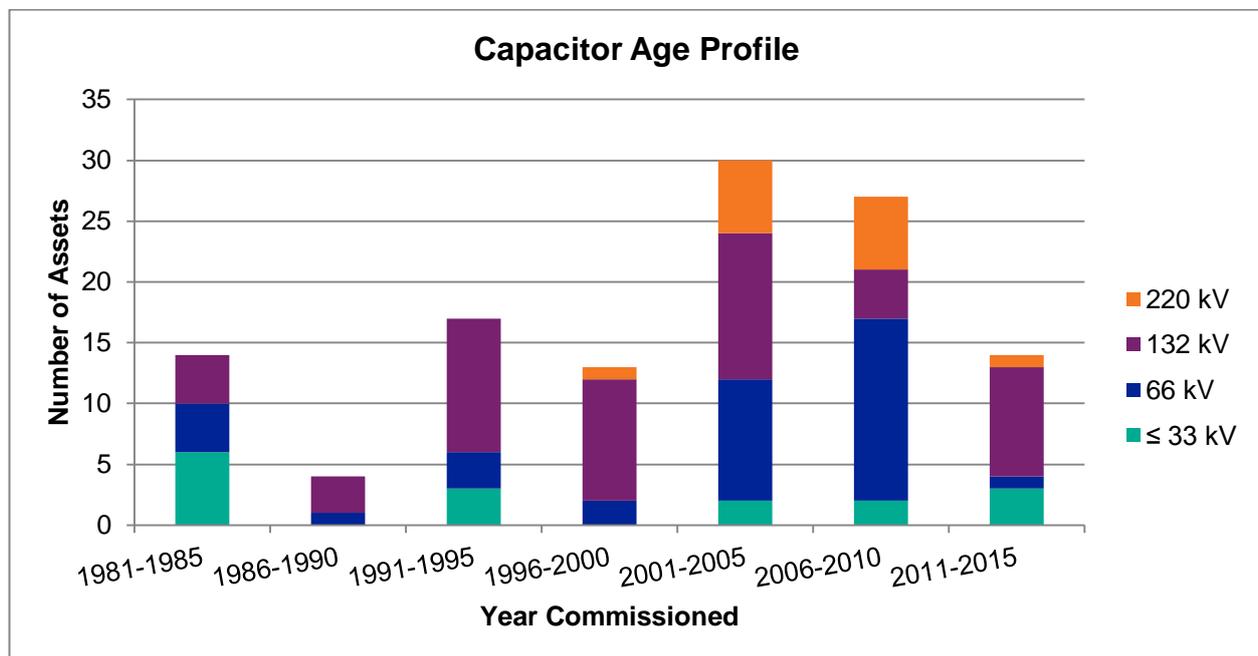
Figure 16: Capacitor Bank – Age profile

The majority of the capacitor units installed are of the internal fuse type but some externally fused units have also been used. All PCB filled capacitors have been replaced and it is for this reason that all of existing capacitors have been manufactured and installed since 1980.

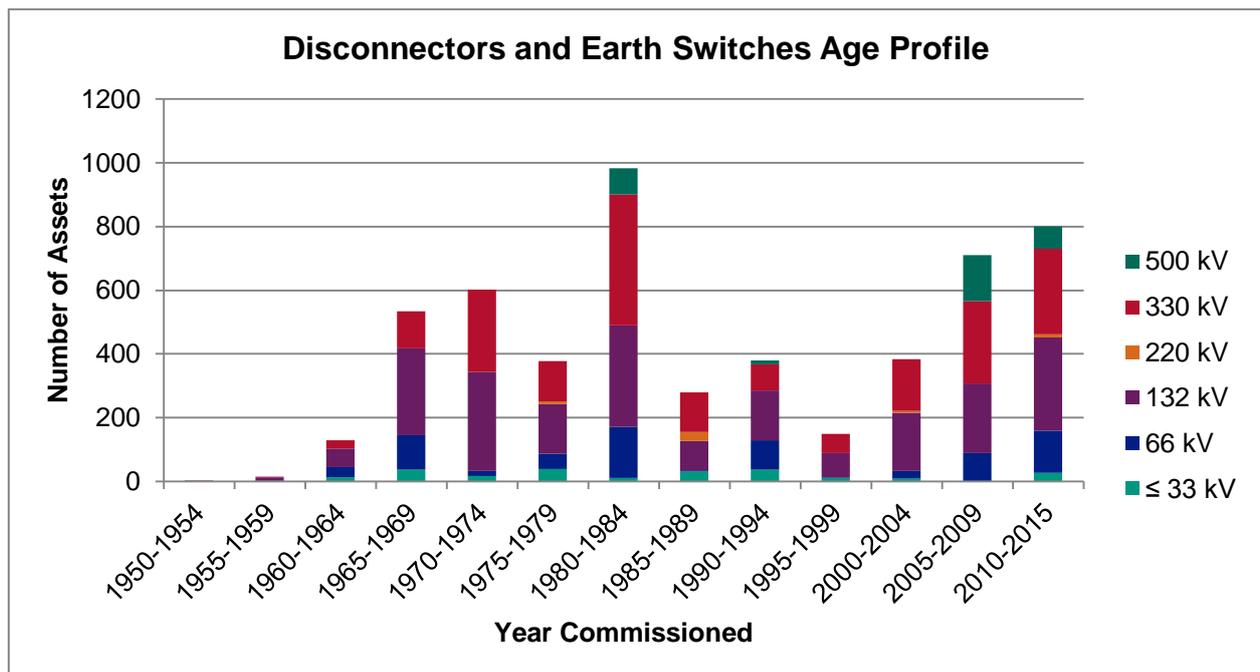
Figure 17: Disconnectors and Earth Switches – population profile

The disconnectors and earth switches age profile is shown in Figure 17 and Figure 18. It shows that approximately 25% of the units were commissioned before 1976, and have thus exceeded their nominal lifespan of 40 years. The oldest units were manufactured in 1950. The disconnectors and earth switches have an average age of approximately 27 years.

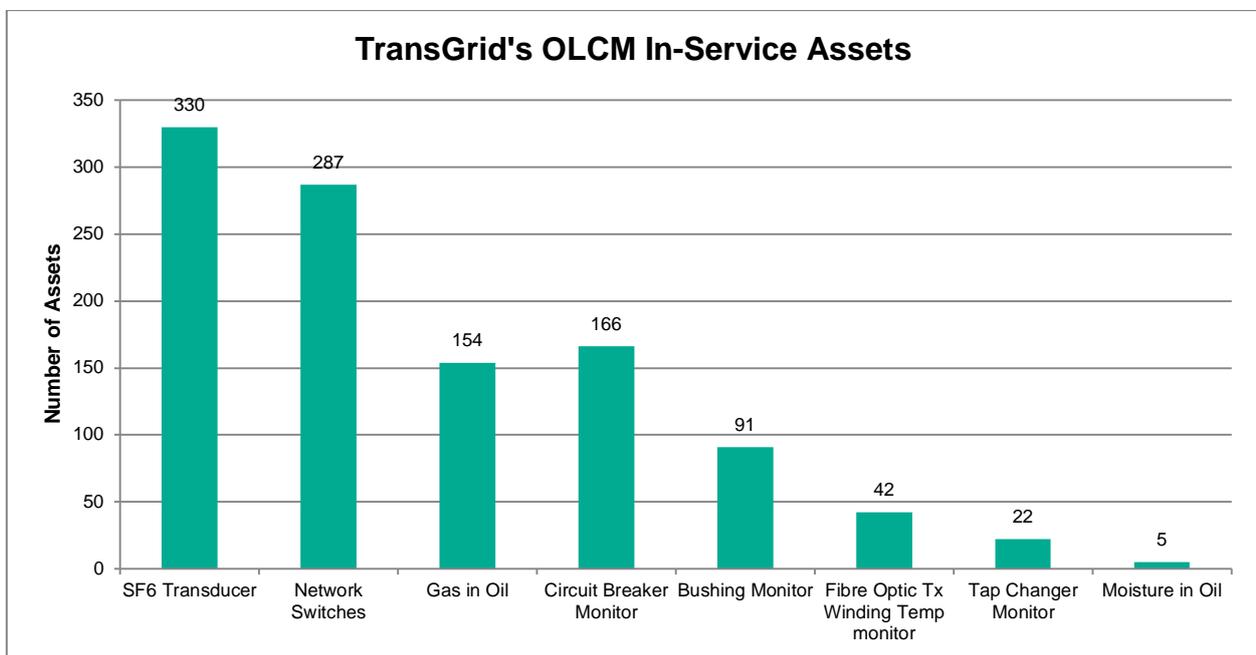
Figure 19: OLCM population profile

- Transformers:
 - Hydrogen (or volatile dissolved gases) in oil.
 - Moisture in oil
 - Bushing Tanδ and Capacitance
 - Diverter Switch drive torque
- Circuit breakers:
 - Timing and travel (during operation)
 - Operating mechanism current consumption
 - Insulating gas density
- Instrument transformers and GIS:
 - Insulating gas density

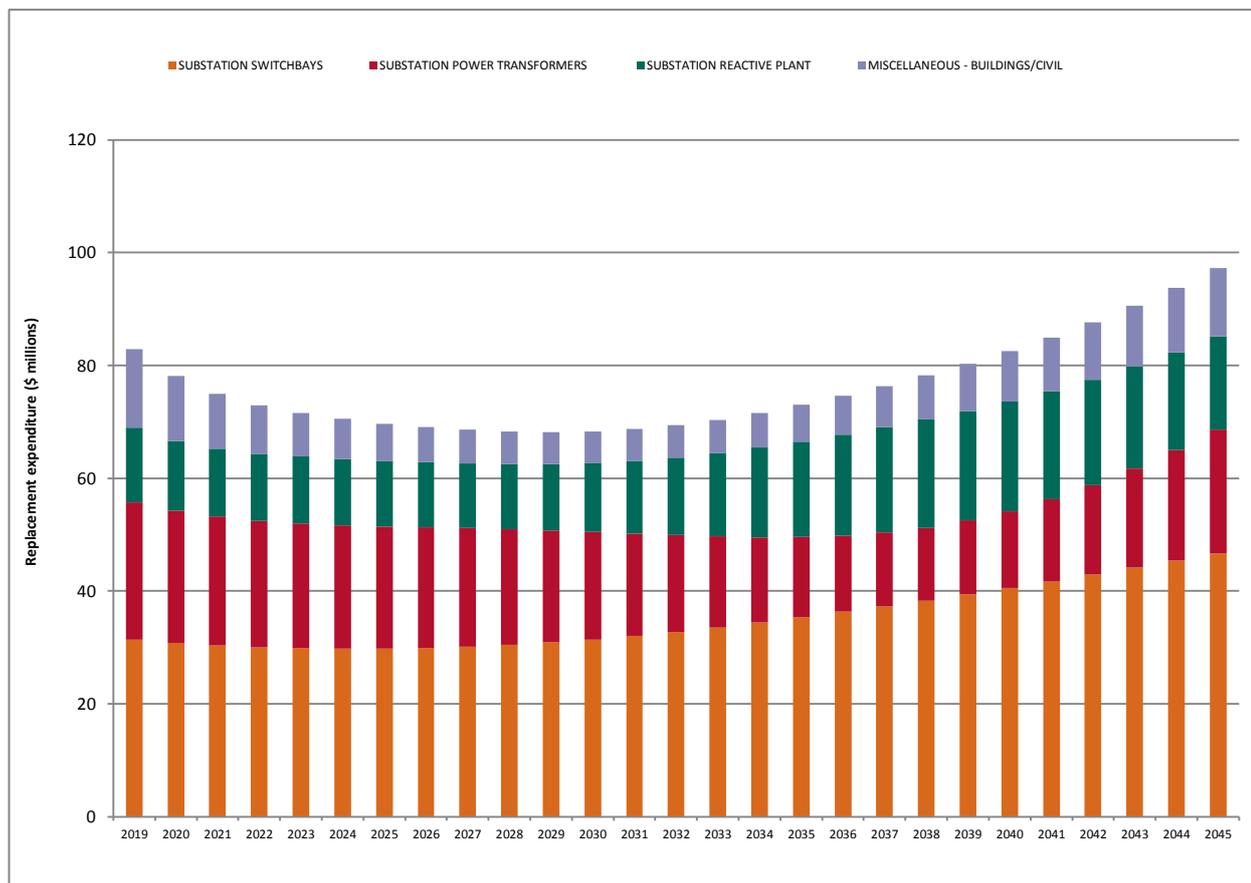
The outcomes of the review are shown in Figure 20 - Anticipated expenditure profile - below, which shows the future renewal, disposal and maintenance expenditure on an aged based assumption in 2016/17 dollars.

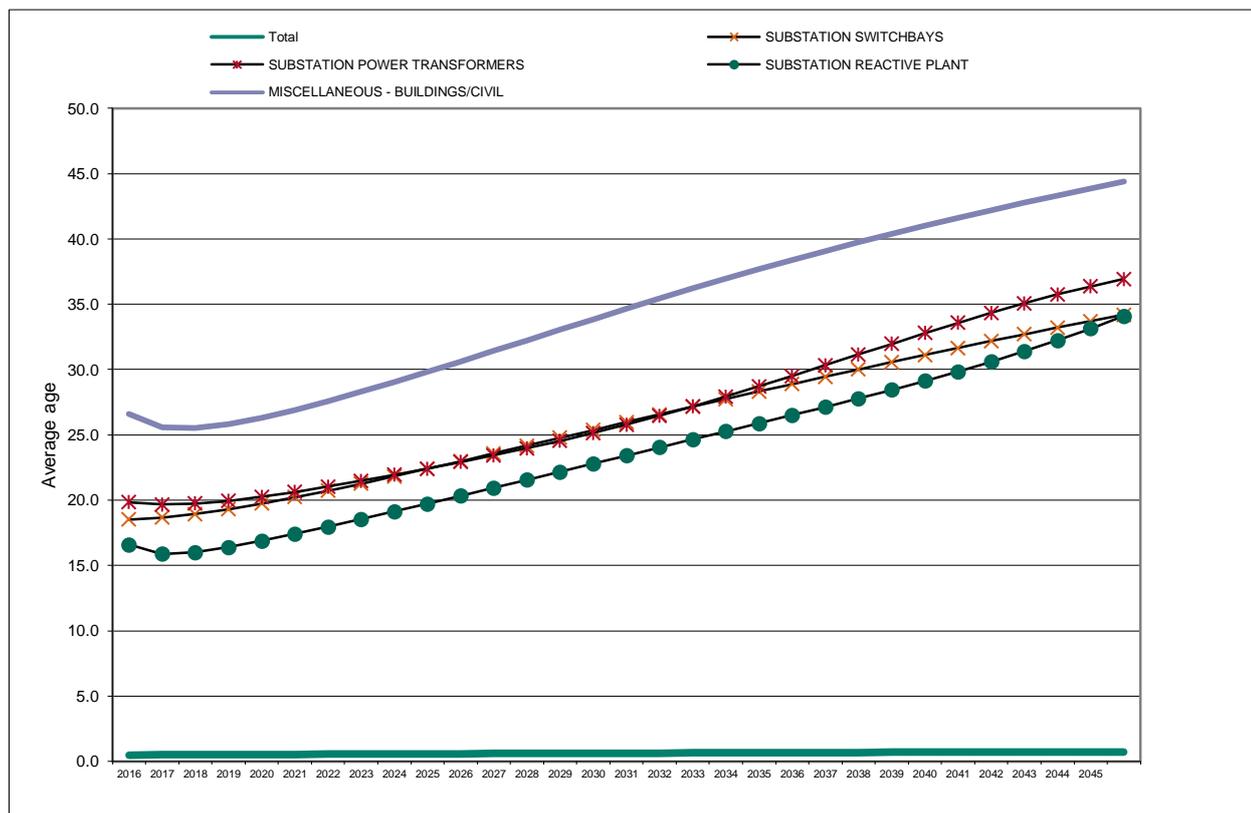
Figure 21 - Projected average age

Using the same age based model, the average age of substation equipment profiles has been projected and is included below in Figure 21 - Projected average age. Over the longer term, an increase in average age can be seen. This has the potential to increase failure rates and lower the overall performance of the network. Additional measure may become necessary to manage the additional risk. The increase is gradual and not significant in a ten year time frame but the situation will be monitored.
