## Transmission Line Renewal and Maintenance Strategy

### Summary

This strategy guides the management of TransGrid's existing transmission line assets.

<b>Revision no:</b>	4	<b>HP TRIM No:</b>	D2014/18624	<b>Approval/ Review Date:</b>	14 December 2016
<b>Business function:</b>	Strategic Asset Management			<b>Document type:</b>	Strategy
<b>Process owner:</b>	Transmission Lines and Cables Asset Manager				
<b>Author:</b>	Jeffree Cairns – Asset Strategist Robert Alcaro – Asset Strategist				
<b>Reviewers:</b>	Steve Stavropoulos – Transmission Lines and Cables Asset Manager				
<b>Approver:</b>	Lance Wee – Manager/Asset Strategy

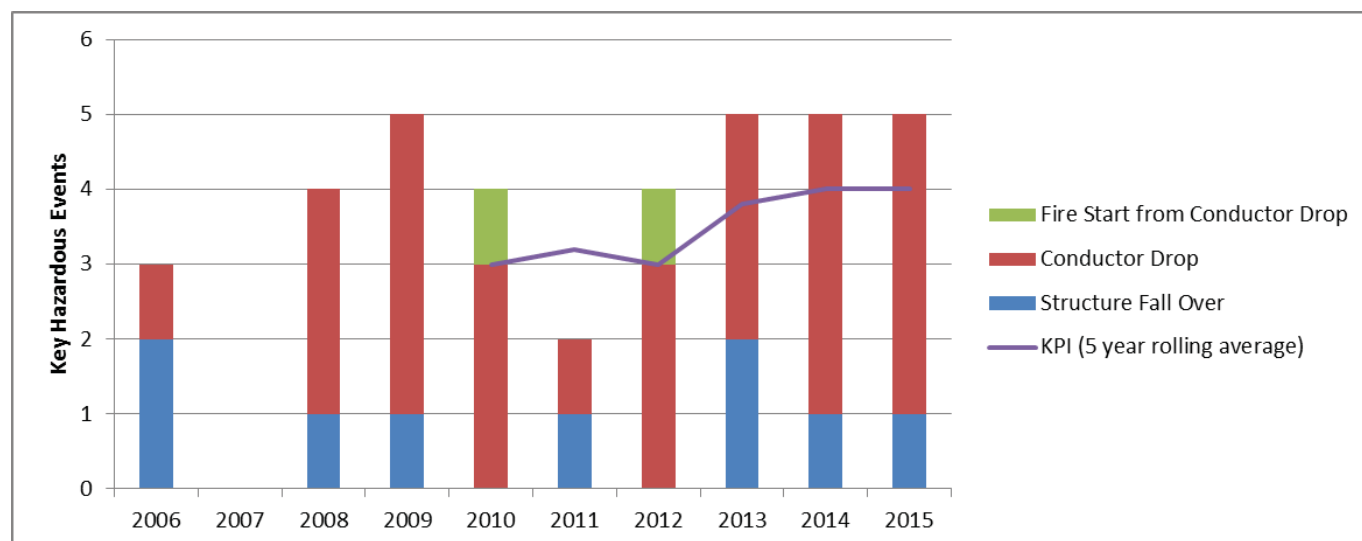
**Figure 2: Transmission Line Failures by Hazard Type**

The Transmission Line failure KPI has not been met since 2011, as shown in Figure 2.

Note: Counts are by calendar years.

The Transmission Line failure KPI has not been met since 2011, as shown in Figure 2.

Asset Management Objectives	Asset Management Performance Indicator	Past Performance
<ul style="list-style-type: none"> <li>Manage network related public and staff safety risks to As Low As Reasonably Practicable (ALARP)/So Far As Is Reasonably Practicable (SFAIRP)</li> <li>Manage network related bushfire risks (people safety) to ALARP/SFAIRP</li> </ul>	<ol style="list-style-type: none"> <li>Zero asset related LTI's</li> <li>Zero asset related fire starts</li> <li>Maintain Key Hazardous Events at 5 year average level:               <ol style="list-style-type: none"> <li>Conductor drop</li> <li>Structure failure</li> <li>Uncontrolled discharge/contact with electricity</li> </ol> </li> </ol>	<ul style="list-style-type: none"> <li>Zero LTI due to asset failure KPI was met.</li> <li>As shown in Figure 3, the fire starts KPI was not met in the 2015 calendar year, but was met the two years prior. The KPI will be met for 2016 if there are no further incidents.</li> <li>Key hazardous event trending is shown below in Figure 2 . This KPI has not been met since 2011.</li> </ul>

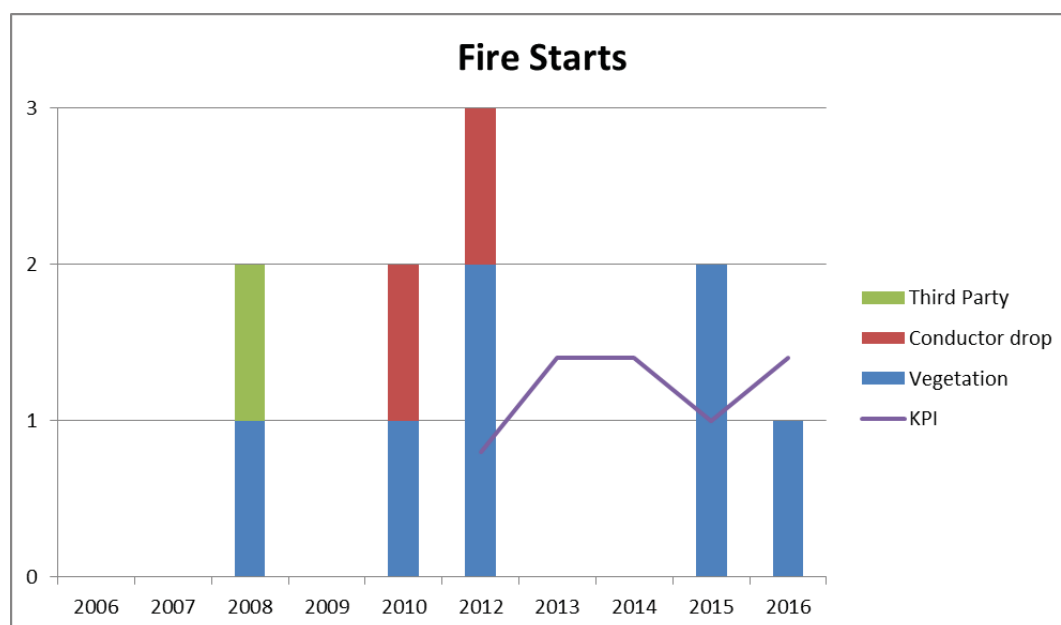
**Figure 3: Fire Starts**

As shown in Figure 3, the fire starts KPI was not met in the 2015 calendar year, but was met the two years prior. The KPI will be met for 2016 if there are no further incidents.

Notes:

- Counts are by calendar years.
- Third party fire start was due to aircraft strike causing conductor to drop

As shown in Figure 3, the fire starts KPI was not met in the 2015 calendar year, but was met the two years prior. The KPI will be met for 2016 if there are no further incidents.

Minimise environmental harm and property damage	Maintain 5 year level average of fire starts	Transmission line fire starts are as per Figure 3. There has not been a fire start due to transmission line asset failure since 2012. In terms of transmission line assets alone this KPI can be considered met, however when easements are considered the target was not met in 2015 calendar year due to vegetation grow-ins and fall-ins.
Maintain network reliability	Maintain 5 year average level of loss of supply events due to Transmission Line asset faults (by calendar year)	The five year loss of supply events are shown in Figure 4. The KPI was achieved in the 2014 and 2015 calendar years but will not be met in 2016 calendar year as the target has been exceeded.
Pursue STPIS revenue where cost effective	Better than average performance of the STPIS measures: Transmission line fault and forced outage rates	<p>The transmission line fault outage rate has been reducing on an average basis since 2009.</p> <p>The 2015 calendar year for forced outage rate was the worst on record, this measure trending to be below average for 2016 (data until October).</p> <p>The STPIS performance is shown in Figure 5</p>

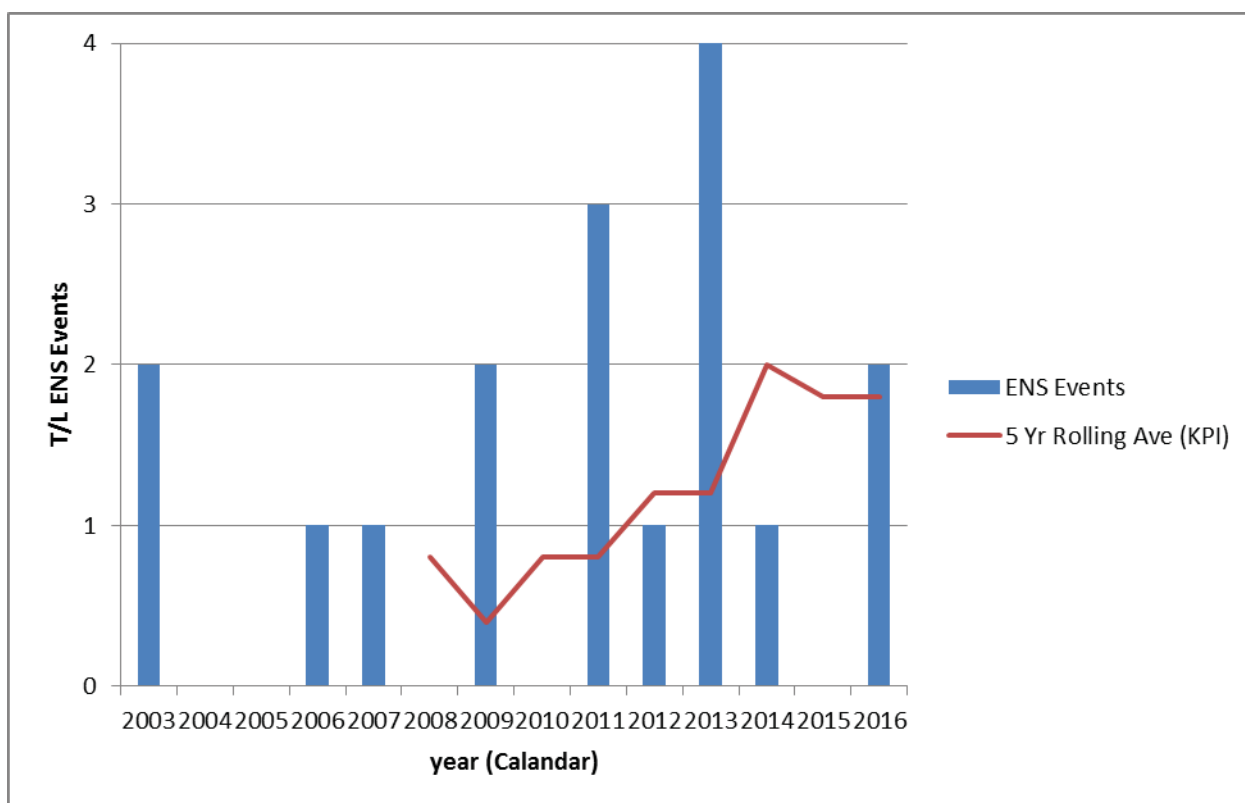
**Figure 4: Transmission Line Energy Not Supplied Events**

The KPI (ENS events less than 5 year rolling average) was met in the 2014 and 2015 calendar years. The current 2016 year events have exceeded the KPI target.

Note: Counts are by calendar years.

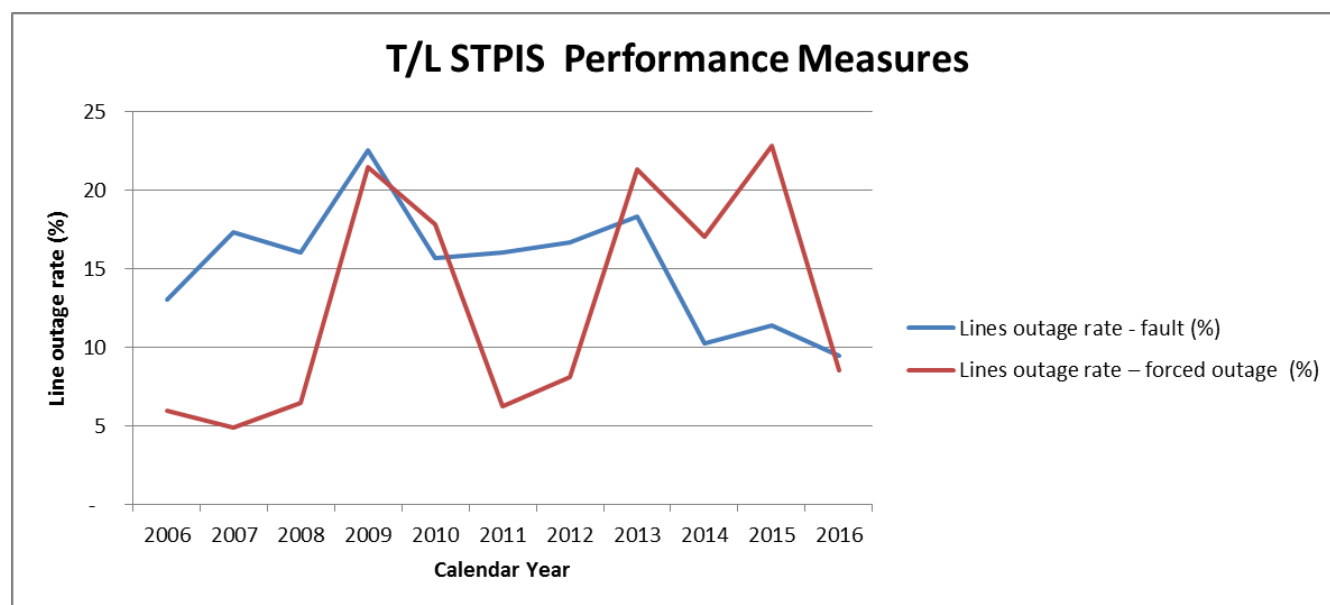
**Figure 5: Transmission Line STPIS Performance Measures**

In regards to STPIS performance, the transmission line fault outage rate has been reducing on an average basis since 2009. The 2015 calendar year for forced outage rate was the worst on record. The 2016 figure (to October) is tracking to meet the KPI.

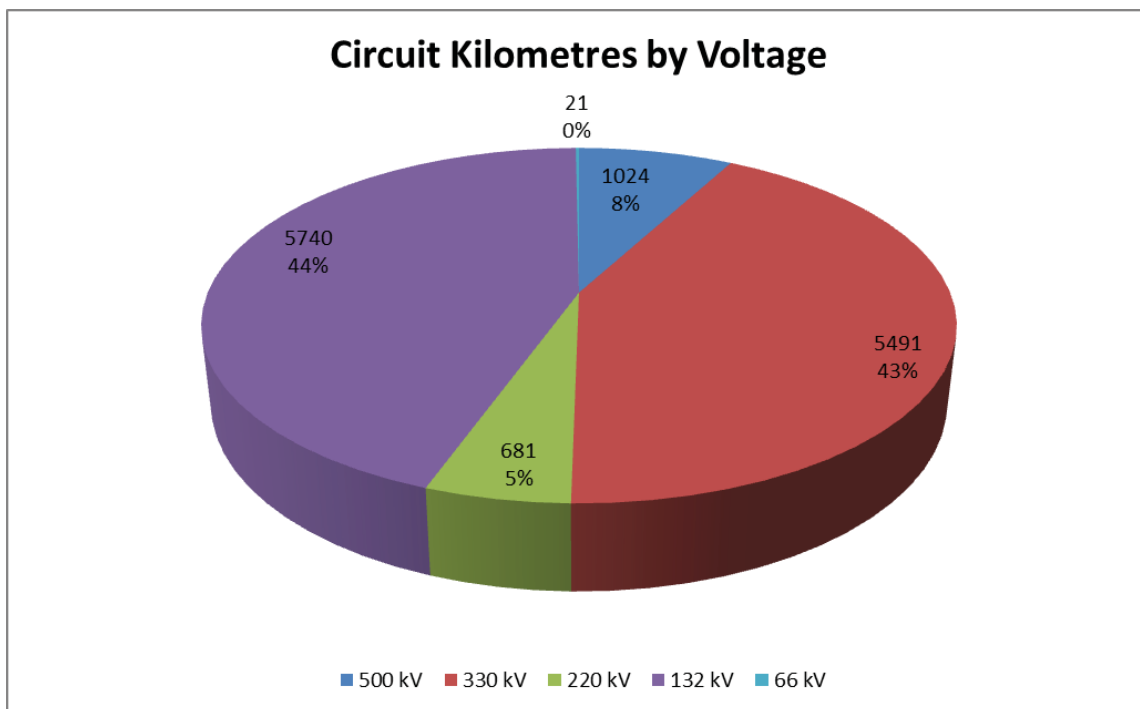
**Figure 6: Transmission Line Assets by Voltage.**

The breakdown of total circuit length is shown by voltage in Figure 6.

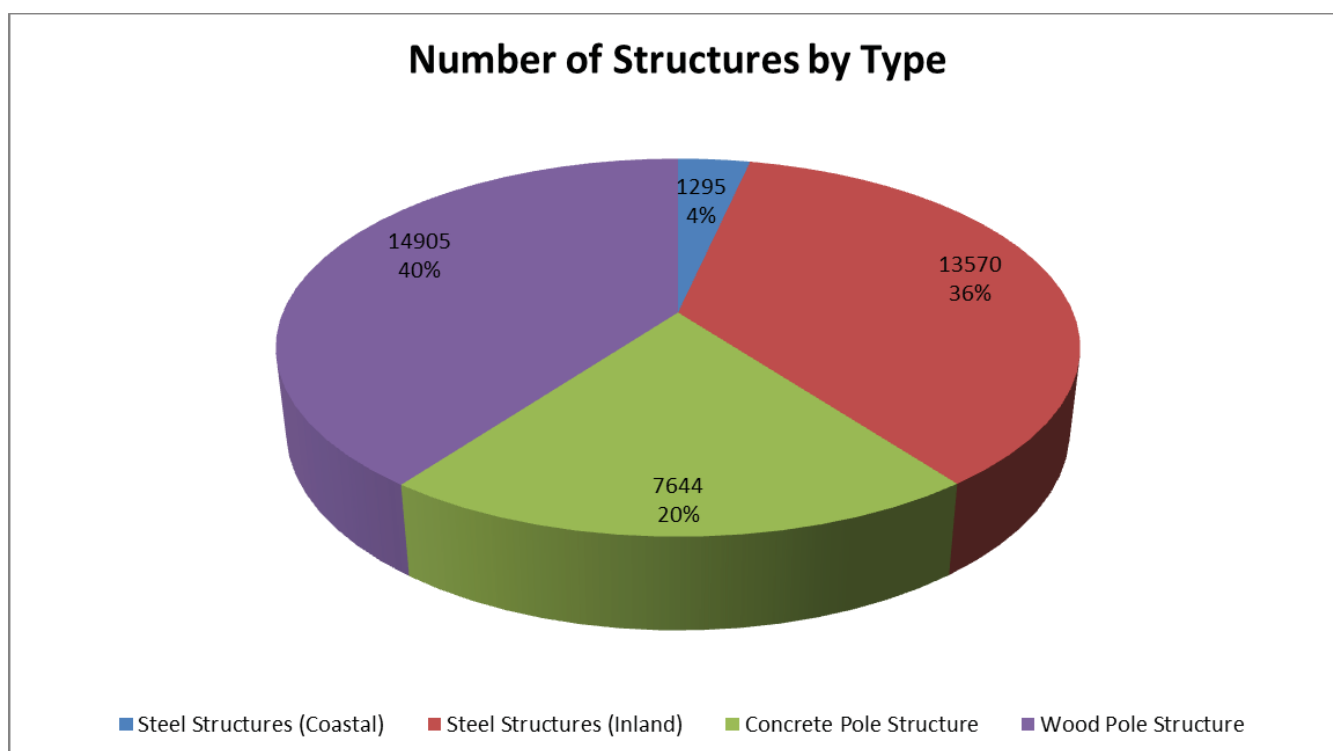
**Figure 7: Transmission Line Assets by Structure Type.**

TransGrid's transmission line assets are broken down by structure type in Figure 7.

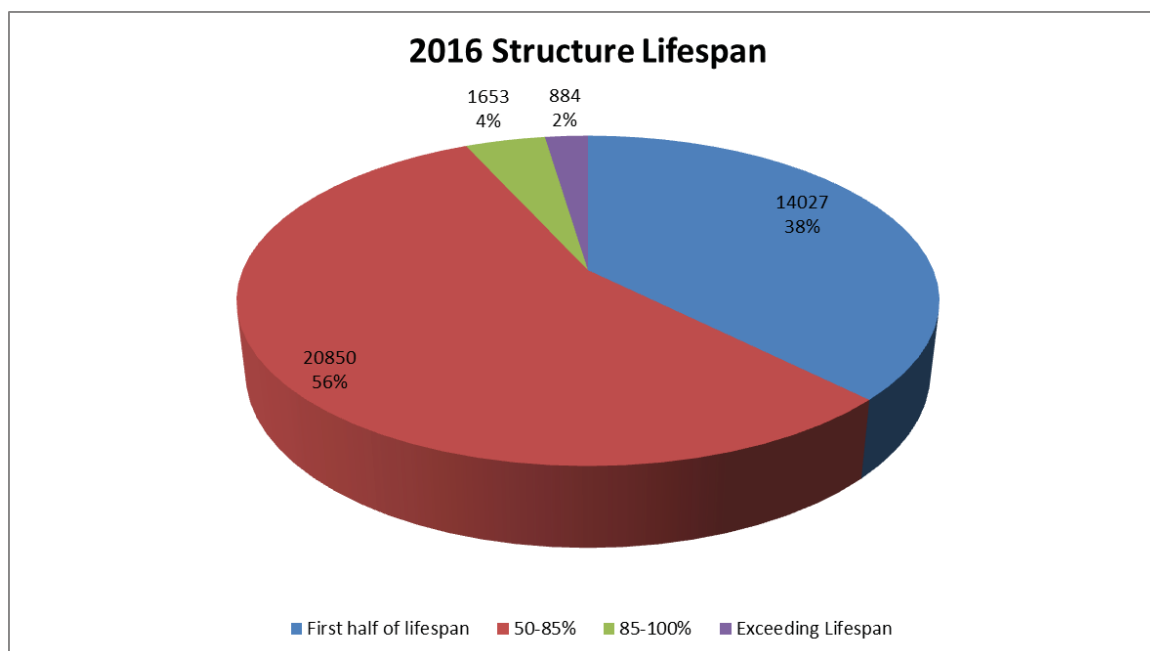
**Figure 8 2016 Structure Remaining Life**

Analysed on a remaining life basis, at June 2016 the asset age profile is as shown in Figure 8.

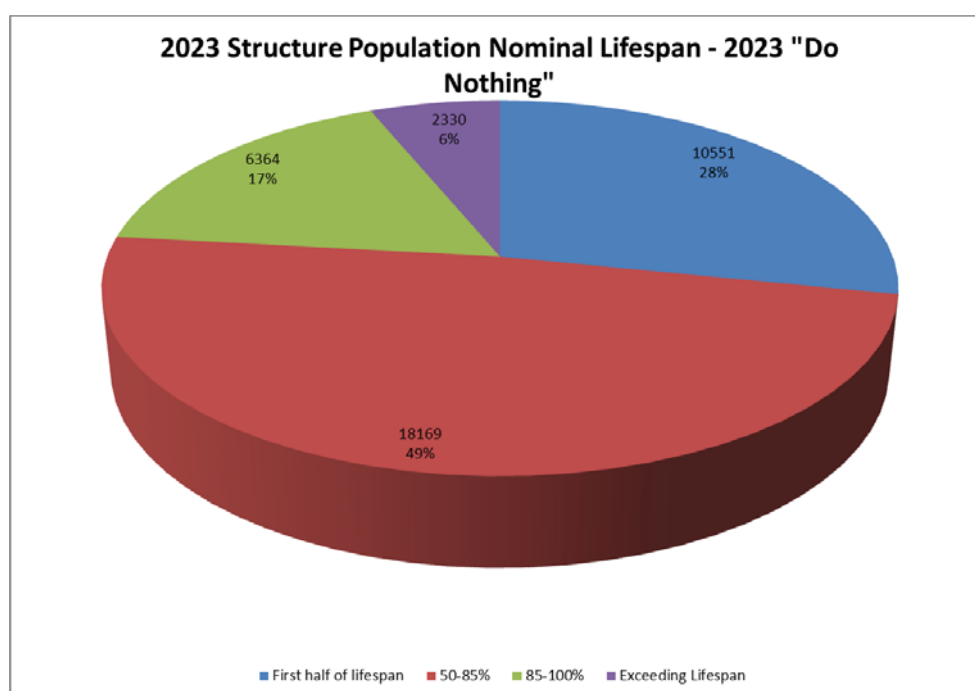
**Figure 9: 2023 structure lifespan “do nothing” forecast.**

Analysed on a remaining life basis, if no intervening measures are taken, the 2023 forecast profile will be as per Figure 9.

This age profile shows that around 23% of TransGrid’s transmission line assets are approaching or exceeding their nominal lifespan at the end of the 2023 period (an increase from 6%); which indicates that these assets are likely to be subject to deteriorating health and obsolescence issues. The assets that are approaching or exceeding their nominal lifespan within the period are as follows:

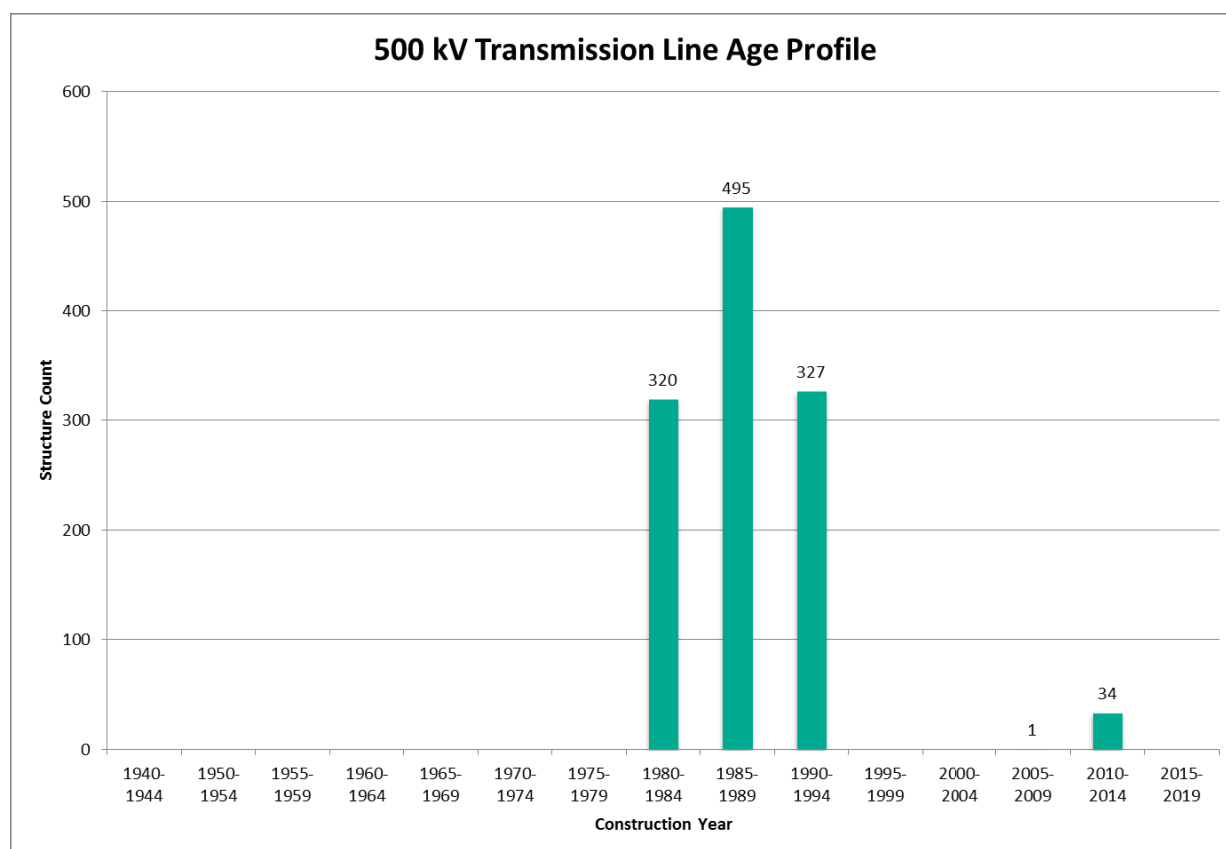
Figure 10: 500 kV Transmission Line Age Profile

The age profile of TransGrid's 500 kV transmission line assets is shown in Figure 10.

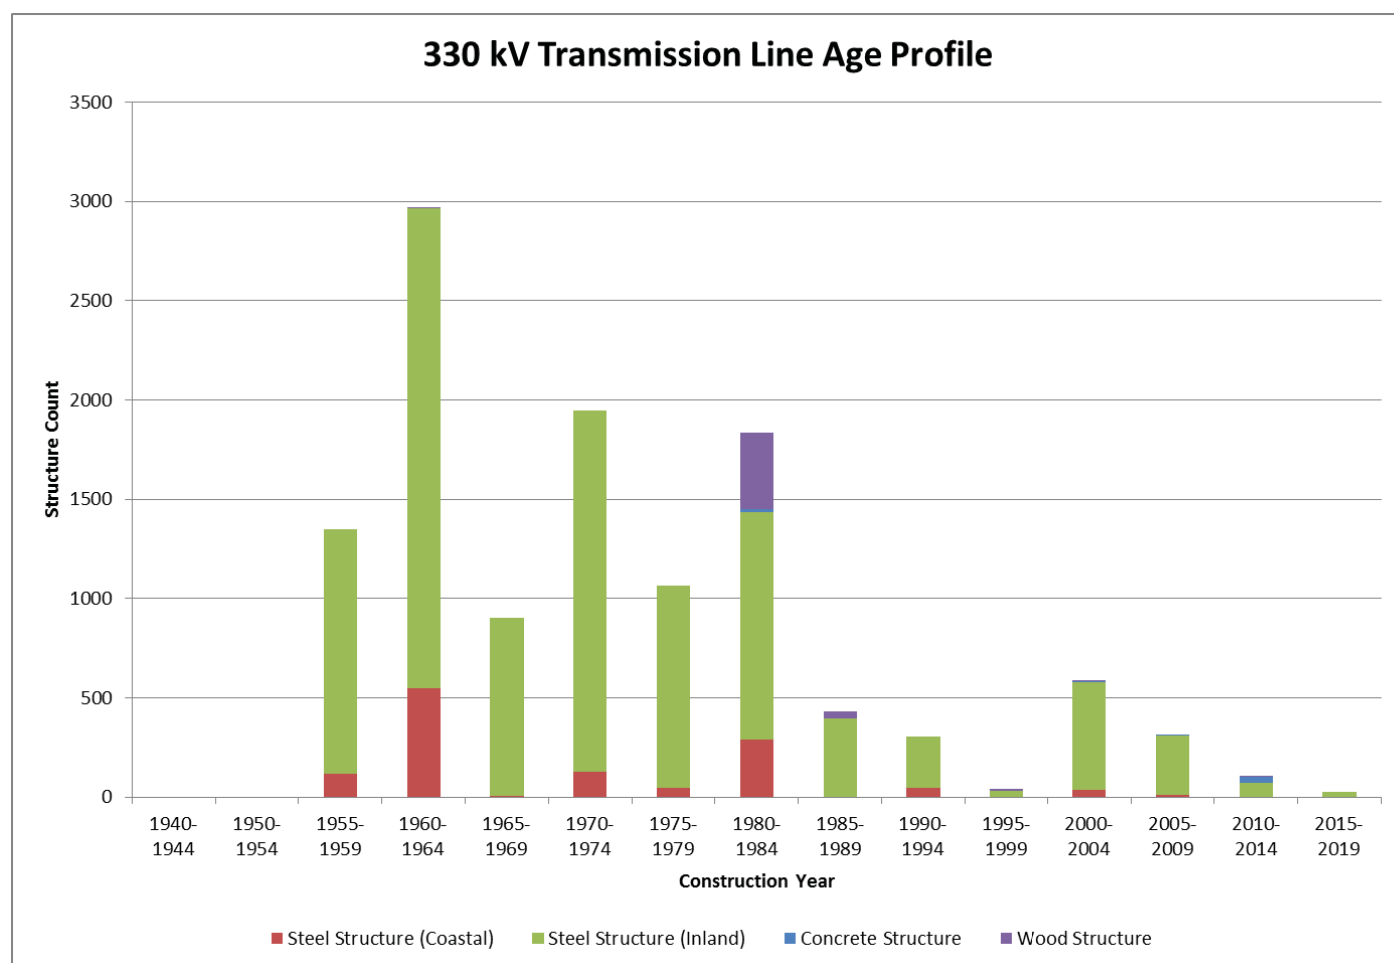
Figure 11: 330 kV Transmission Line Age Profile.

The age profile of TransGrid’s 330 kV transmission line assets is shown in Figure 11.

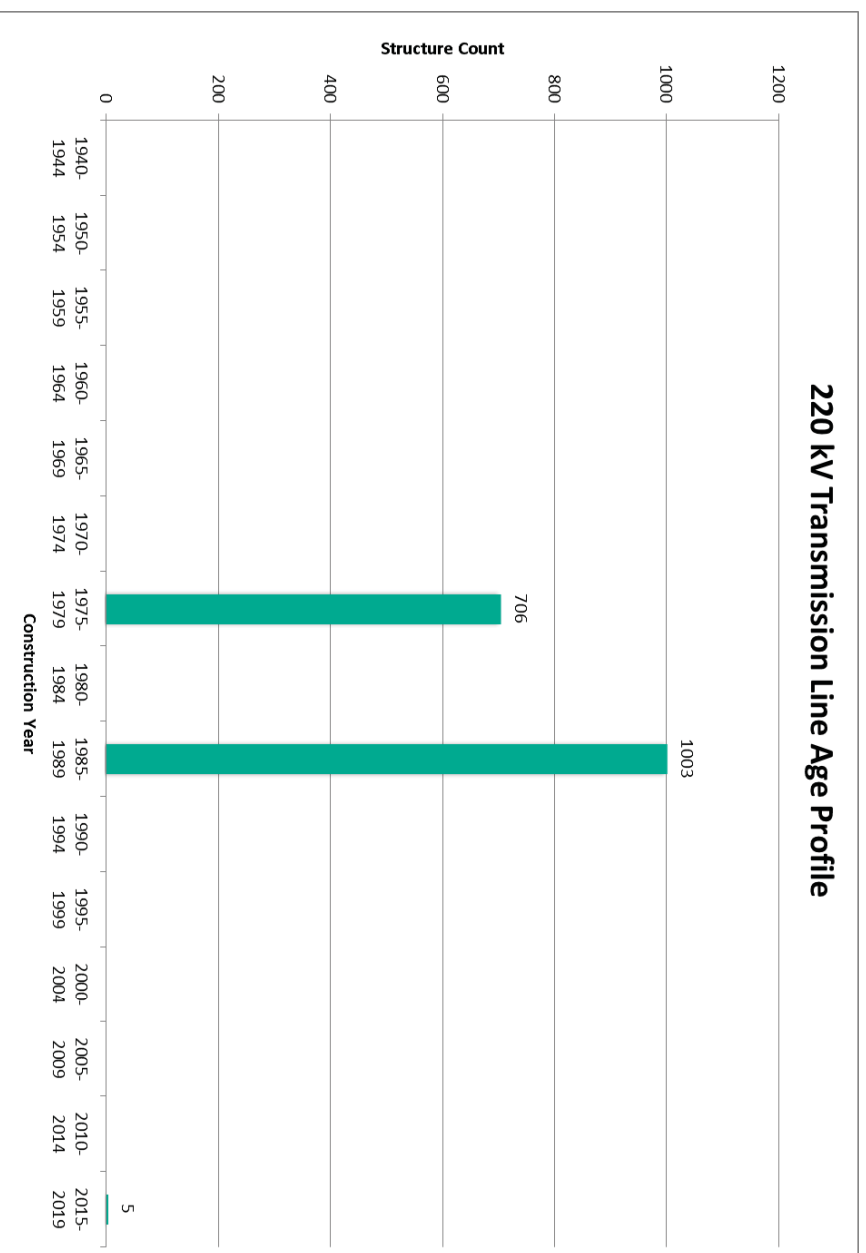
Figure 12: 330 kV Transmission Line Age Profile.

The age profile of TransGrid's 220 kV transmission line assets is shown in Figure 11.

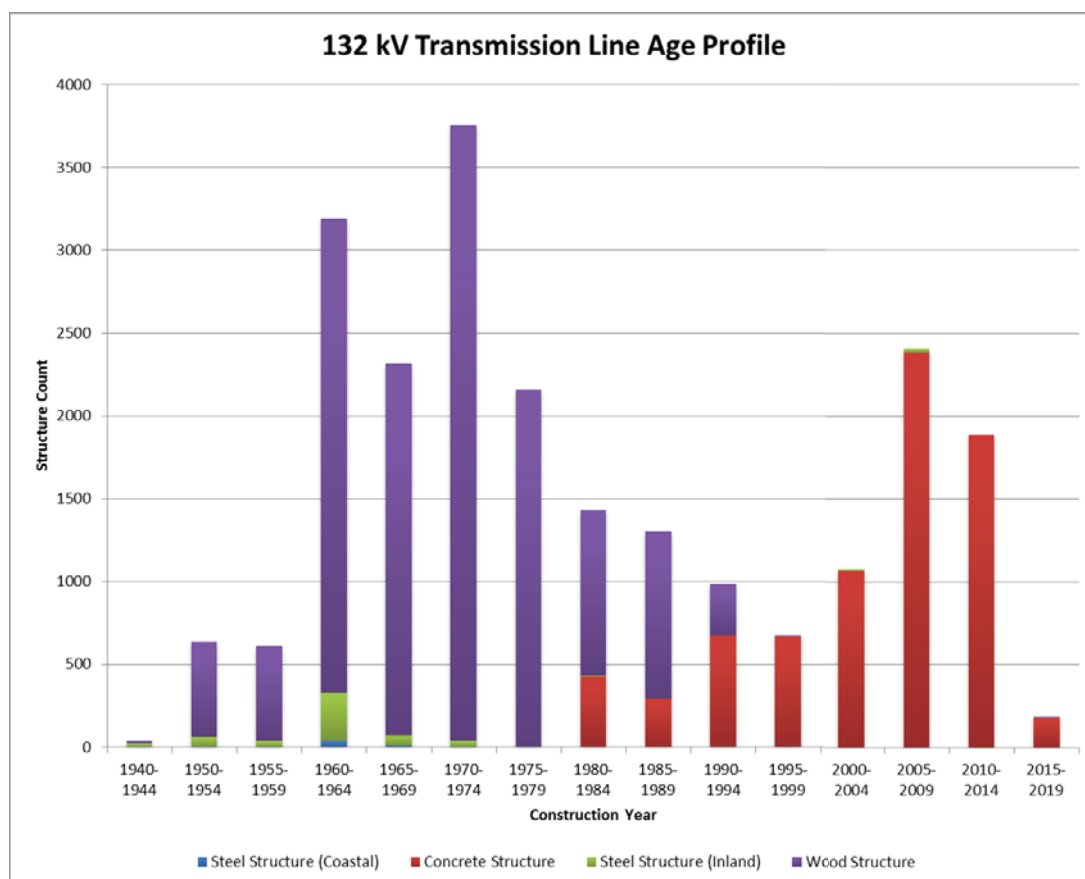
Figure 13: 132 kV Transmission Line Age Profile

The age profile of TransGrid’s 132 kV transmission line assets is shown in Figure 13.

The above age profile shows that prior to the 1990s, the majority of TransGrid's 132 kV installations were wood pole structures and since the 1990s the majority of installations have been concrete pole structures. Notwithstanding any intervening actions, over the 2023 period, the above age profile will result in the outcome shown in Figure 14.

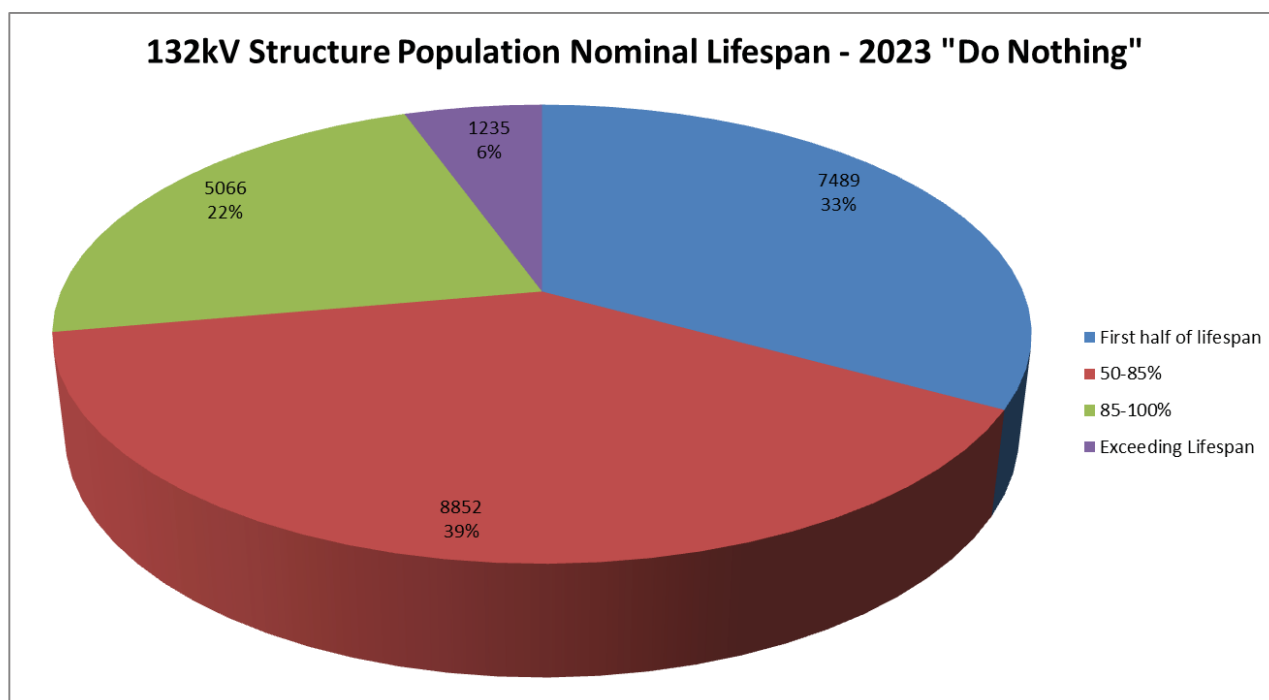
Figure 14: 132 kV Transmission Line Age versus Nominal Lifespan

This age distribution shows that around 28% of TransGrid's 132 kV transmission line assets are approaching or exceeding their nominal lifespan; which indicates that these assets are likely to be subject to deteriorating health and obsolescence issues.

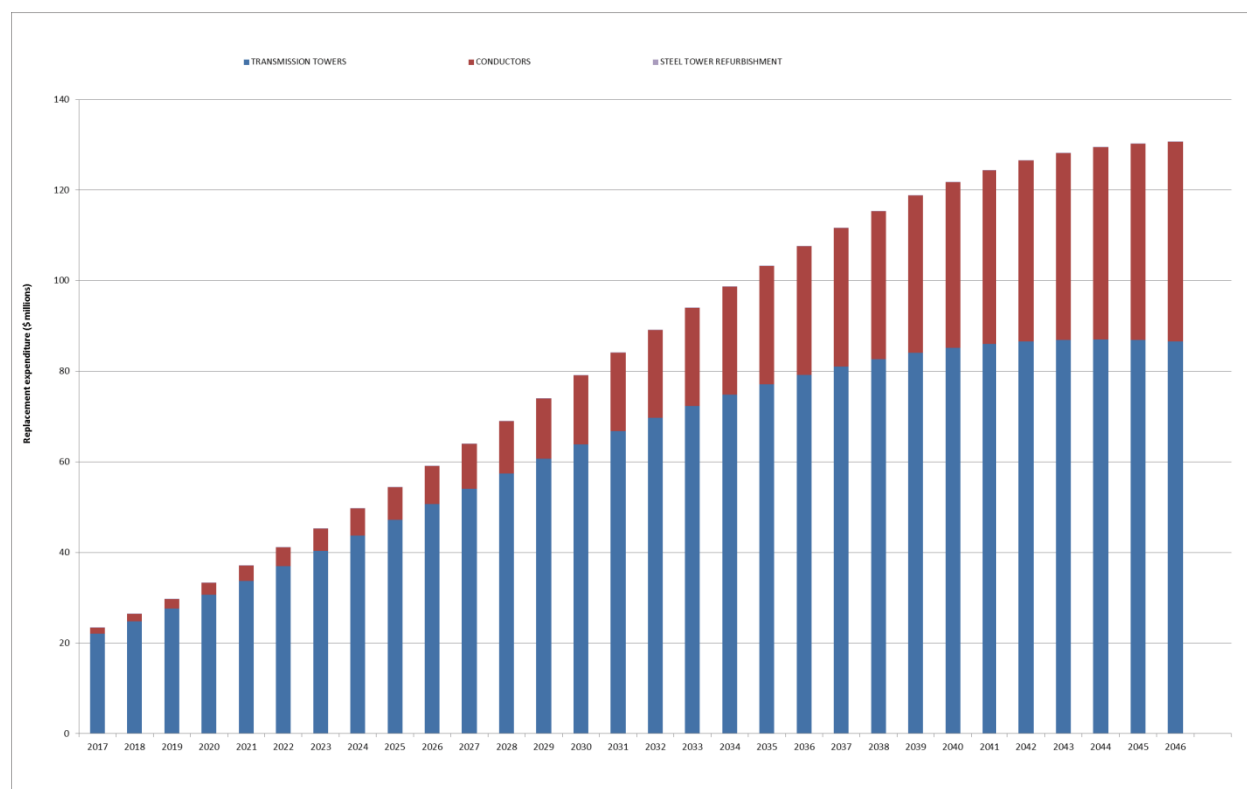
**Figure 15: Long Term Forecast Capital Expenditure Based on Age**

Figure 15 below shows the future renewal, disposal and maintenance expenditure on an aged based assumption in 2016/17 dollars.

This graph should be taken as a guide only as expenditure on transmission line assets is condition based. For example in the 2018-23 regulatory period TransGrid has proposed \$325.2M in transmission line capital expenditure. The forecast spend in the REPEX model is \$183.9M. This reason for the departure is due to a handful of unique issues that fall outside the model. These are:

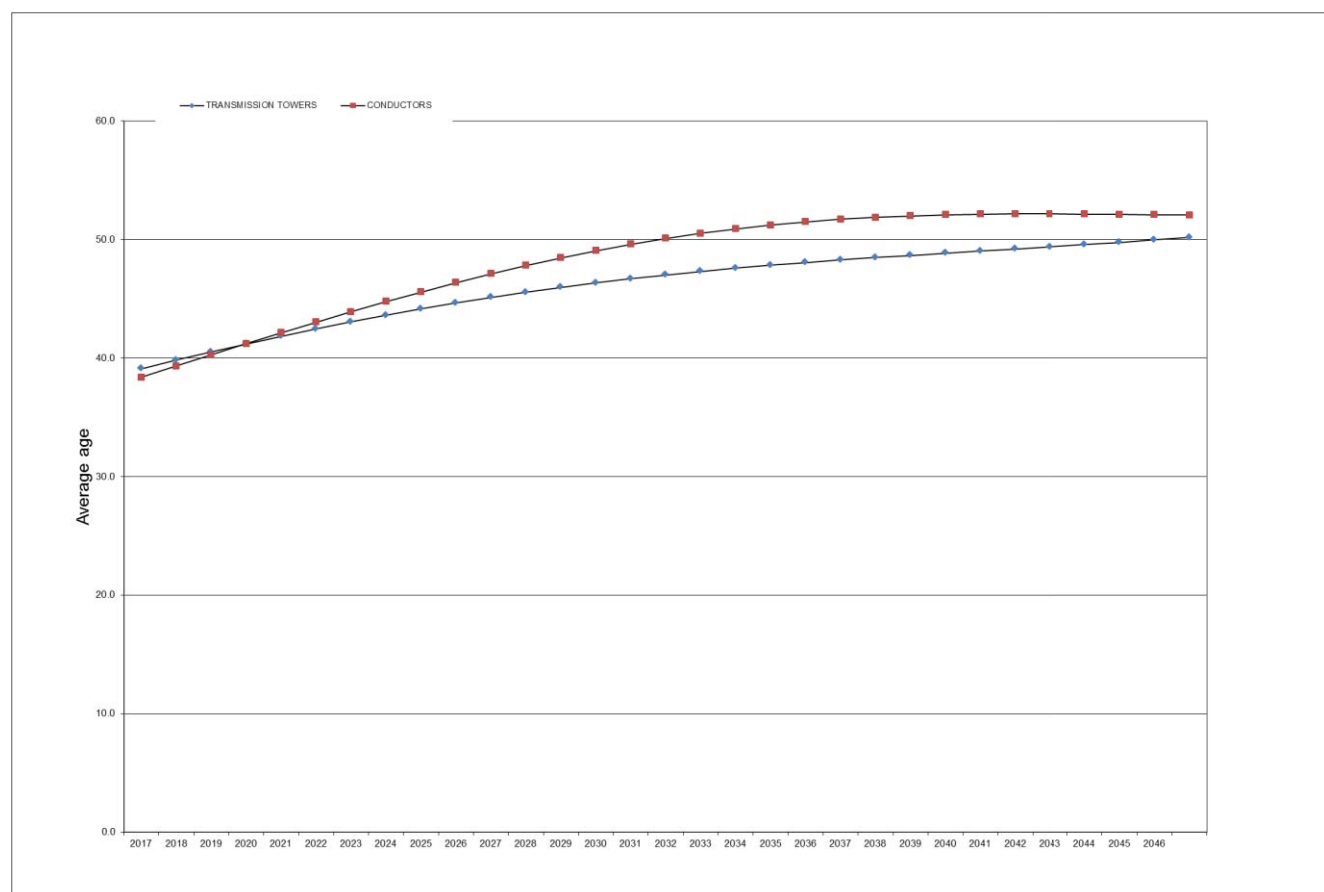
Figure 16: Long Term Forecast Average Age

The proposed long term age based capital forecast would result in an average age profile as shown in Figure 16.

It is clear that even with the large capital expenditure in the long term forecast, the average age of the tower assets are still increasing albeit at a slower rate. This will need to be addressed through strategies which increase the life of assets or replace old assets with new assets at a sustainable rate. The conductor age will plateau.

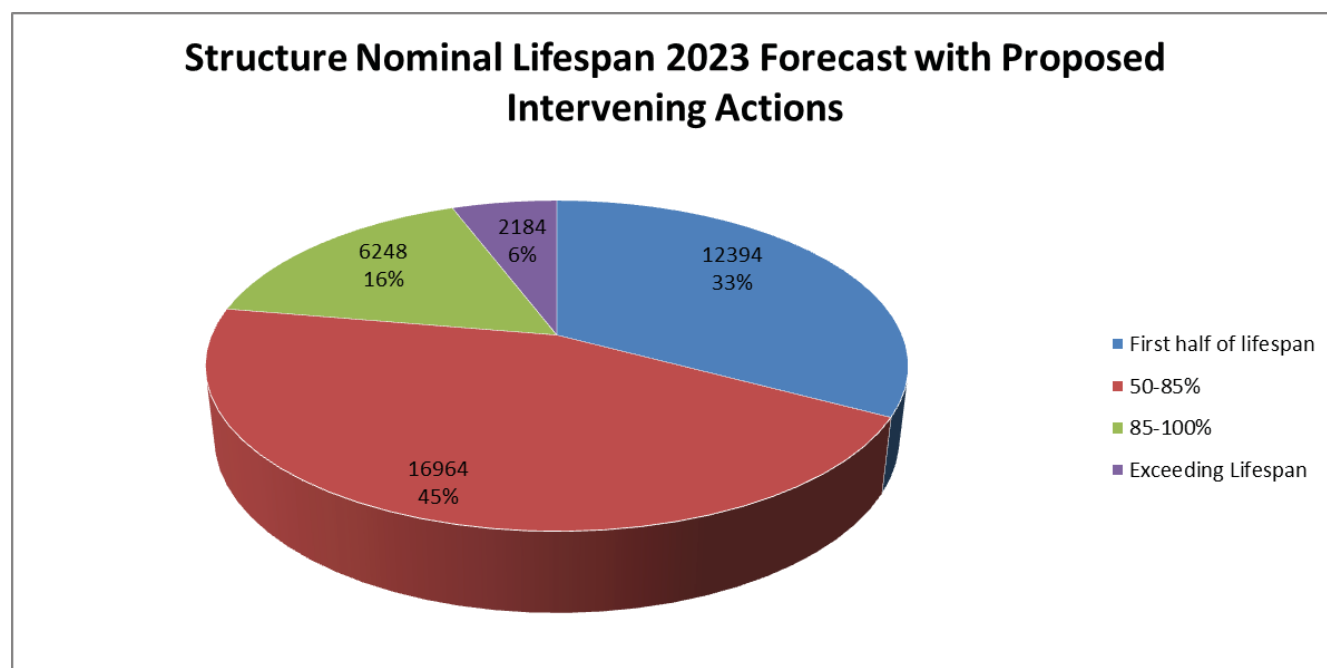
Figure 17: 2023 Forecast with proposed intervening actions.

Anticipated changes to the transmission line asset base as at June 2023 will result in the lifespan profile as per Figure 17.

The major changes are as follows:
