# Asset Management Plan Services

## Executive Summary

This Asset Management Plan (AMP) covers the class of assets known as Overhead Customer Services (“overhead services”).

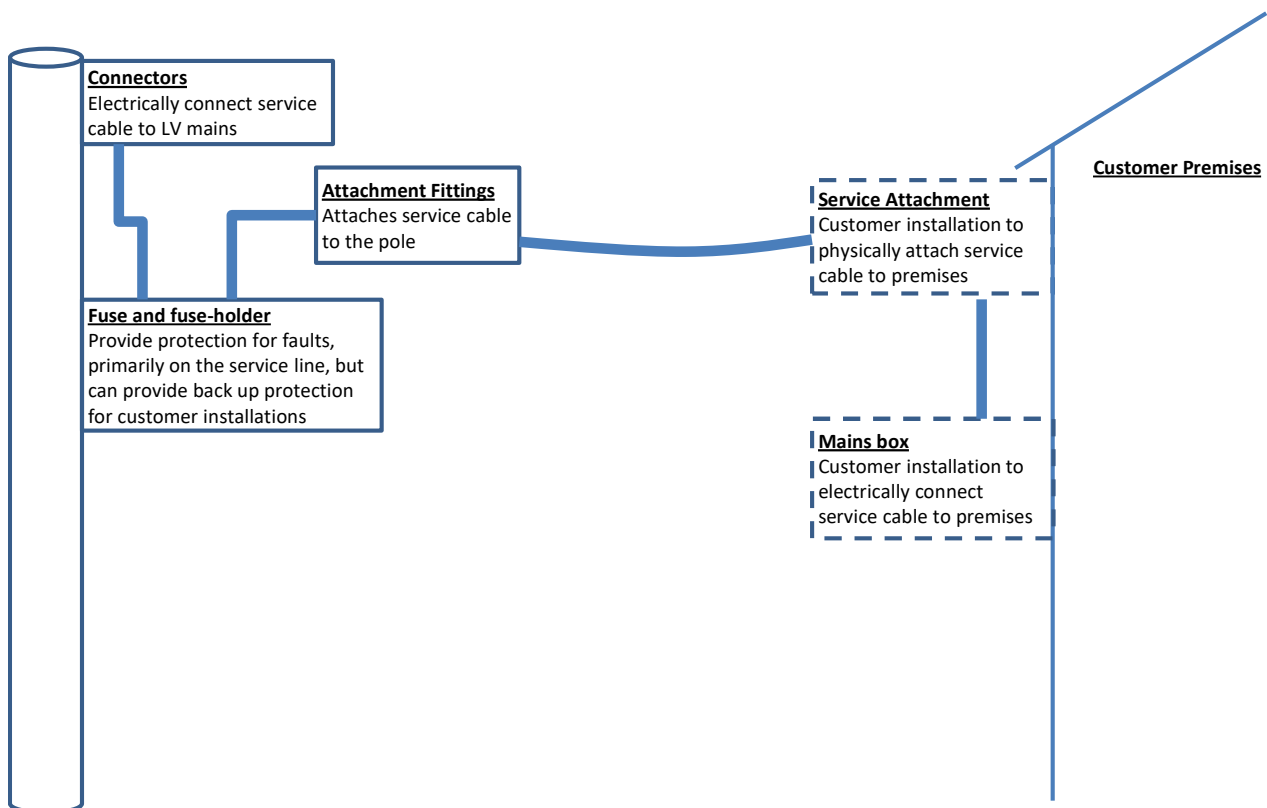
Figure 3: Functional Model Of An Overhead Service

Figure 3 provides a simple representation of a service connection.

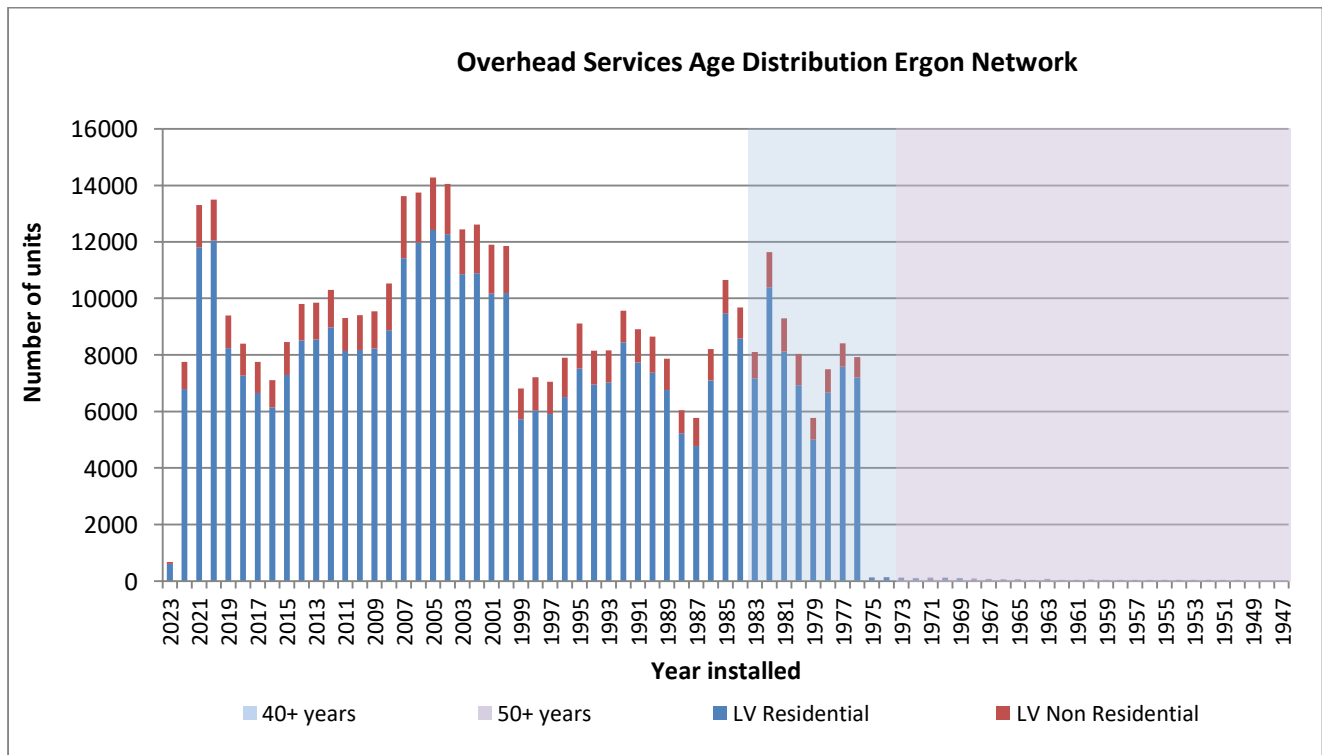
Figure 4: Age Profile Overhead Services – Ergon Energy

The actual age of overhead services has been problematic to establish, as the year of installation for the overhead services was not generally recorded until around 2006. The age data presented herein is consistent with the information reported in the annual Regulatory Information Notices (RINs) and represents the best information currently available. Figure 4 and Figure 5 show the age profile of EQL's overhead services. While reviewing the following data, it should be assumed that data quality deteriorates with age.

Ergon Energy replacement practices have relied upon visual condition inspection and targeted overhead service line volume replacement programs (reflecting known systemic failures of specific Overhead Service cable types). The effect of this approach is reflected in the relatively consistent age (low standard deviation from the mean) of the Ergon Energy overhead services assets depicted in Figure 4.

As the replacement cycle continues, older overhead services are being replaced with the newer XLPE overhead services. The age profile information in Figure 4 combined with Table 4 suggests that around a quarter of all services in the Ergon Energy are likely to be open wire services; however, this is not the case. In 2012-2015 Ergon Energy implemented a significant replacement program of open wire overhead services with XLPE overhead service cables up to the point of connection. However, there is still a number of open wire overhead services in-situ, particularly in rural locations employing privately owned overhead circuits.

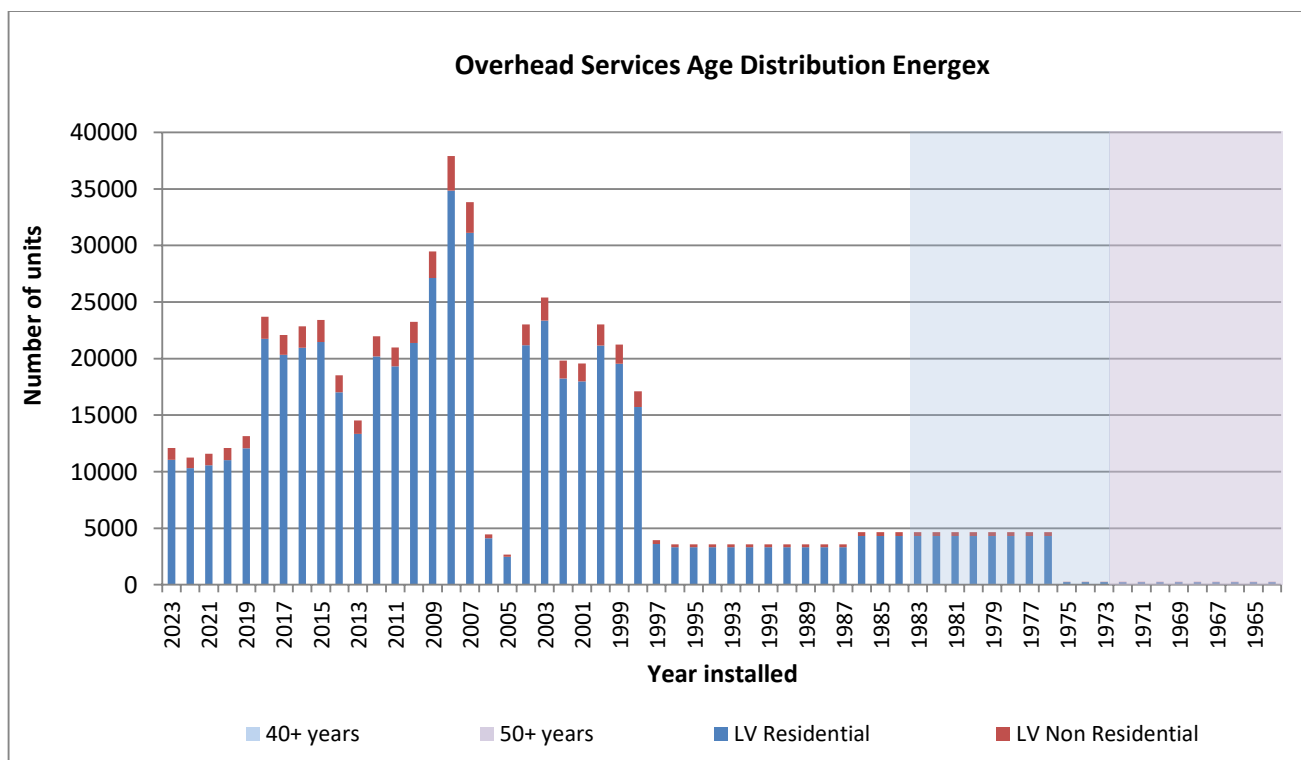
**Figure 5: Age Profile Overhead Services - Energex**

The sudden increase in the Energex age profile commencing around 1997 reflects a strong influence by the Queensland Electrical Safety Office to reduce public shocks.

From 2004 to 2006 overhead services installations were reduced significantly as a result of temporary resource redeployment for work related to the Somerville Enquiry in 2003-2004<sup>1</sup>. The replacement work backlog created during this hiatus period was recovered in the following three years commencing 2007.

Energex has implemented a significant asset replacement program of overhead services in an effort to mitigate public safety issues experienced on the network, effectively placing less reliance upon visual inspections compared to targeted type replacements. This strategy is reflected in the age profile by the volume of assets installed in recent years.

The Energex approach has resulted in a generally younger population and significantly lower rates of public shocks per annum when compared to the Ergon Energy. EQL has now initiated a planned targeted replacement program in Ergon Energy intended to reduce public shocks.

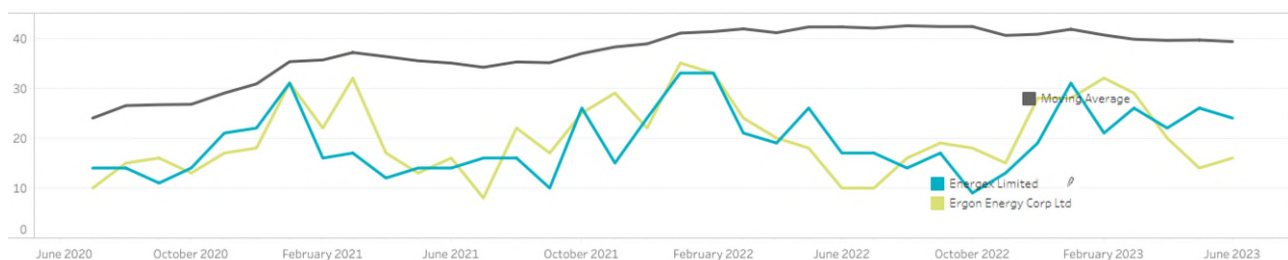
**Figure 6 - Shock by Entity - Trendline**

Performance in later years has stabilised and is slowly trending downward as shown below in Figure 6. While this indicates improvement, for future performance targets to be achieved it is necessary that additional work in this space is needed.

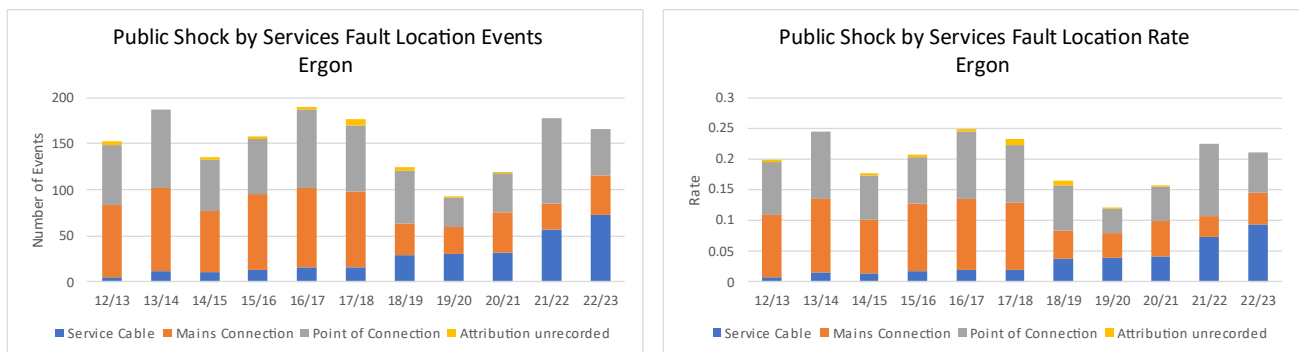
**Figure 7: Overhead Service Related Shock Performance – Ergon Energy**

Over recent years there have been approximately 154 shocks per annum directly attributable to overhead services. This equates to an average rate of 0.0197 shocks per annum. The annual performance history in Figure 7 demonstrates that these assets have consistently been underperforming relative to the 2032 EQL performance targets.

Shocks predominantly occur in coastal regions, which is consistent with population demographics.

The identification of obsolete claw clamps and split bolt connectors is continuing as part of the Pole Inspection Program. In the Ergon Energy, current asset performance (refer Figure 7) suggests ongoing monitoring will be adequate to identify potential replacements.

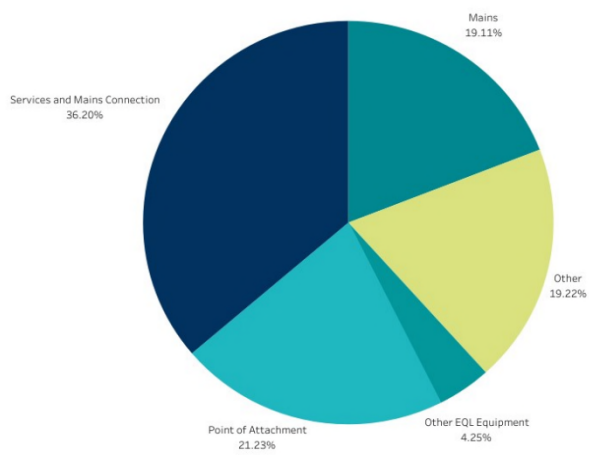
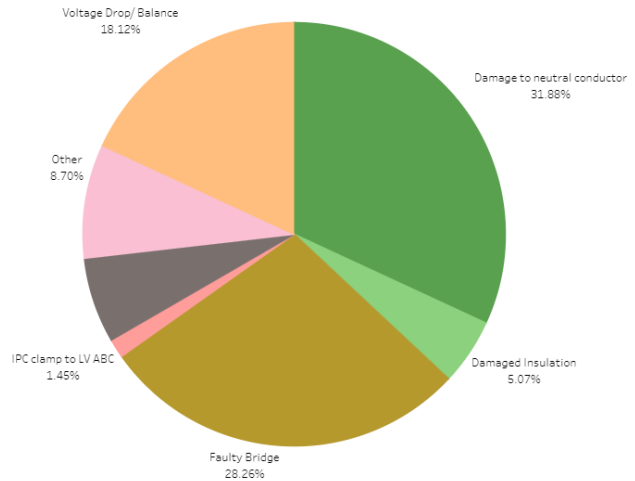
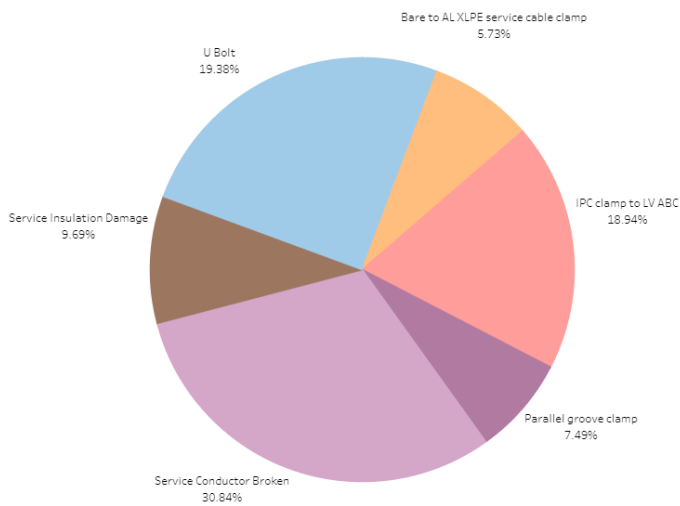
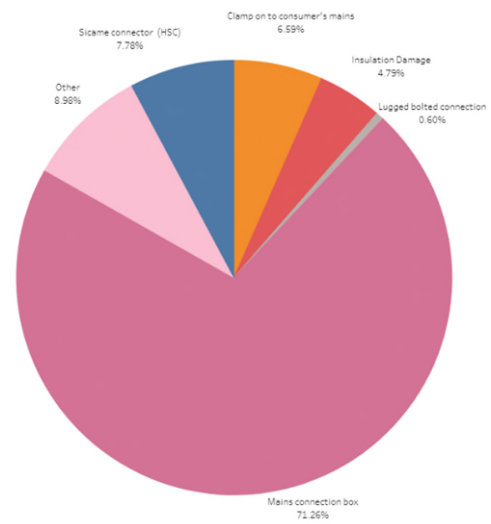
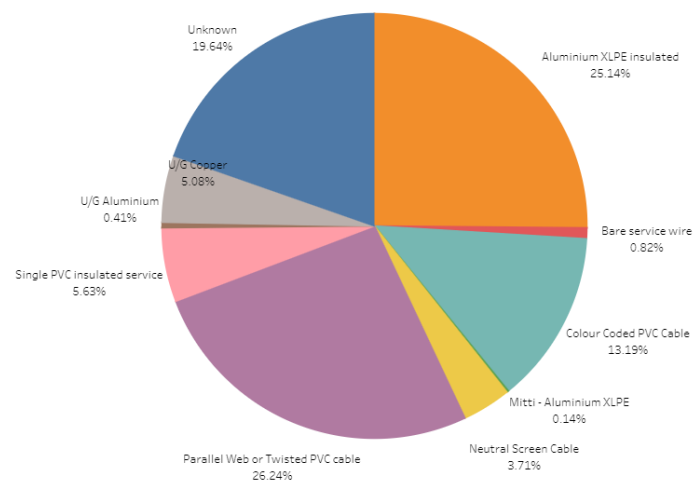
**Figure 8: Overhead Service Shock Rate (4 Years) – Ergon Energy**

Figure 8 below highlights that for Ergon Energy, there have been significant performance issues related to services and mains connection (which is the service cable). Following this are the mains connection boxes within the POA group. These units are customer owned, however, are required to be inspected by EQL under the ESR<sup>3</sup>. Mains connections of all types appear to perform similarly. PVC cables (particularly parallel web or twisted multiphase PVC) are the worst performers.

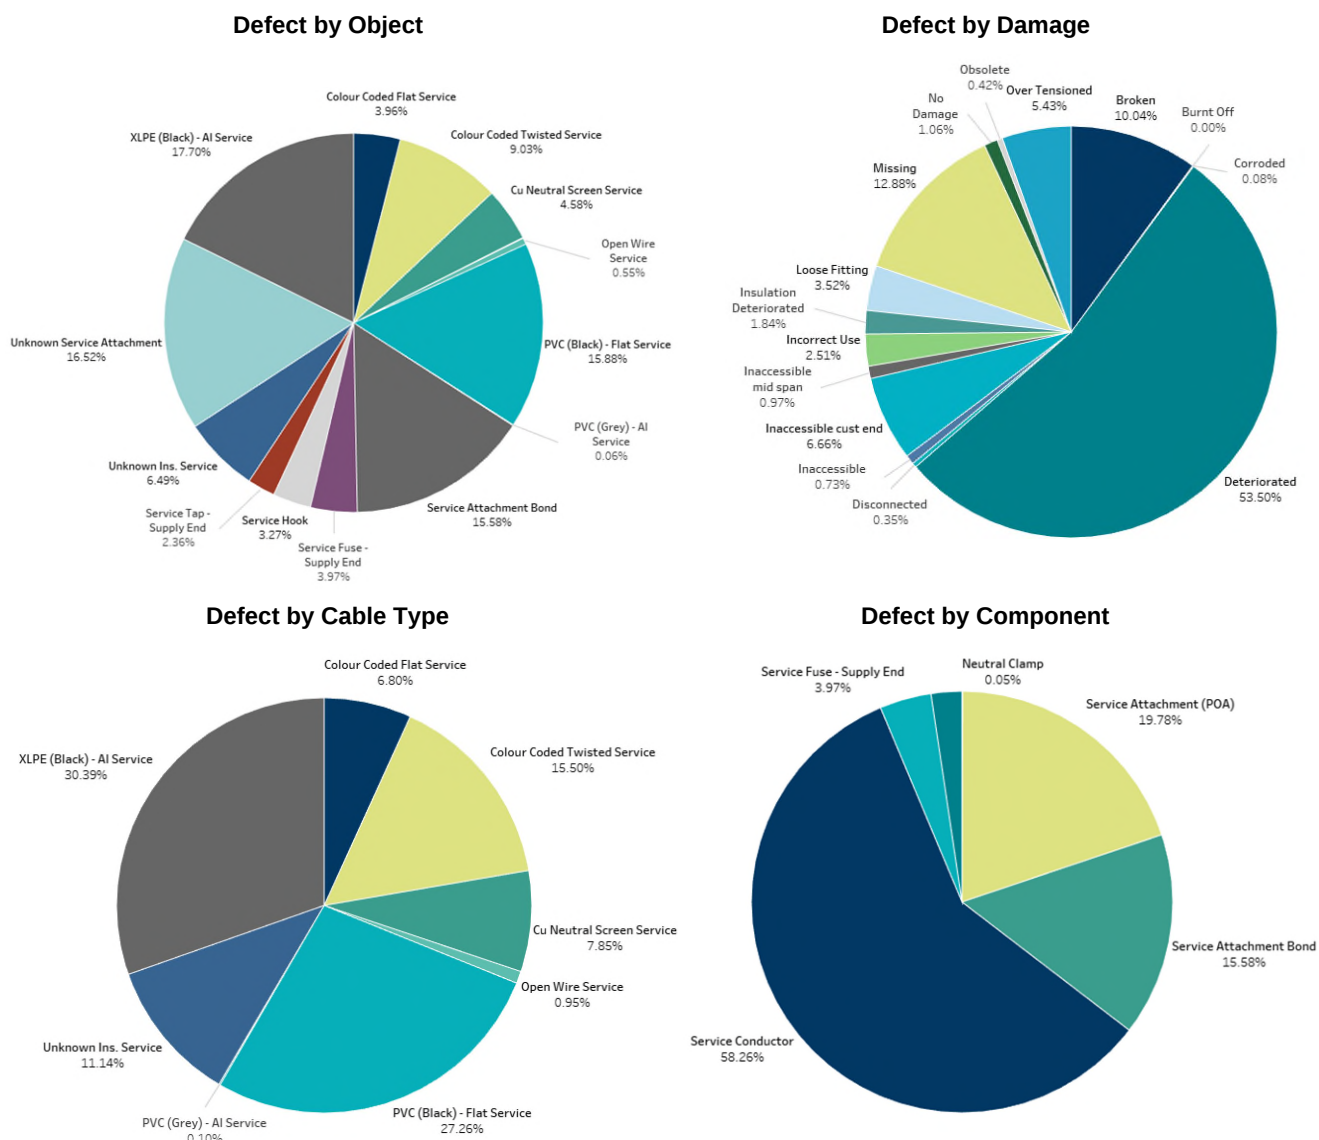
**Figure 9: Defect Repair Focus - Ergon Energy**

Figure 9 below breaks down the major overhead service component items that contributed to these works.

Defects are repaired as corrective maintenance. Faults are typically repaired as forced maintenance.

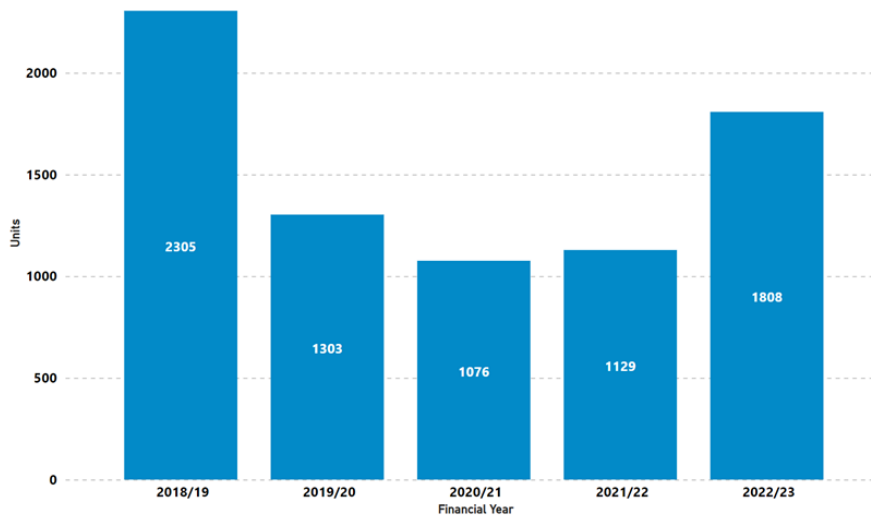
Figure 10: Overhead Service Failure Quantity – Ergon Energy

Figure 10 and Figure 11 detail the number of actual failures of overhead services and breakdown of these failures by cause and object respectively. These failures are also known as unassisted failures due to excluding those failures caused by external influences such as storms or third parties.

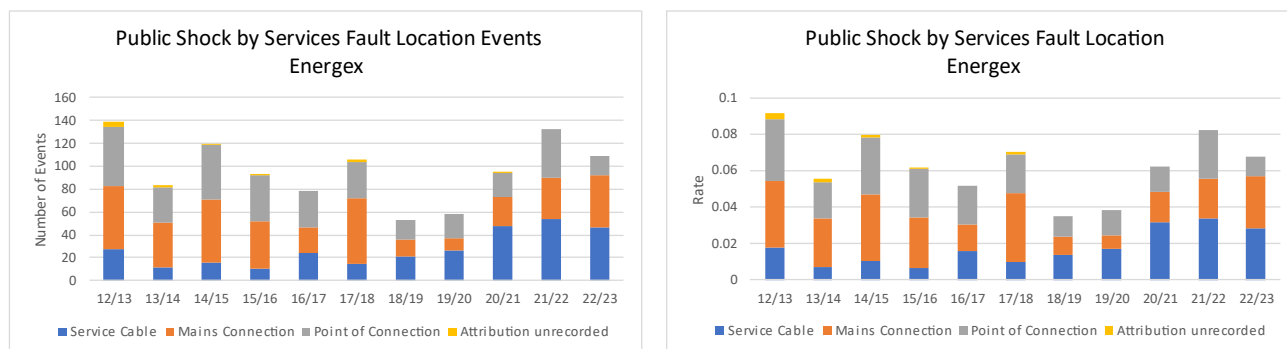
**Figure 12: Overhead Service Related Shock Performance – Energex**

Over recent years there have been on average 112 shocks per annum directly attributable to overhead services as shown in Figure 12. This equates to an average rate of 0.0705 shocks, which is below the performance requirements for the Energex provided in Table 6. There have been increased targeted public awareness programs which have possibly attributed to this increase in recent years. Additionally, the method of reporting has been clarified to more align with the method Ergon Energy utilise to capture and report.

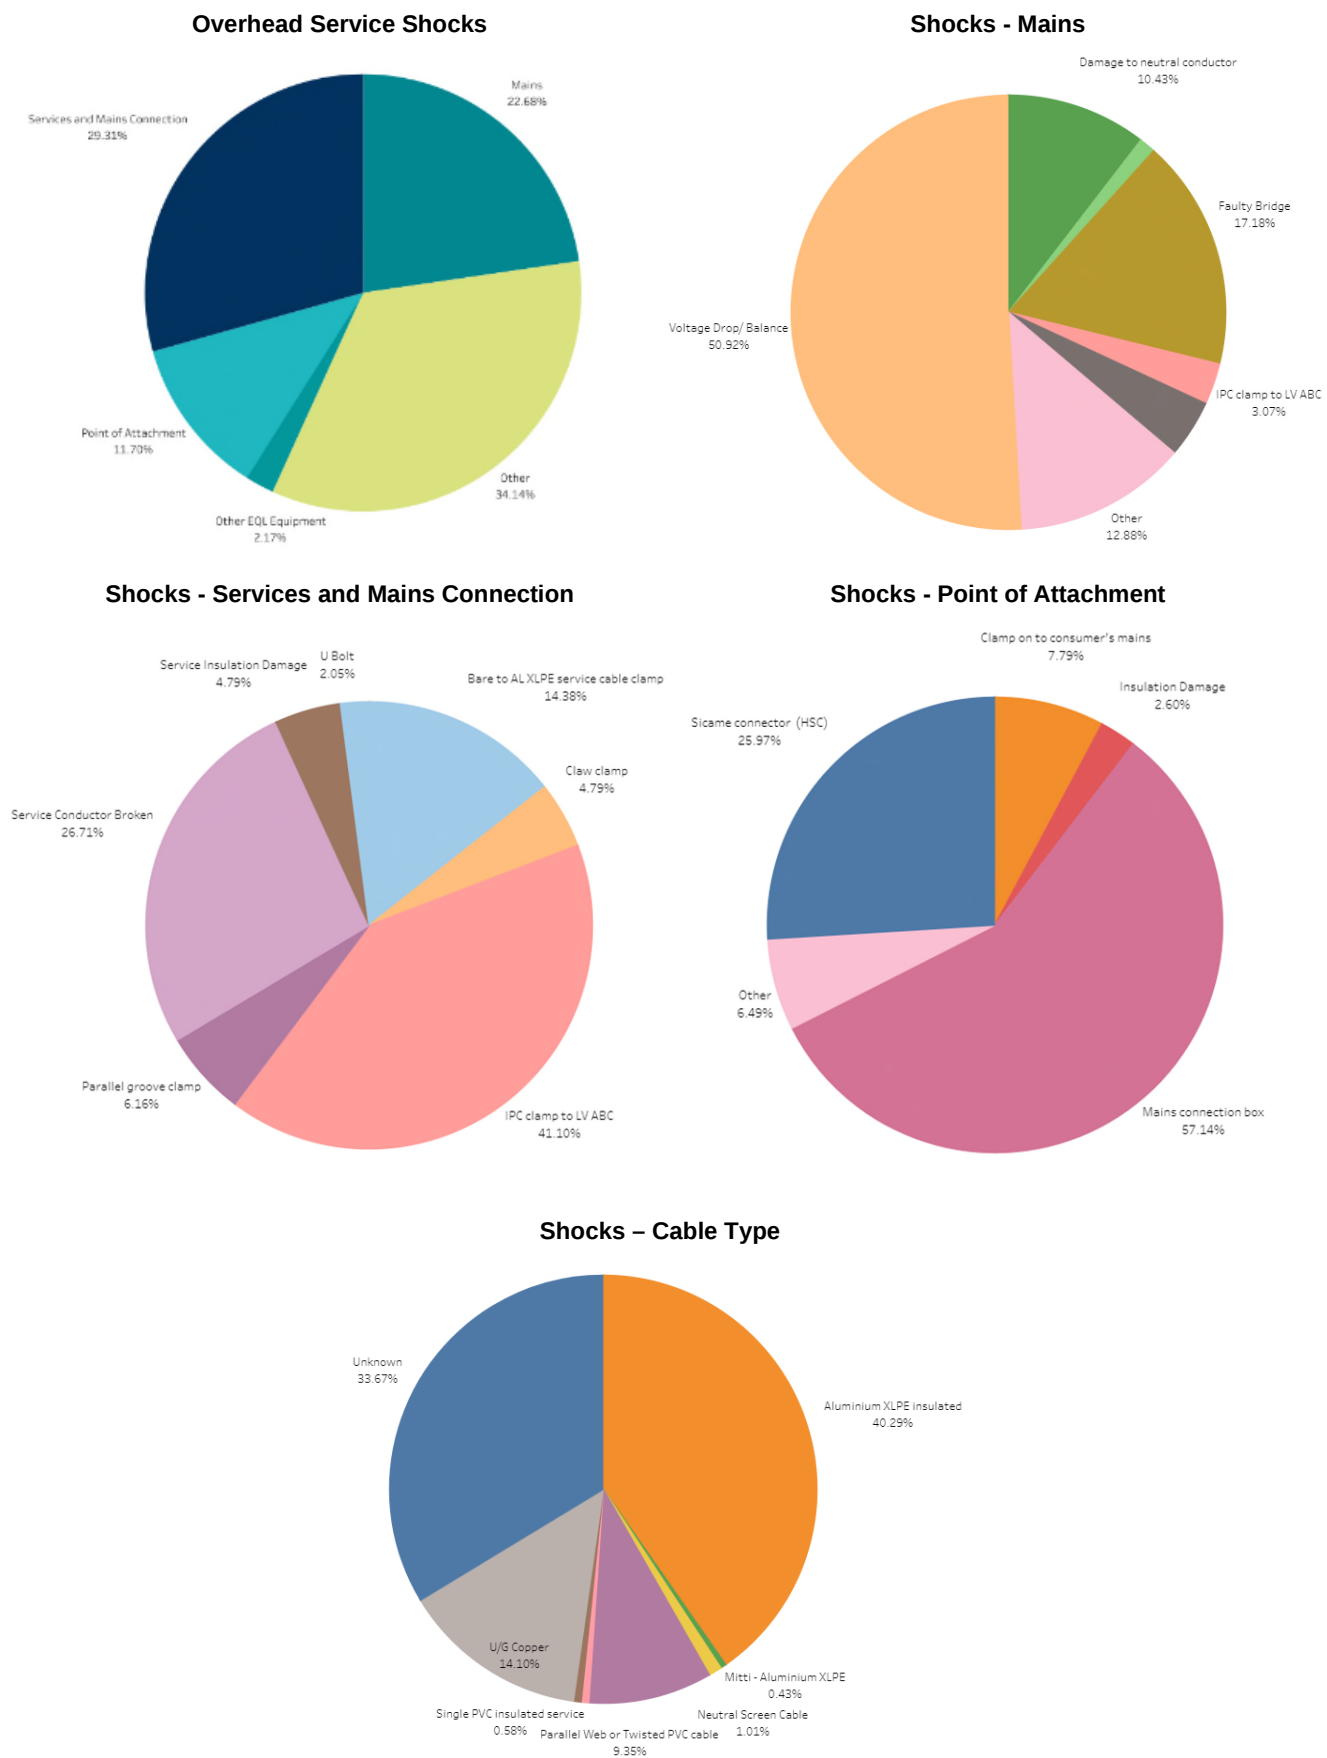
**Figure 13: Average (6 Years) Overhead Service Shock Rate – Energex**

Figure 13 below shows the breakdown of the overhead service shock rate for the Energex as an average over the last four years and highlights that for Energex, Mains Connection boxes continue to present performance issues. Mains Connection boxes are customer owned but required by regulations to be inspected by EQL. Clamp connections appear to present the most prevalent contributor to shock for mains-services connections. PVC cables, particularly parallel web or twisted multiphase PVC, are the worst performers.

Given XLPE insulated cables are the more modern and current standard in use and that XLPE service cables make up around 70% of the population, the table reflects that both age and technology are influencing asset performance. The lifecycle strategies outlined in Section 9 reflect the different failure rates in the treatment of the different types of cable.

Additionally, Figure 13 highlights the essential reasons for legacy organisation Energex's asset management approach for services. Connections contribute to more than 50% of public shocks involving Services, divided relatively evenly between the mains connections and the customer point of connection. Replacement of problematic services directly targets the two largest root causes of shocks.

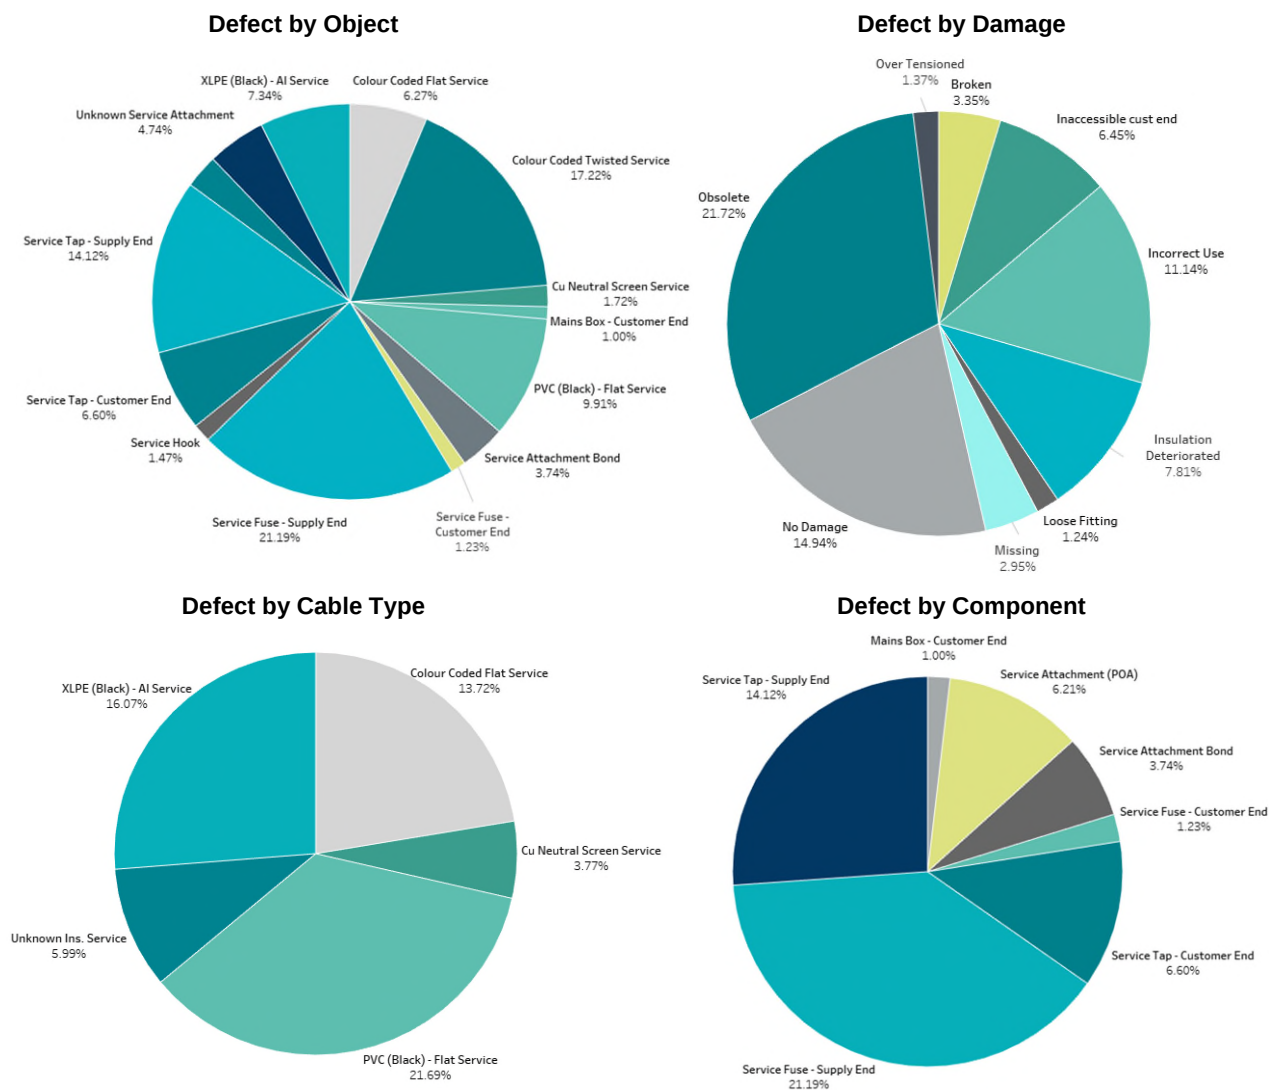
**Figure 14: FY18/23 Defect Repair Focus – Energex**

Figure 14 shows a focus summary of recent proactive and reactive repair works that have been conducted on overhead services. This supports that EQL is meeting its regulatory obligation to inspect and maintain its assets.

Inspection defects are repaired as corrective maintenance. Faults are typically repaired as forced maintenance.

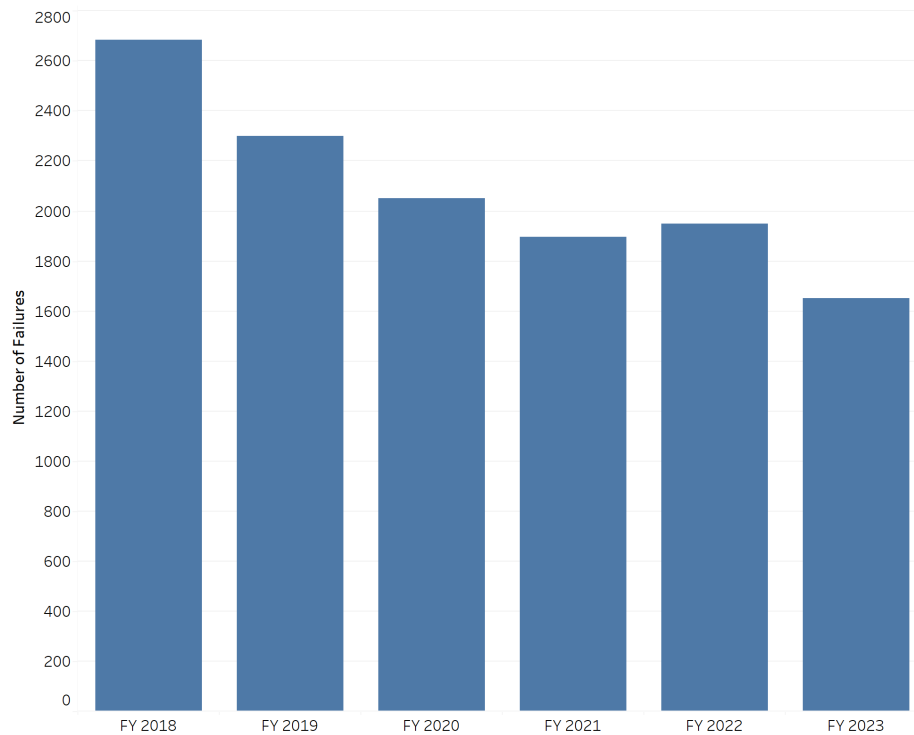
**Figure 15: Overhead Service Failure Quantity – Energex**

Figure 15 and Figure 16 above detail the number of actual failure and breakdown of overhead services, excluding failures caused by external influences such as storms or third parties.

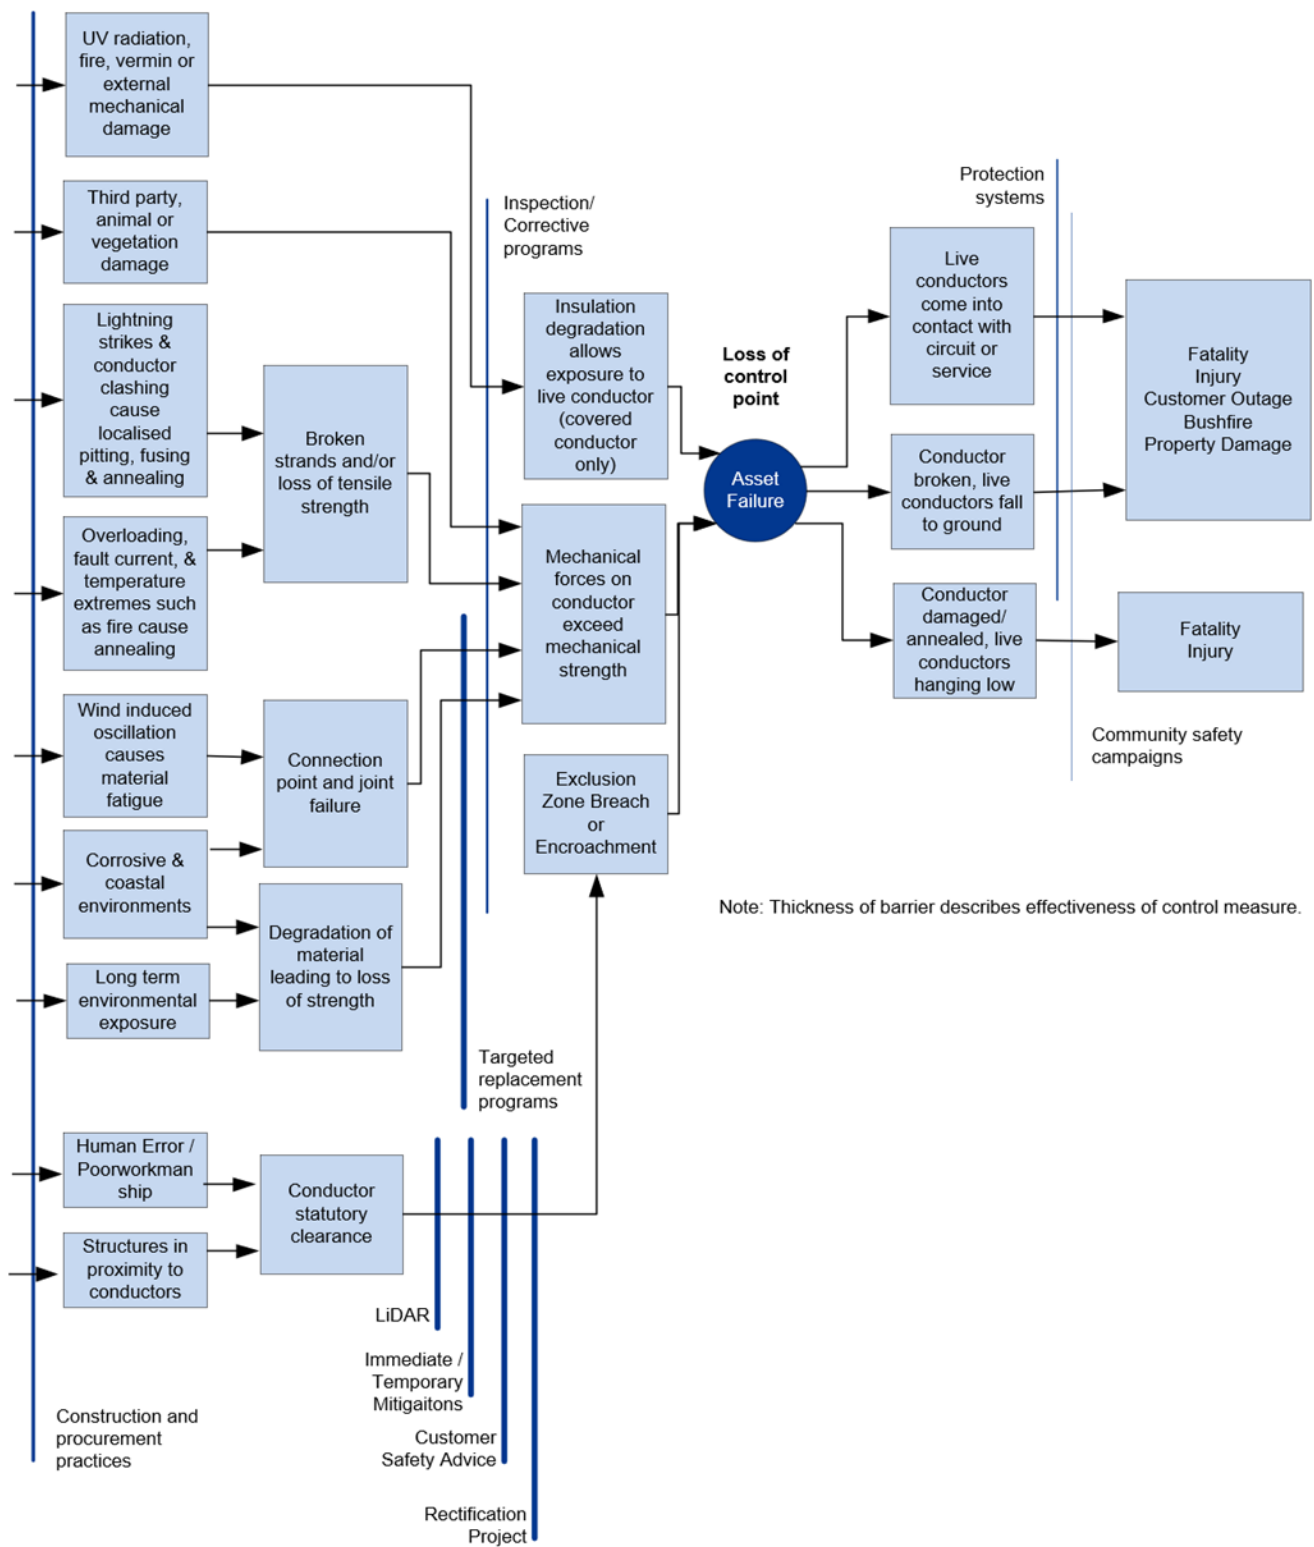
Figure 17: Threat-Barrier Diagram for Overhead Services

Figure 17 provides a threat-barrier diagram for EQL overhead services assets. Many threats are unable to be controlled (e.g. third party damage), although EQL undertakes a number of actions to mitigate them SFAIRP/ALARP. Failure of an overhead service risks public and staff safety in several ways, most notably:

- bringing energised electrical conductors to easily accessible heights, risking public contact, shock and electrocution.
- neutral circuit failure leading to potential shock and electrocution within the customer premises; and
- loss of supply to customer premises.
