AusNet

Circuit Breakers

Asset Management Strategy

Document number: AMS 10-54

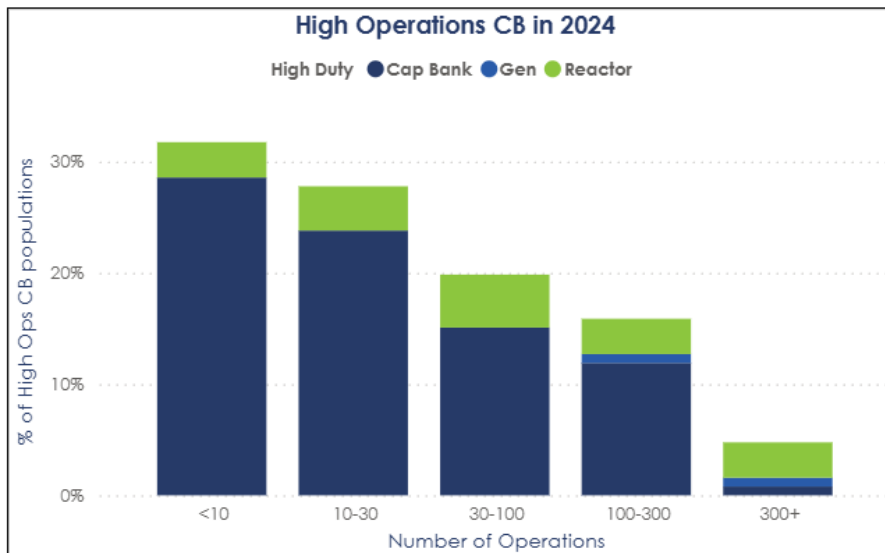
Operational frequency analysis in figure 13 shows approximately 20% of the fleet are in the high operation categories > 100 operations per year, and 5% in the very high operation category of over 300 per year. In this high operation category, CBs are wearing out in 15 to 30 years range, and in latter very high category even a modern circuit breaker would reach wear out limits within 10 – 20 years.

Figure 13: Capacitor bank, Generation & Shunt Reactor CB operation graph in 2024

However, it has been observed that the number of operations for some high-duty circuit breakers has slightly declined over the past three years. This trend may be attributed to several factors, including changes in load and generation profiles, as well as modifications to network configuration and operational strategies.

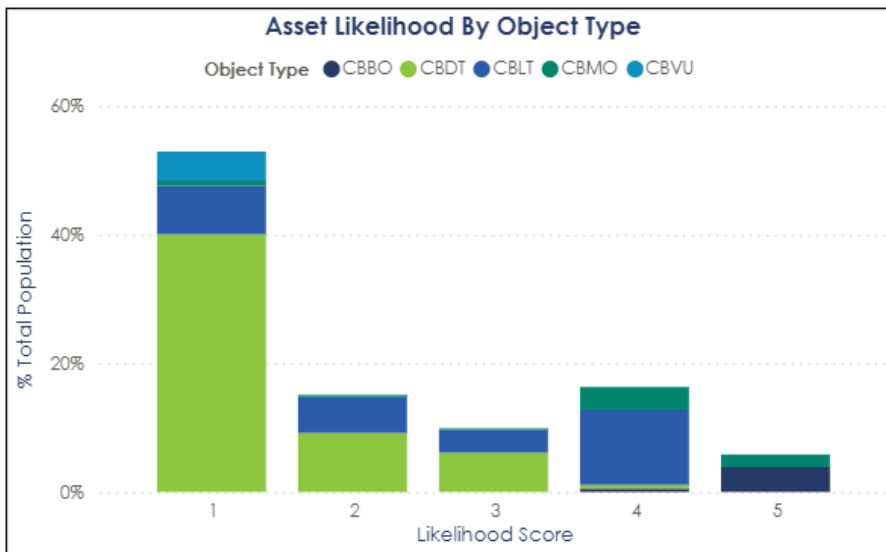
Figure 15: CB Likelihood Score by Object Type

Key Findings on Asset Health Conditions Derived from the Figures above:

- Nearly all units, along with several underperforming CBMO currently carry a likelihood score of 5, indicating a high risk of failure. [C . I . C] circuit breakers, which fall under the CBBO category and are equipped with porcelain bushings, pose a risk of catastrophic failure, potentially endangering both assets and personnel in proximity. Furthermore, these breakers are fully obsolete and no longer supported by any original equipment manufacturer (OEM), compounding the operational and maintenance challenges. Major station rebuild at TTS and asset replacement at FTS, GNTS and HOTS are proposed to replace these high risk bulk oil breakers before [C . I . C]

- The remaining CBMO units and certain older vintages of 500kV have a likelihood score of 4, indicating elevated failure risk and signalling that these circuit breakers are nearing end-of-life. The [C.I.C] 220kV and HPL breakers, classified CBMO and CBLT respectively, have experienced repeated failures due to mechanism-related issues. These units are fully obsolete with limited OEM support. A replacement program was initiated in previous TRR periods to recover mechanisms for refurbishment and extend asset life. Continuation of this program is required for TRR 27–32.

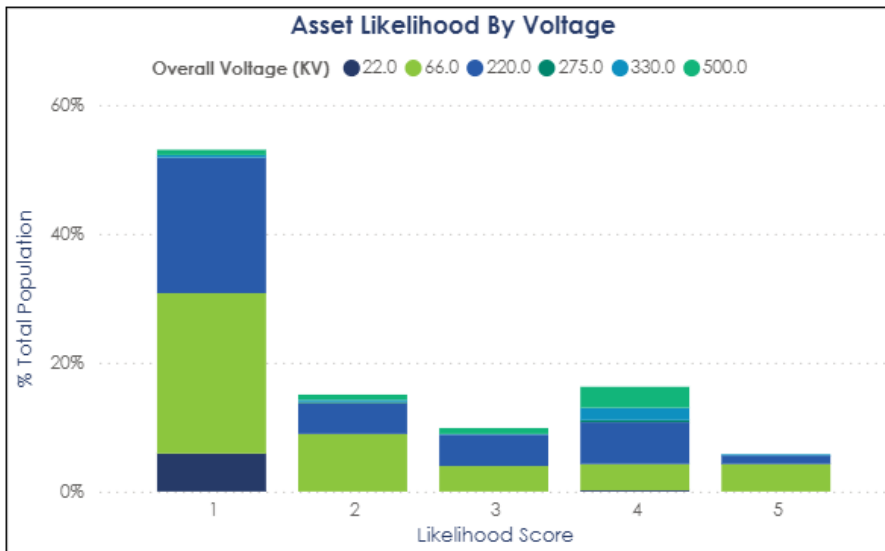
Figure 16: CB Likelihood Score by Voltage Class
