Business Case - Capital Expenditure

Pipe Support Replacement Business Case Number BC263 AA23-27

PIPE SUPPORT REPLACEMENT

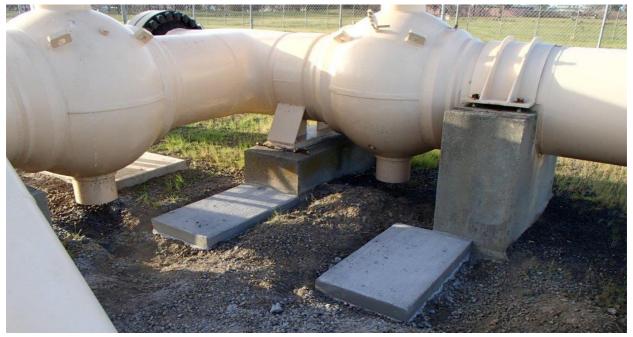
The above photo shows a pipe support on the right that has an interface between the concrete and the steel pipe. This support design is acceptable until the coating (paint) deteriorates and allows moisture and direct contact between steel and concrete. When this occurs is unknown as it cannot be inspected. The support on the left demonstrates a support with similar performance but longer life.

The older design of pipe supports often used wide concrete supports with the pipe contacting the concrete with minimal interface protection. When the pipe begins to corrode, it cannot be inspected and thus corrosion can continue unidentified. Recent replacements of some supports of this design have shown corrosion.

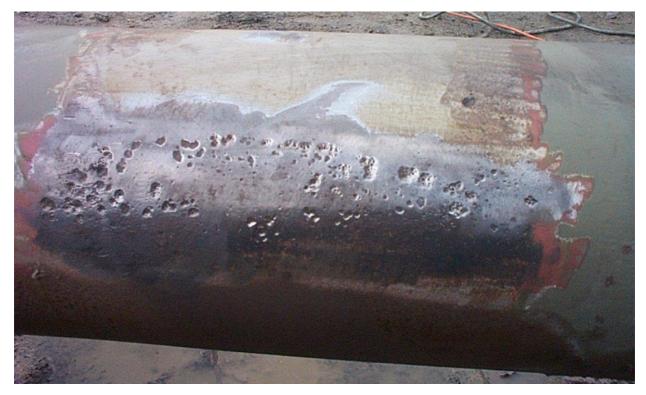
The above photo demonstrates the localized pitting corrosion where a pipe support has been removed. Note that either side of where the pipe support attached to the pipe is free from corrosion and paint in reasonable condition.

The environment within some pipe supports promotes corrosion once the coating system deteriorates. In some conditions this corrosion is not able to be identified without either removing the support (replacement) or until a loss of containment. A loss of containment will likely result in a small, manageable gas leak, but difficult to repair.
