Business Case – Capital Expenditure

Pipe Support Replacement

Business Case Number 263

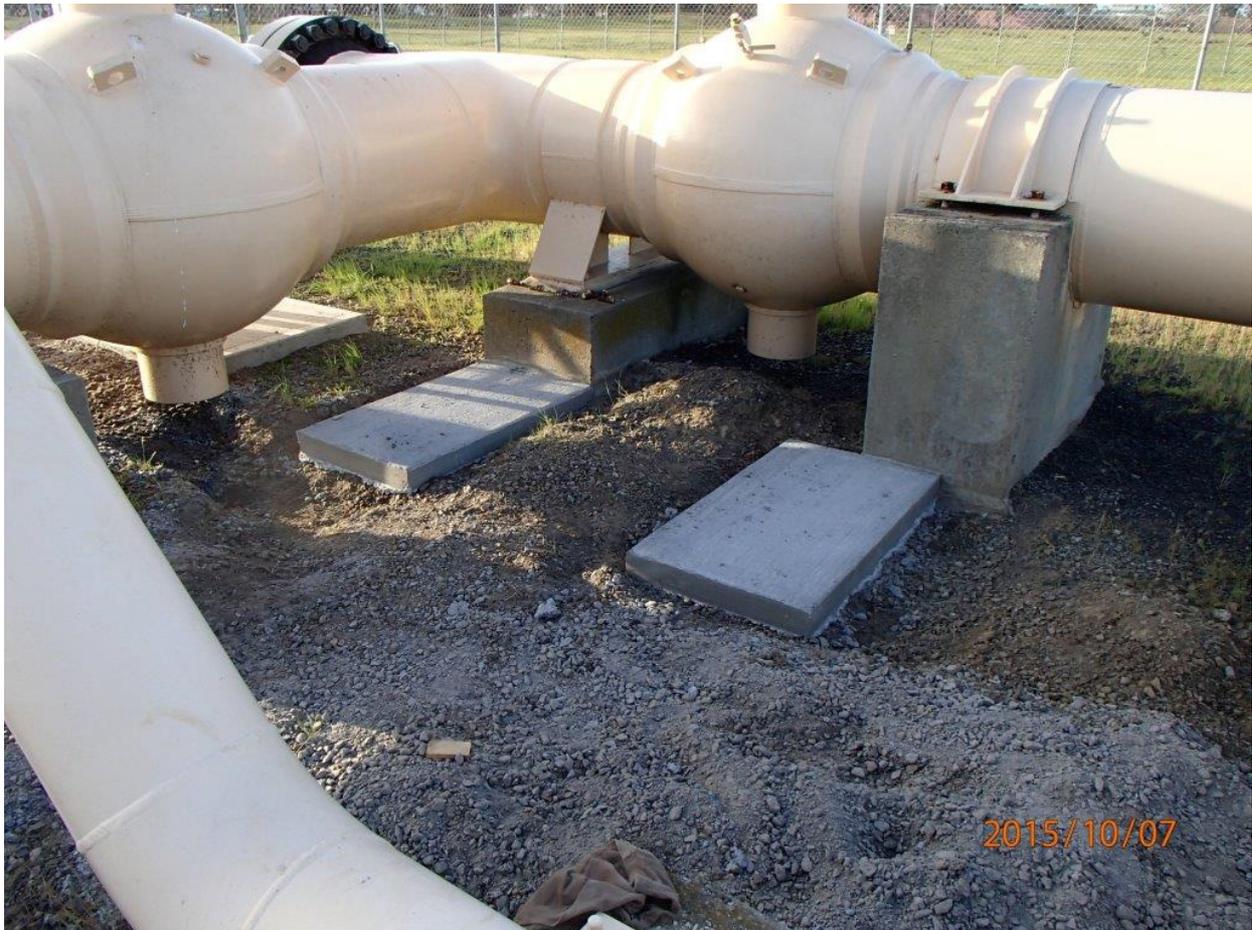
The above photo shows a pipe support on the right that has an interface between the concrete and the steel pipe. This support design is acceptable until the coating (paint) deteriorates and allows moisture and direct contact between steel and concrete. When this occurs is unknown as it cannot be inspected. The support on the left demonstrates a support with similar performance but longer life.

The older design of pipe supports often used wide concrete supports with the pipe contacting the concrete with minimal interface protection. When the pipe begins to corrode, it cannot be inspected and thus corrosion can continue unidentified. Recent replacements of some supports of this design have shown corrosion.

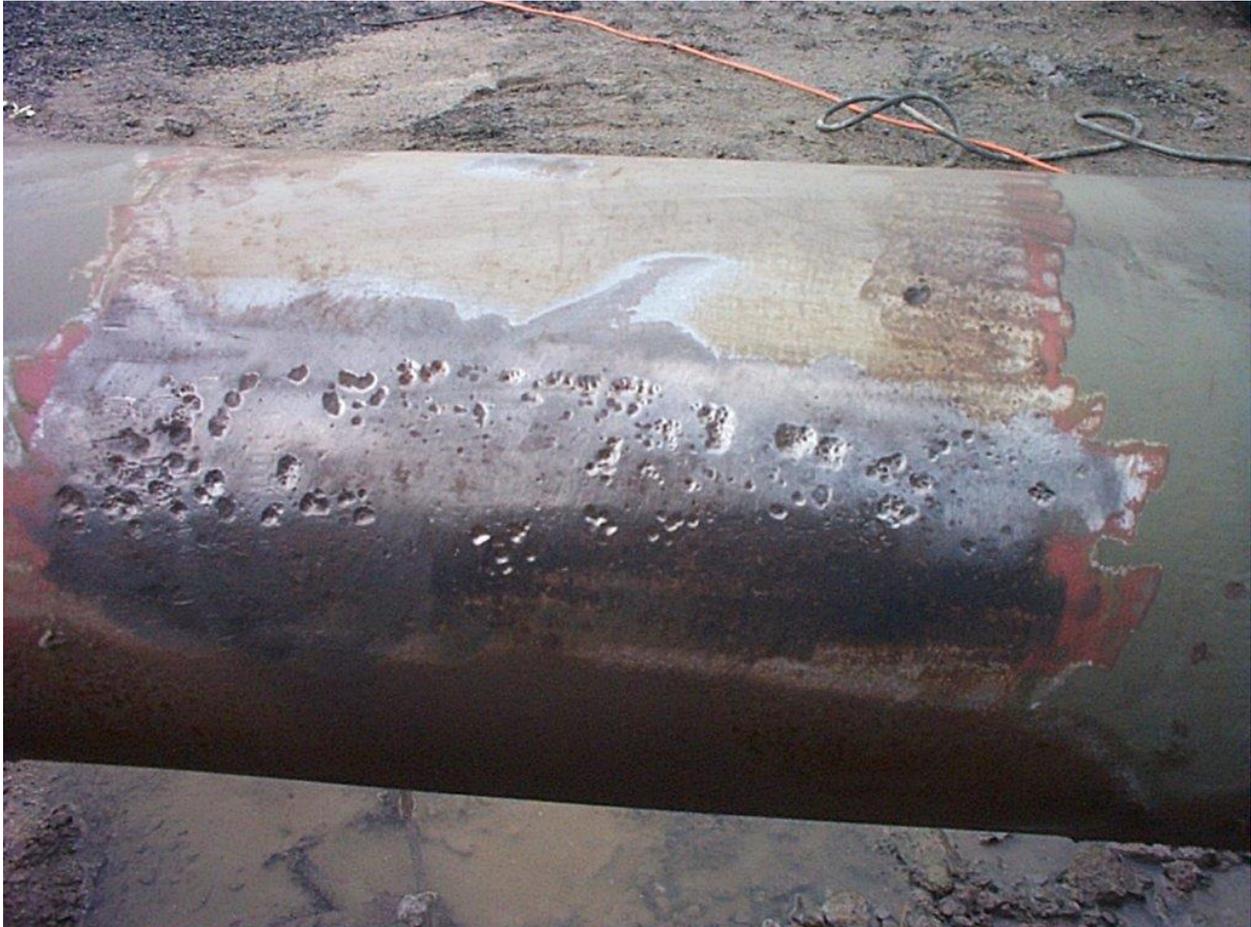
The above photo demonstrates the localized pitting corrosion where a pipe support has been removed. Note that either side of where the pipe support attached to the pipe is free from corrosion and paint in reasonable condition.

The environment within some pipe supports promotes corrosion once the coating system deteriorates. In some conditions this corrosion is not able to be identified without either removing the support (replacement) or until a loss of containment. A loss of containment will likely result in a small, manageable gas leak, but difficult to repair.
