Condition Assessment Report

Keith - Snuggery 132kV Transmission Line

F1837 - Built Section (1223)

October 2011

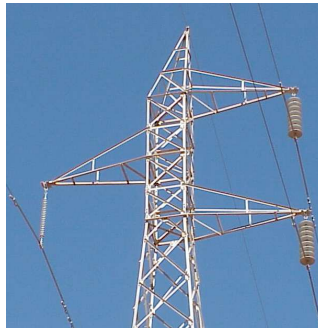
F1837 Tower Suspension Structure (464).

The Feeder construction type consists of ETSA Lattice Towerss constructed by Transfield.

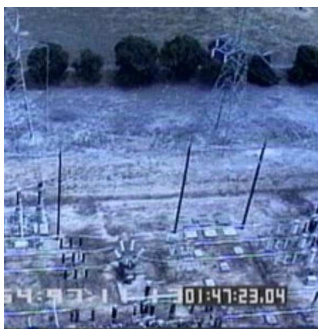
F1837 Tower Tension Structure (39).

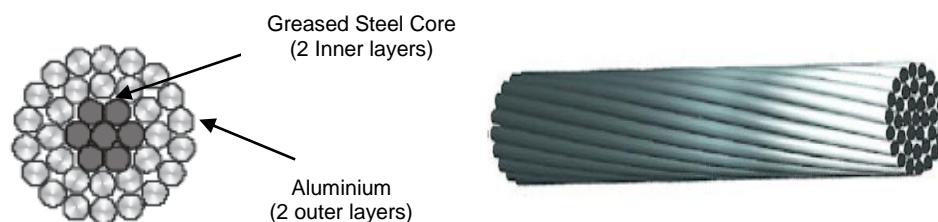
Figure 1. Typical ACSR Conductor

Chloride and pollutant deposition is deposited on the conductor and acts as an electrolyte between the zinc, steel and aluminium. The corrosion progresses as follows:

1. The grease degrades over time, dries out and becomes ineffective (where grease is applied, if not corrosion will start at step 2),
2. The zinc layer (galvanising) coating the steel strands begins to corrode as it is highest in the galvanic series (zinc 1st, aluminium 2nd, steel 3rd),
3. Once the zinc is lost, or the zinc is electrically isolated due to corrosion product, the aluminium starts to corrode,
4. Only once the aluminium is significantly corroded does the steel begin to corrode.

As the steel is the last part of the conductor to corrode there still remains a great amount of mechanical strength remaining in the conductor despite heavy loss of aluminium.

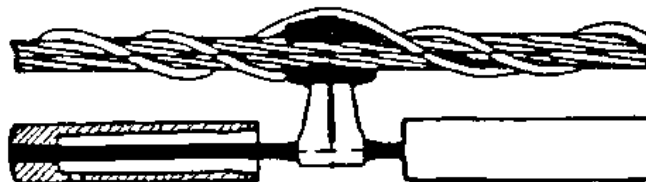
Figure 2. ES2 Damper

In the early life of the line damage to the conductor from aeolian vibration occurred before ES2 dampers were fitted to absorb energy and to limit fatigue at the conductor attachment points. Dampers are discussed in more detail in below.

ES2 Dampers had specific issues with an elastomer insert that was designed to limit fatigue damage at the damper attachment point, however this insert had two negative effects. The first was to inhibit the transfer of energy from the vibrating conductor to the messenger wire that resulted in the damper unable to stifle reduce the vibration at the most damaging frequencies. The second effect was to hold moisture and contaminants that when combined with the semi conductive properties of the elastomer resulted in corrosion damage at the damper attachment point.

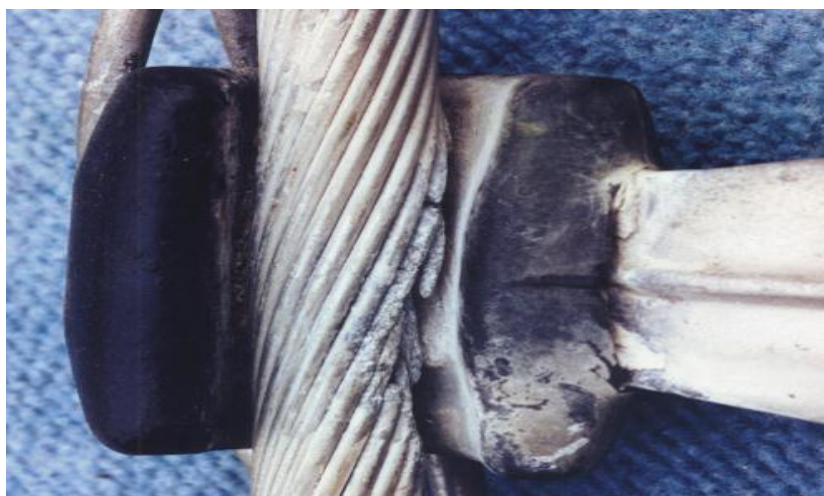
Image 1. Severe ES2 Damper Damage

ES2 dampers caused damage, grading from superficial to serious at a significant number of locations. All ES2 dampers were replaced in the period 1992 to 1994. Repairs to the corrosion damage were carried out using various repair rods in accordance with a prescribed regime which effectively reinstated the mechanical and electrical properties of the conductor.

The key issue affecting this repair is the potential for corrosion to continue to occur in the void under the repair rods due to the ingress of moisture and corrosive elements, resulting in reduced mechanical strength and current carrying capacity from the loss of cross-sectional area of the aluminium.

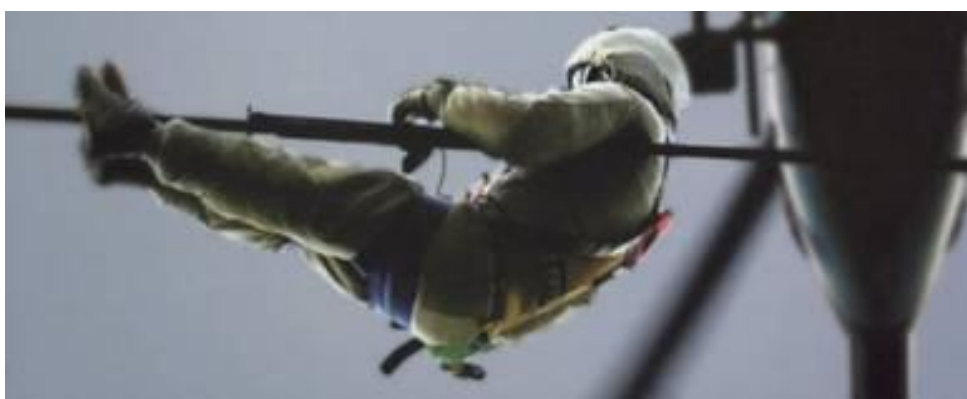
Image 3. Live Line Conductor Joint Testing

The aim of joint resistance testing is to provide an indication of the current condition of the joints. Field measurements and more importantly analysis of the results is an expensive and specialised task. A methodical approach to scoping, collection of field data and analysis is required to determine remaining life and evaluate replacement criteria.

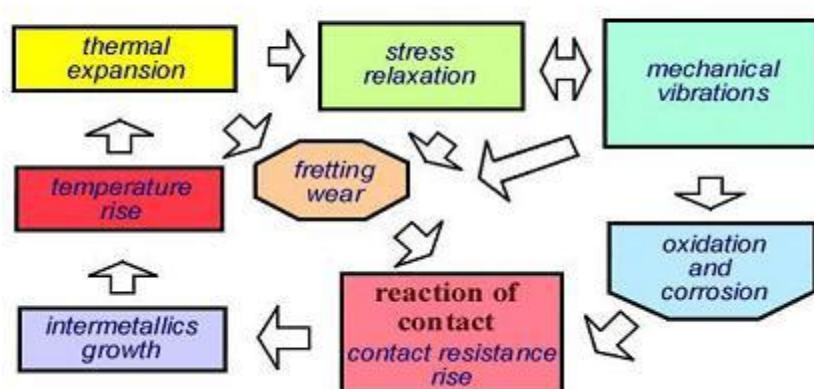
Figure 3. Schematic representation of the synergistic action of degradation mechanisms on electrical contacts.

Deterioration of the joint can occur as a consequence of various atmospheric degradation, thermo-mechanical stresses and/or vibration. Over time, joint resistance will increase and if left unchecked can lead to overheating and eventual failure. Accelerated degradation also occurs due to higher thermal operating temperatures. Poor construction practices increase the risk of joint failure.

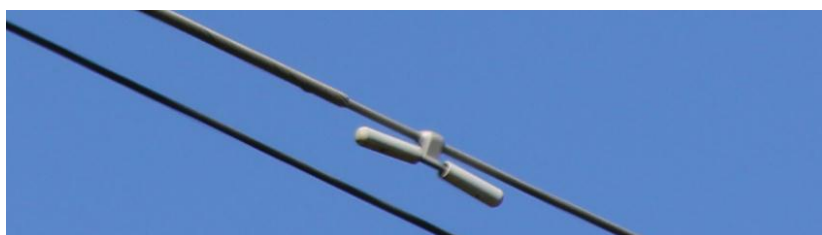
Image 4. Stockbridge Damper

Vibration Dampers assist in dissipating energy and reducing conductor amplitude created by aeolian vibration. Damper selection and installation is specialised and are designed to limit bending stress and strain along the conductor to permissible levels over a wide frequency range.

Typical degradation modes are drooping messenger wires or dropped weights (not common).

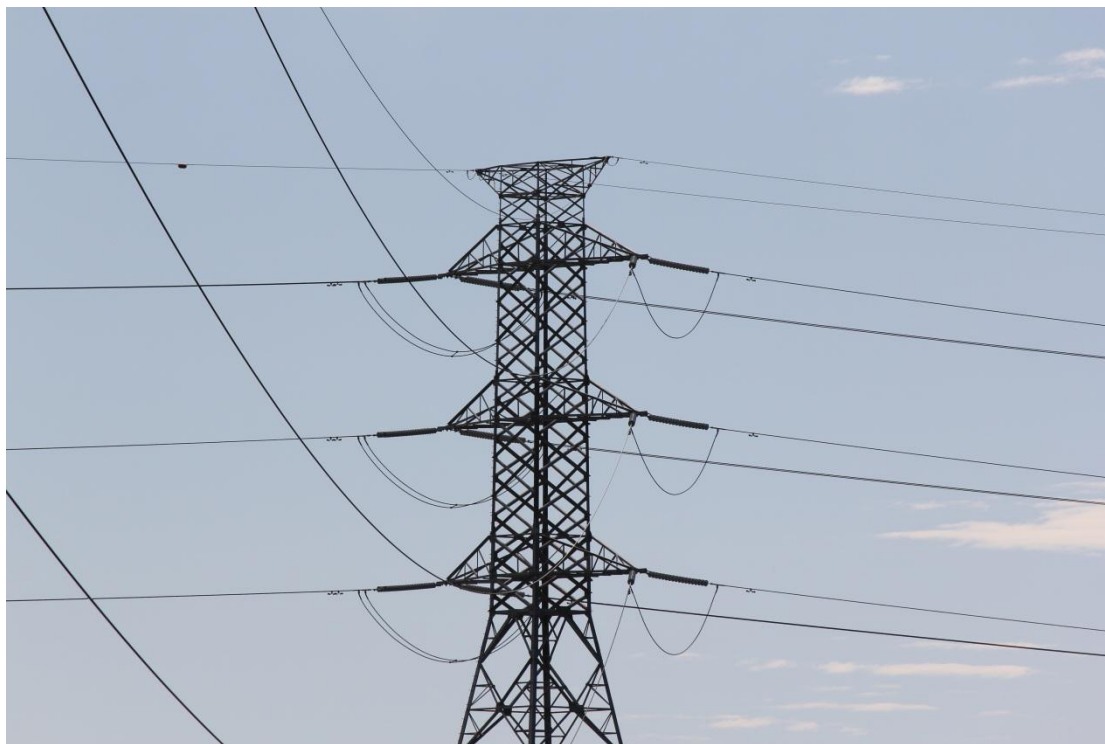
Image 5. Tension Structure

Insulators are required to withstand both mechanical and electrical stresses. Mechanical stresses on standard suspension insulators are applied in tension. Electrical stresses include power frequency, switching and lightning over-voltages.

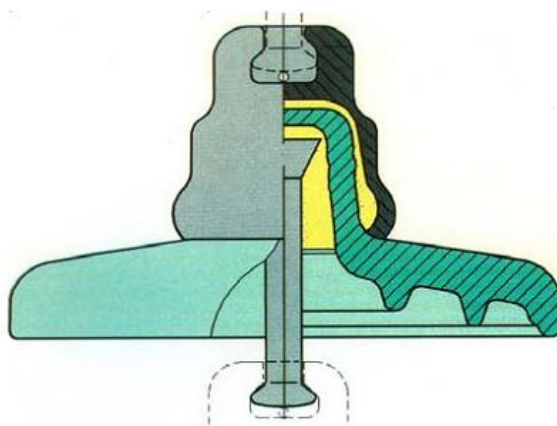
Figure 3. Cross-section Cap & Pin Insulator

Internal defects within the porcelain are not visible and can lead to failure both electrically and mechanically. Porcelain insulators should be electrically tested to identify units requiring replacement. Electrically defective insulators have an increased risk of failure mechanically and should be replaced as soon as practically possible to ensure adequate line security is maintained.

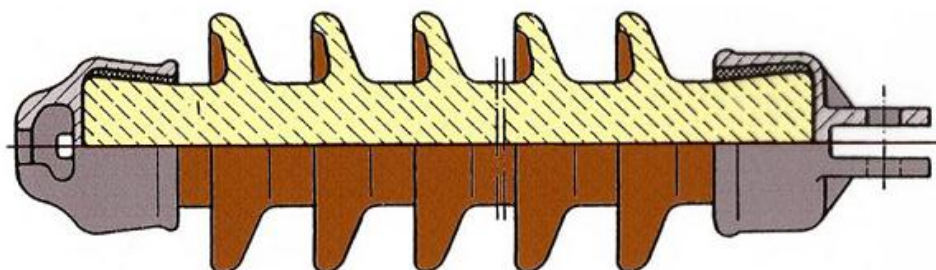
Figure 4. Cross-section Porcelain Long Rod Insulator

Porcelain Long Rods are constructed from a single piece of porcelain with metal caps either end and provide a high arc resistance with excellent self-cleaning characteristics.

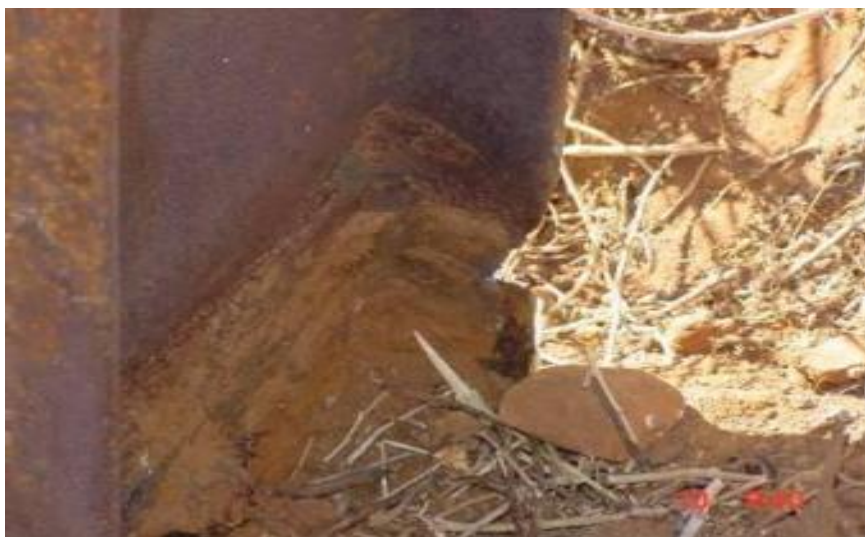
Image 6. Stobie Pole – Ground Line Corrosion

The external interface between the steel and concrete is likely to be the first area to show signs of corrosion. This is due to the water (from rain and dew) that runs down the tower and collects at this point. Any detritus material at the interface can retain moisture and contribute to corrosion.

As the corrosion process requires water it is essential that the foundation tops are shaped or angled to allow water to flow freely from their surfaces. It is also important that the surrounding soil is free draining and does not allow water to pool around a foundation.

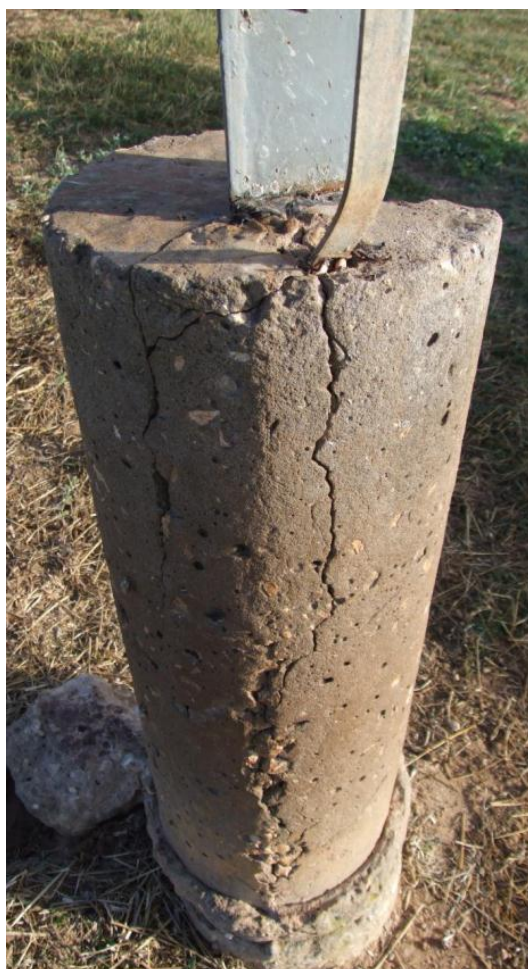
Image 7. Unreinforced and (Exposed) Foundation

Circa 1965, an ETSA internal memo recommended the installation of a single ring of reinforcing steel to be placed near the top of concrete foundations to constrain radial movement of the foundation.

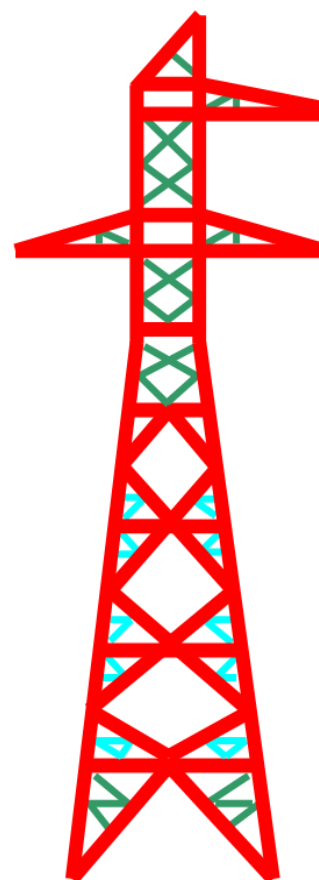
Figure 6. Schematic showing Member Importance and Duty (with Narrative)

Redundant Members are generally limited to those members providing buckling support to secondary members or perform duties of a minor nature such as ladder attachments. These members are at best only required during critical loading events and are provided to effectively stiffen the structure rather than carry significant loads

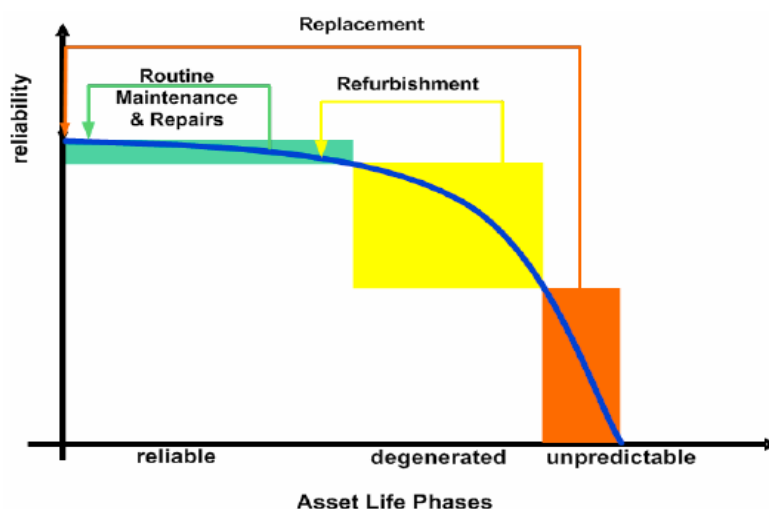
Table 1. States of Aging Concept and Possible Asset Management Actions
(Cigre TB309 Asset Management of Transmission Systems and Associated CIGRE Activities)

The following graph provides a high level view of the interrelationship between the condition assessment results and asset management decisions with respect to proposed actions.

The aim of condition assessment is to establish where on the curve the various components that make up a transmission line fit, to provide an estimate as to both the general condition and the expected remaining life of components that make up the asset. Identification of any special inspection or detailed assessments that are required to make such decisions should also be provided.

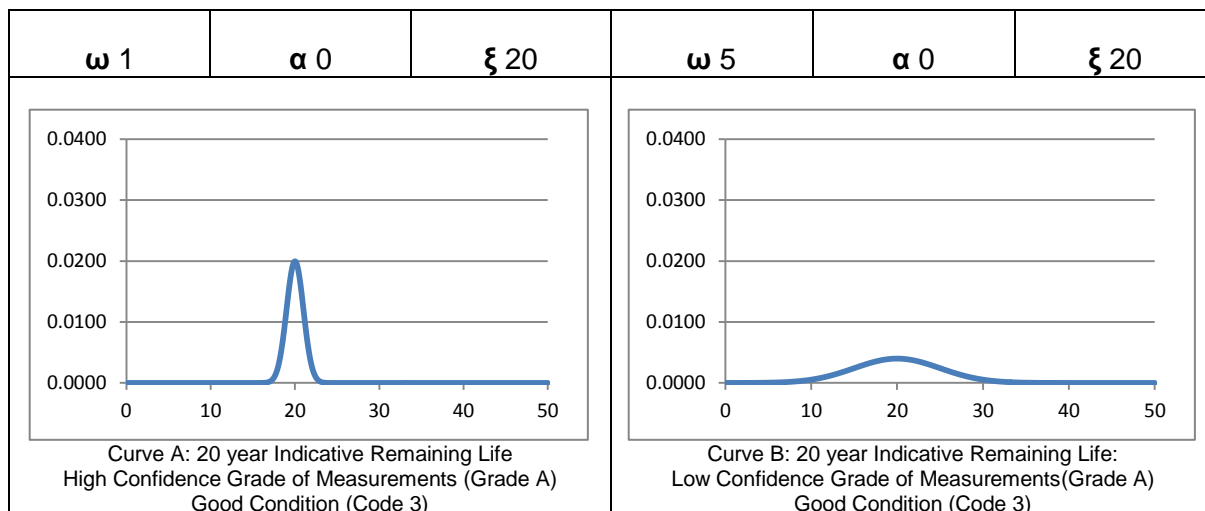
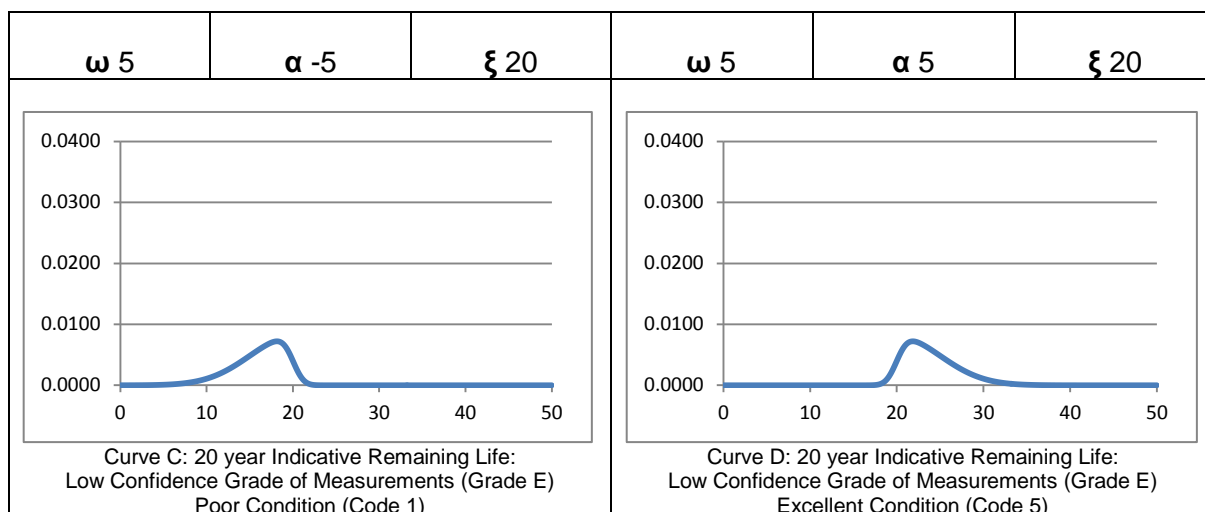
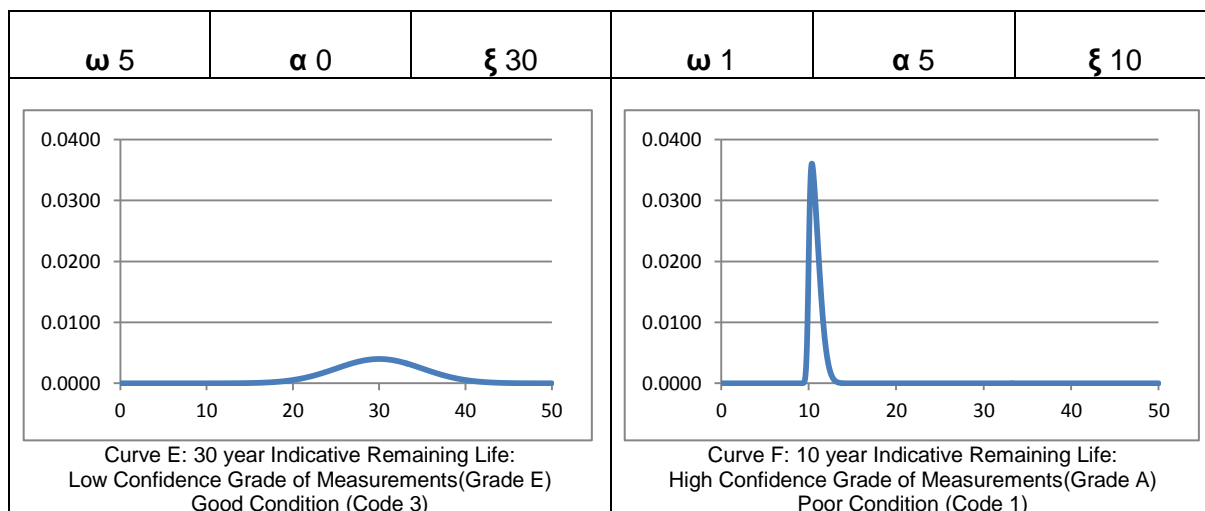
A prediction of expected maximum and minimum remaining life is generated based on the 90th percentile of the skew-normal probability density function spread.

Below are examples of the effect of the properties on the distribution function:

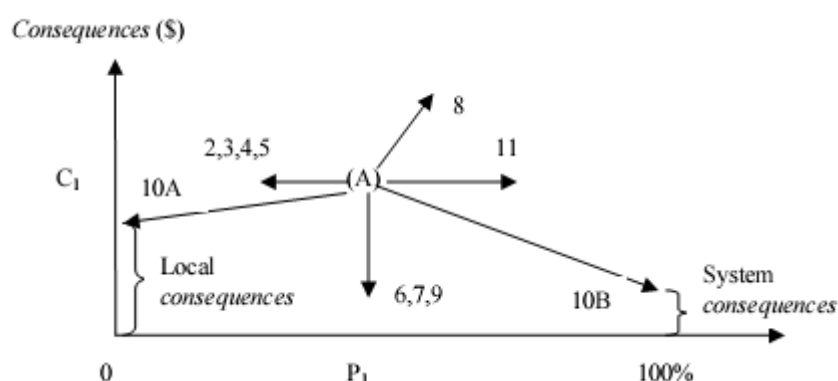
(Cigre TB309 Asset Management of Transmission Systems and Associated CIGRE Activities)

Below is an excerpt form CIGRE technical Brochure 309 (Asset Management of Transmission Systems and Associated CIGRE Activities) which provides the effect of various management actions from the present day. Of relevant note here is the effect of upgrading on increased consequence and probability of failure. Various options exist to mitigate and reduce the effect of upgrading and these should be considered during any proposed increase of operational load requirements.

1	Risk Acceptance	Remain @ A
2	Maintenance	Movement to the left
3	Refurbishment	Movement to the left
4	Life Extension	Movement to the left
5	Upgrading	Movement to the left
6	Insurance	Movement down
7	Fast Restoration	Movement down
8	Upgrading	Movement up and to the right
9	System Development	Movement down
10a	Decommissioning	OHTL operation consequences have 0% probability (a decommissioned line can not fail)
10b	Decommissioning	System operations consequences have 100% probability (a decommissioned line is continually missing)
11	Reduce	Movement to the right
