BUILDING CONDITION REPORT

TransGrid

Sydney North Substation, 1103 Old Northern Rd, Dural NSW 2158

6 May 2016

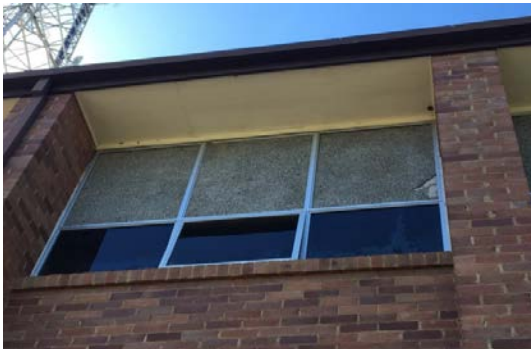
1.1.2	Fascia and Soffits - Control Building	Timber soffit and timber / metal fascia's with paint finish.	In fair overall condition.	Redecorate in the medium term to prevent further deterioration of the surfaces.	R&M	2				\$	3,250.00		3,250.00

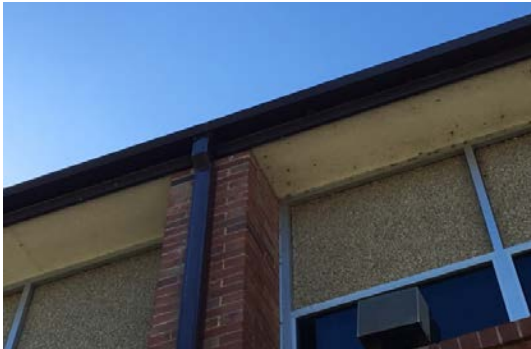
1.1.3.1	Drainage - Control Building	Metal eaves gutters draining to metal downpipes.	In good overall condition.	Allow to replace rainwater goods in-line with roof coverings in the long term.	CAP	4				\$	11,625.00	\$	11,625.00

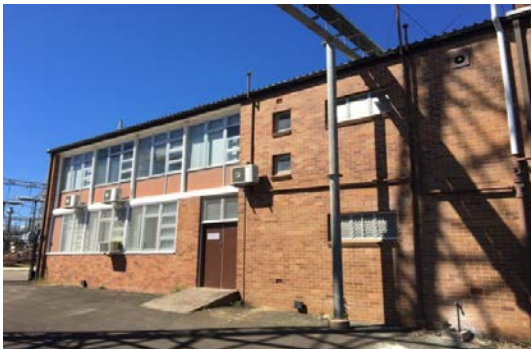
1.2.1	Façades- Control Building	Fair faced cavity brick elevations.	In good overall condition.	No action required.	CAP	4						\$	-

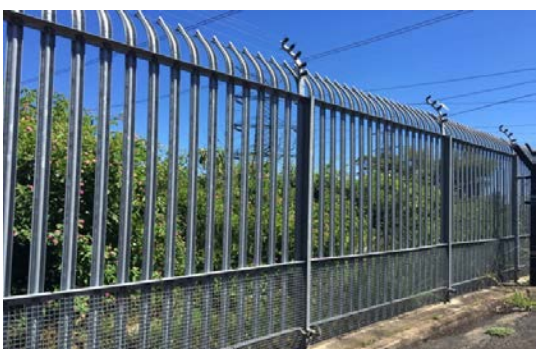
.3.2.2	Entry Gates	Mechanically operated sliding metal entry gate.	In good overall condition.	No action required, ongoing maintenance as normal.	CAP	4						\$	-

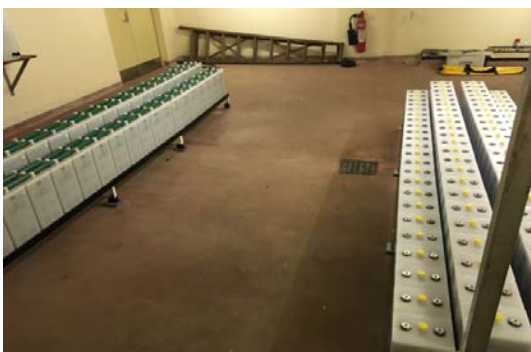
2.5.3	Floors	Fairfaced concrete.	In fair overall condition.	Allow to install epoxy floor finish in the short term.	CAP	2		\$	15,840.00		\$	15,840.00

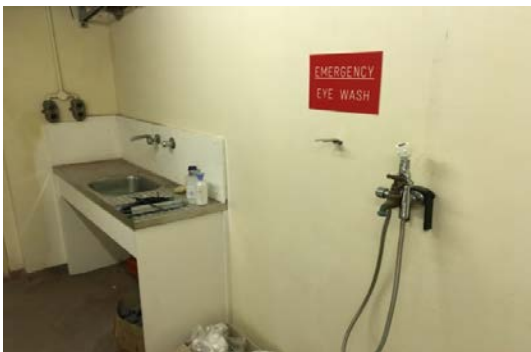
2.5.6	Emergency shower and eyewash station	Hose provided, non-compliant.	In fair to good overall condition.	Install new compliant emergency shower and eyewash station as required.	BCA	1	\$	10,000.00			\$	10,000.00

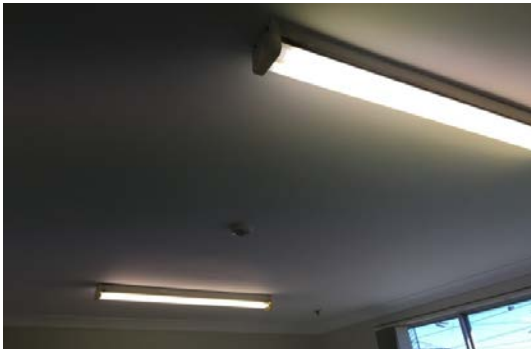
2.10	Control Building - First Floor - Kitchen / Lunch												
2.10.1	Ceilings	Suspended plasterboard ceiling with paint finish.	In fair overall condition.	Allow to repaint surfaces.	R&M	3			\$	480.00	\$	480.00

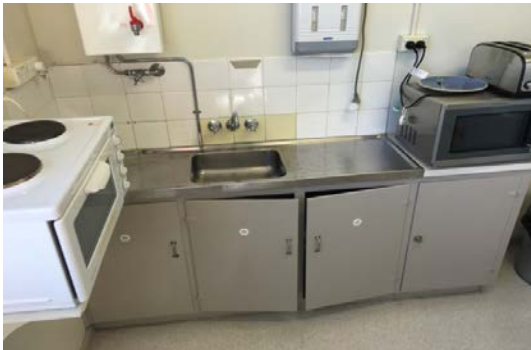
2.10.3	Floors	Vinyl sheet.	In fair to good overall condition.	Allow to replace vinyl sheet in the medium term.	CAP	2			\$	1,680.00	\$	1,680.00	 
2.10.4	Joinery- Kitchen	Laminated base units, stainless steel sink and drainer.	In fair to good overall condition.	Allow to replace kitchen units throughout.	CAP	3			\$	7,500.00	\$	7,500.00

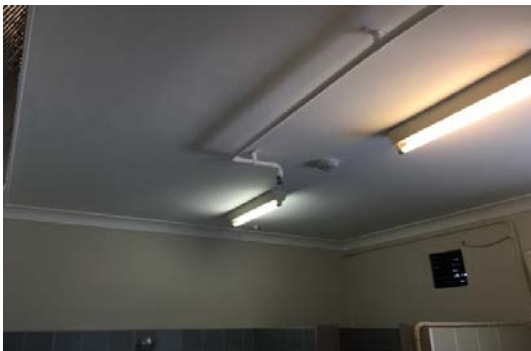
2.11	Control Building - First Floor - WCs												
2.11.1	Ceilings	Suspended plasterboard ceiling with paint finish.	In fair overall condition.	Allow to paint ceiling surfaces.	R&M	2			\$	240.00	\$	240.00

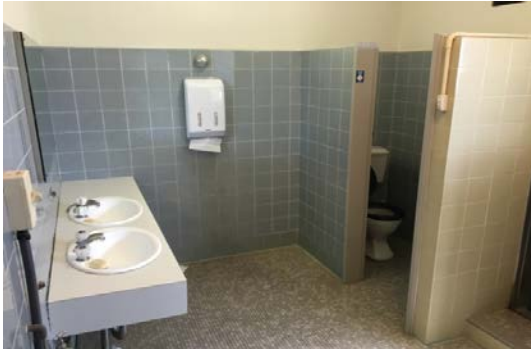
2.11.2	Walls	Tiled wall surfaces, half height.	In poor to fair overall condition.	No action required.	CAP	2				\$ 6,120.00	\$ 6,120.00

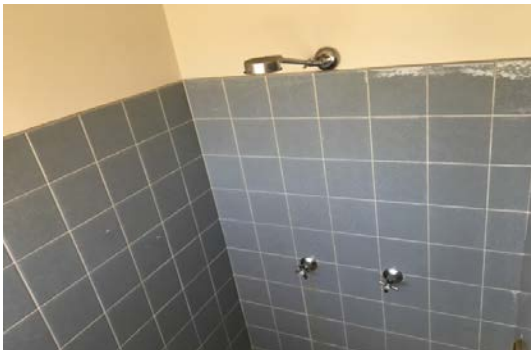
2.11.7	Fixtures and Fittings	Vitreous china WHB's, WCs, small urinal and showers.	In poor to fair overall condition.	Allow for medium term replacement.	CAP	3				\$ 13,500.00	\$ 13,500.00

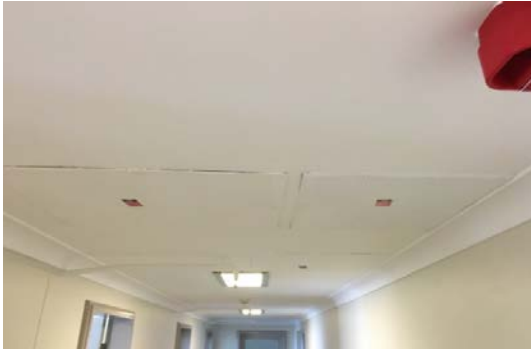
2.12	Control Building - First Floor - Old Offices and Corridor											
2.12.1	Ceilings	Suspended plasterboard ceiling with paint finish.	In fair overall condition.	Allow to paint ceiling surfaces.	CAP	3				\$ 3,300.00	\$ 3,300.00

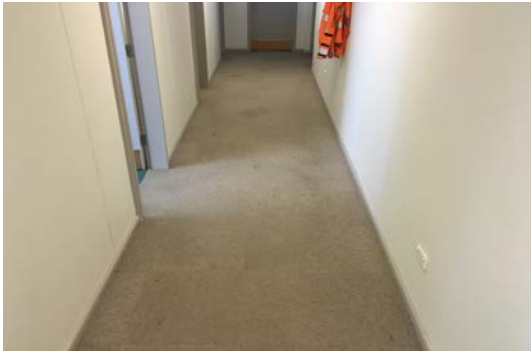
2.12.2	Walls	Painted plasterboard walls and partitions.	In fair overall condition.	Allow to repaint wall surfaces.	R&M	3				\$ 3,600.00	\$ 3,600.00	
2.12.3	Floors	Carpet flooring.	In fair overall condition.	Allow to replace with vinyl sheet.	CAP	3				\$ 3,080.00	\$ 3,080.00

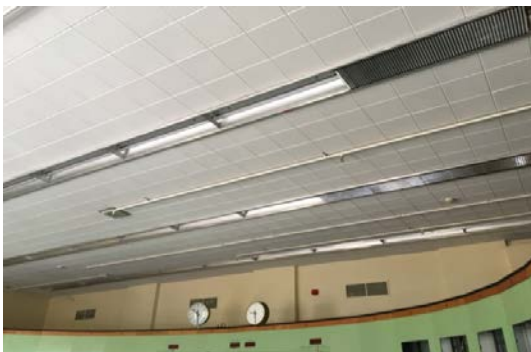
2.13 Control Building - First Floor - Control Room														
2.13.1	Ceilings	Dated installations.	In fair overall condition.	Allow to replace with modern equivalent in the medium term.	CAP	3			\$	14,280.00	\$	14,280.00

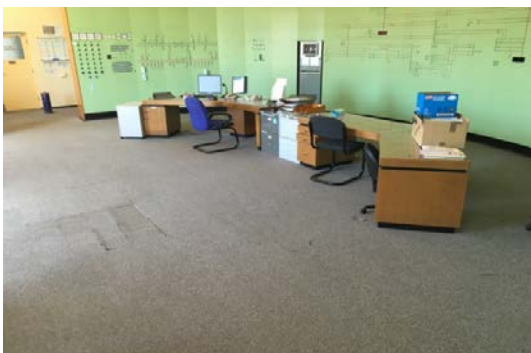
2.13.2	Walls	Painted plasterboard walls and partitions.	In good overall condition.	Allow to repaint wall surfaces.	R&M	3			\$	4,080.00	\$	4,080.00

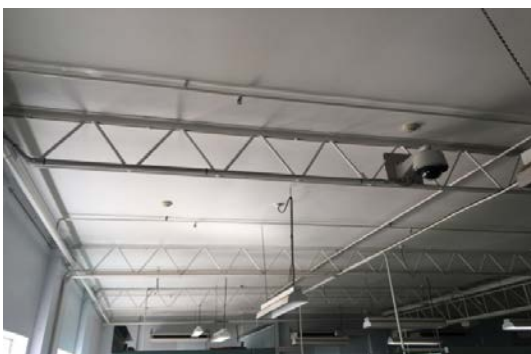
2.14 Control Building - First Floor - Relay Room														
2.14.1	Ceilings	Suspended ceiling with exposed grid and lay-in tiles.	In good overall condition.	Allow to repaint surfaces.	R&M	4				\$	7,440.00	\$	7,440.00

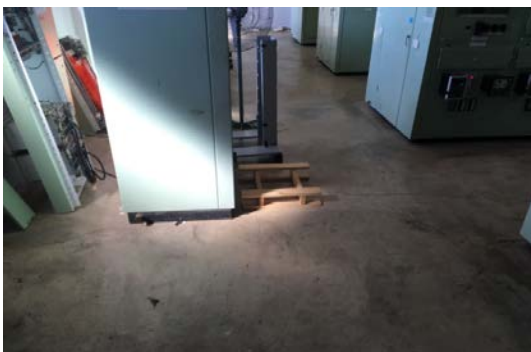
2.14.2	Walls	Painted plasterboard walls and partitions.	In good overall condition.	Allow to repaint wall surfaces.	R&M	4				\$	4,080.00	\$	4,080.00

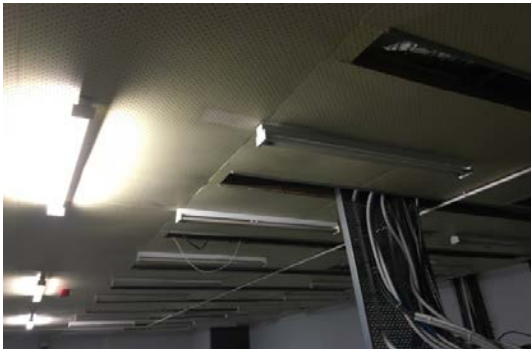
2.15	Control Building - First Floor - Comms Room													
2.15.1	Ceilings	Proprietary ceiling finishes.	In good overall condition.	Allow to replace with new system in the long term.	CAP	4				\$	12,600.00	\$	12,600.00

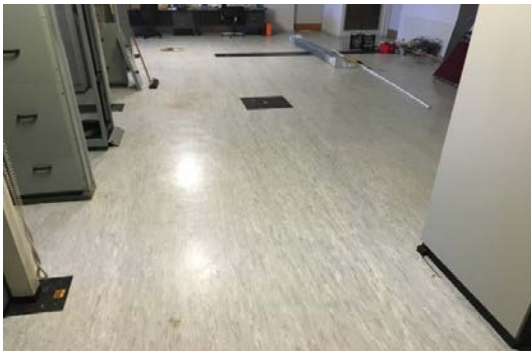
2.15.2	Walls	Painted plasterboard walls and partitions.	In good overall condition.	Allow to repaint wall surfaces.	R&M	4				\$	3,360.00	\$	3,360.00

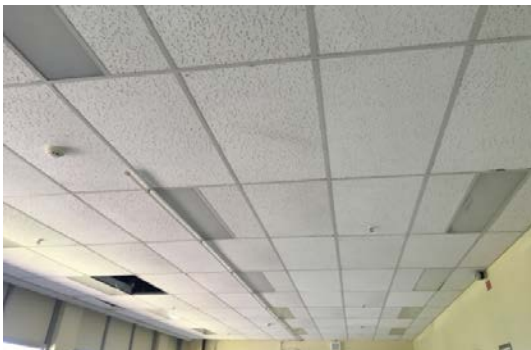
2.16.1	Ceilings	Suspended ceiling with exposed grid and lay-in tiles.	In fair to good overall condition.	Disused room - no action required.	CAP	4						\$	-

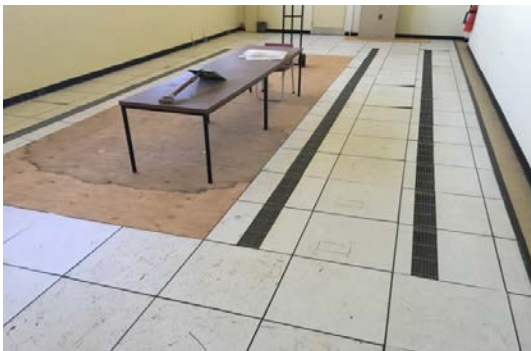
2.16.2	Walls	Painted plasterboard walls and partitions.	In fair to good overall condition.	Disused room - no action required.	CAP	4						\$	-

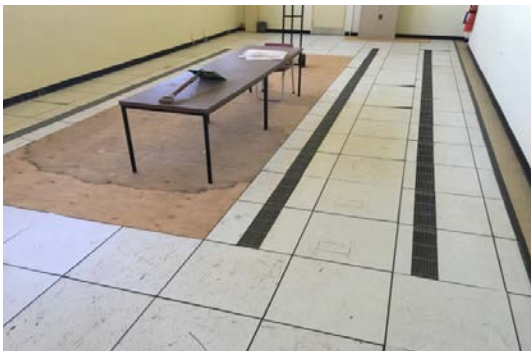
2.16.4	Joinery- Doors	Timber access doors with paint finish.	In fair to good overall condition.	Disused room - no action required.	CAP	4						\$	-

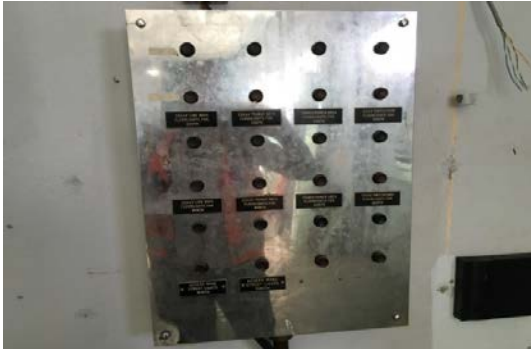
3.11	Building Services Generally	Mains Distribution board and switchboards.	In fair overall condition.	Aged but still performing. There are limited RCDs on the circuits however, other parts are becoming obsolete. Allow for short term replacement of the affected boards.	CAP	2		\$	10,000.00		\$	10,000.00

The electrical services are generally in fair condition albeit aged and would welcome an overhaul in the reporting period given their age and parts becoming obsolete. A number of boards did contain RCDs, which was required from the 18th February 2015 under Occupational Health and Safety Amendment (Residual Current Devices) Regulation 2011. The wiring to the property appears to be in fair condition and we do not expect any major rewiring is required within the reporting period. Although we did note some areas surrounding the cable basement contain what appear to be original light switches and therefore what is assumed to be original wiring.
