BUILDING CONDITION REPORT

TransGrid

Sydney South Substation, 925A Henry Lawson Drive, Picnic Point NSW 2213

6 May 2016

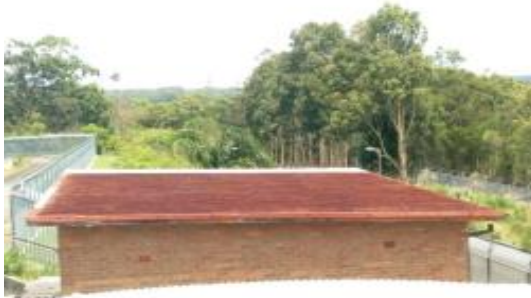
1.1.3	Ancillary Buildings - Fire Pump House .	Steel framed roof structure covered with profile metal sheeting.	In poor overall condition.	Heavily corroded coverings. Allow to replace coverings in the immediate term to the Fire Pump House .	CAP	1	\$ 14,400.00				\$ 14,400.00

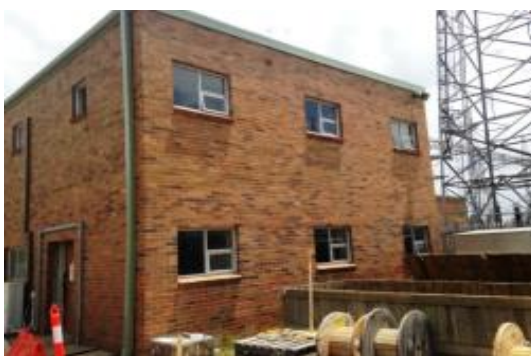
1.1.6	Fascia and Soffits - Control Building	Timber soffit and timber / metal fascia's with paint finish.	In fair overall condition.	Redecorate in the medium term to prevent further deterioration of the surfaces.	R&M	2			\$ 2,900.00		\$ 2,900.00

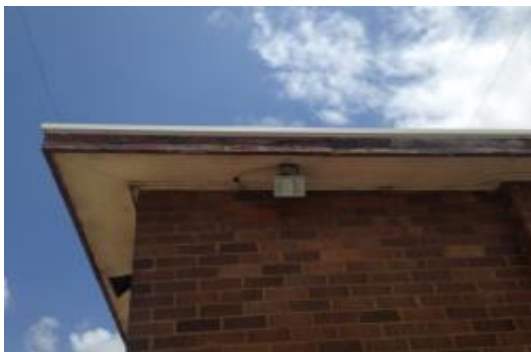
1.1.7	Fascia and Soffits - LVAC Building	Timber soffit and fascia's with paint finish.	In poor overall condition.	Redecorate in the immediate term to prevent further deterioration of the surfaces.	R&M	1	\$ 1,100.00				\$ 1,100.00

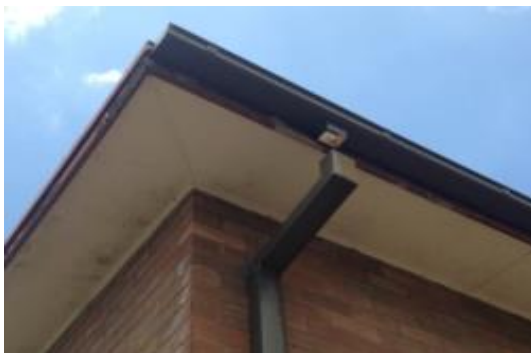
1.1.11.3	Ancillary Buildings - Fire Pump House.	Metal eaves gutters draining to metal downpipes.	In poor overall condition.	Allow to replace rainwater goods in-line with roof coverings in the immediate term. Maintenance and repairs required to select locations of Fire Pump House .	CAP	1	\$ 2,700.00				\$ 2,700.00

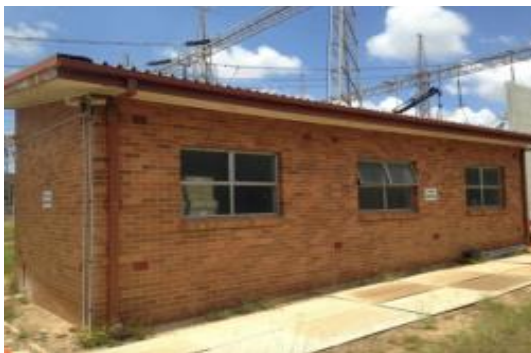
1.1.11.5	Ancillary Buildings - Oil Spill Building	Metal eaves gutters draining to metal downpipes.	In fair to good overall condition.	Allow to replace rainwater goods in-line with roof coverings in the short term.	CAP	3		\$ 1,875.00			\$ 1,875.00

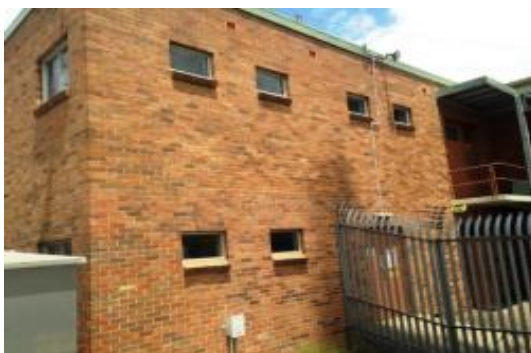
1.2	External Elevations											
1.2.1	Façades- Control Building	Fair faced cavity brick elevations.	In good overall condition.	No action required.	CAP	4					\$ -

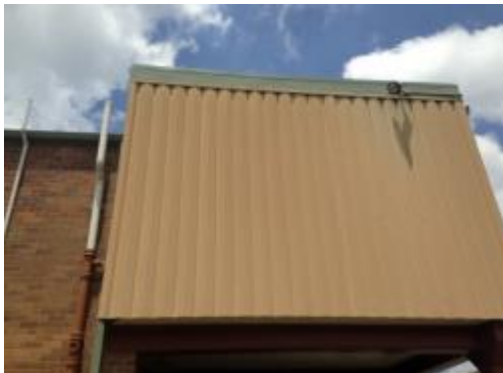
1.2.2	Façades- Control Building	Profiled metal sheet cladding.	In fair to good overall condition.	Allow for lifecycle replacement in the long term.	CAP	4				\$ 6,600.00	\$ 6,600.00

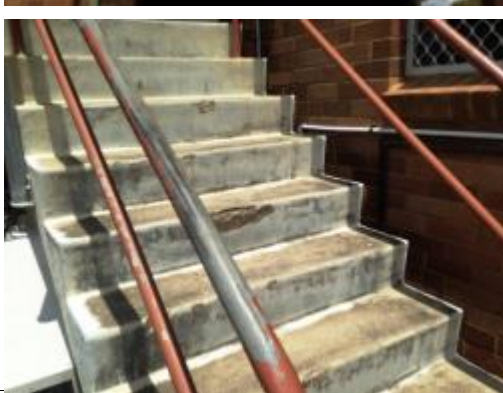
PREDICTED CAPEX & MAINTENANCE COSTS (\$) excl GST												
ITEM NO	LOCATION/ELEMENT	DESCRIPTION	CONDITION	REMEDIAL WORKS REQUIRED	CAP/ R&M	PRIORITY	Replacement Date & Cost				TOTAL BUDGET (excludes per annum)	Photo Ref
							Immediate (within 12 months)	Short (1-2 years)	Medium (3-5 years)	Long (6-10 years)		
.2.3	External Stairs - Control Building - North	Reinforced concrete steps providing access to first floor. Painted steel handrails and balustrades.	In poor to fair overall condition.	Spalling of concrete evident and handrails in poor decorative order. Allow for concrete repairs and overhaul of handrail / balustrades in the short term.	R&M	2		\$ 6,000.00			\$ 6,000.00

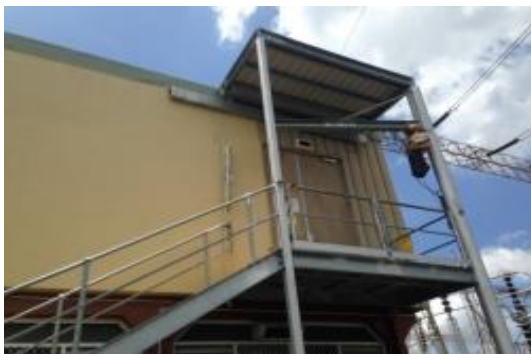
.2.4	External Stairs - Control Building - South	Steel steps providing access to first floor. Painted steel handrails and balustrades.	In good overall condition.	No action required. Ongoing maintenance as normal.	CAP	4					\$ -

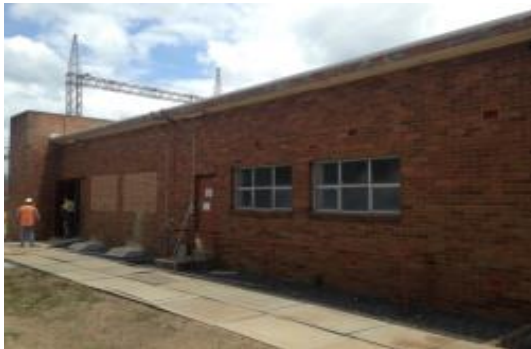
.2.5	Façades- LVAC Building	Fair faced cavity brick elevations.	In good overall condition.	A number of previous window installations have been bricked up. No action required.	CAP	4					\$ -

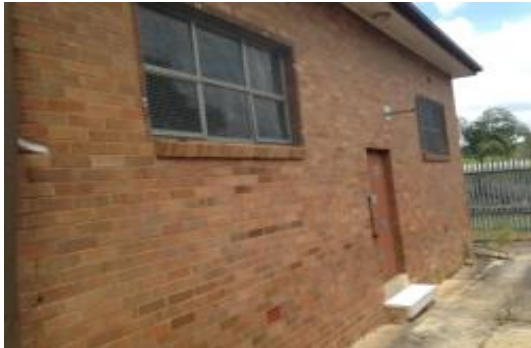
.2.6	Façades - Fire Pump House	Fair faced cavity brick elevations.	In good overall condition.	No action required.	CAP	4					\$ -

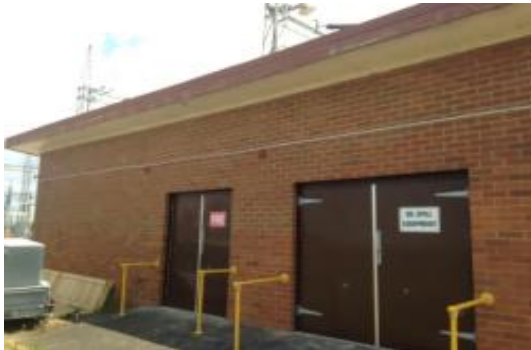
.2.7	Façades - Oil Spill Building	Fair faced cavity brick elevations.	In good overall condition.	No action required.	CAP	4					\$ -

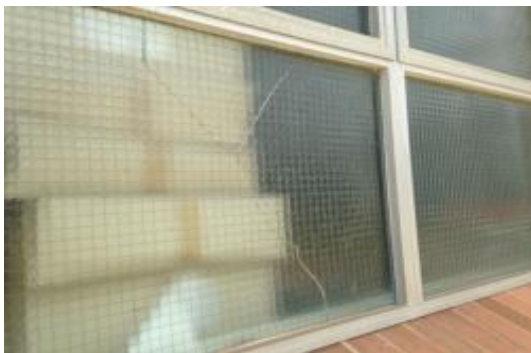
PREDICTED CAPEX & MAINTENANCE COSTS (\$) excl GST													
ITEM NO	LOCATION/ELEMENT	DESCRIPTION	CONDITION	REMEDIAL WORKS REQUIRED	CAP/ R&M	PRIORITY	Replacement Date & Cost				TOTAL BUDGET (excludes per annum)	Photo Ref	
							Immediate (within 12 months)	Short (1-2 years)	Medium (3-5 years)	Long (6-10 years)			
.2.8.6	Windows - Oil Spill Building	Metal framed single glazed windows	In fair overall condition.	Allow to undertake repairs such as deteriorating joints and sealants and cracked glazing in the short term.	CAP	3		\$	2,040.00		\$	2,040.00

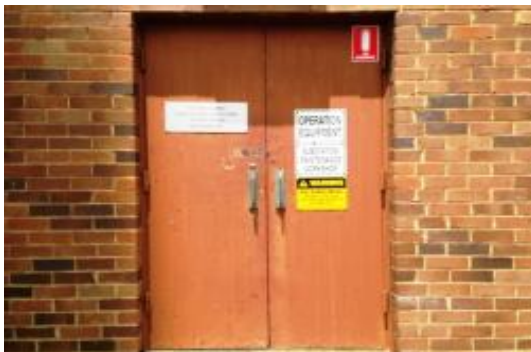
.2.8.7	Doors - Control Building	Timber access doors with paint finish.	In poor to fair overall condition.	Allow to replace doors in the short term due to lifecycle expiry and rot in select areas.	CAP	2		\$	28,500.00		\$	28,500.00

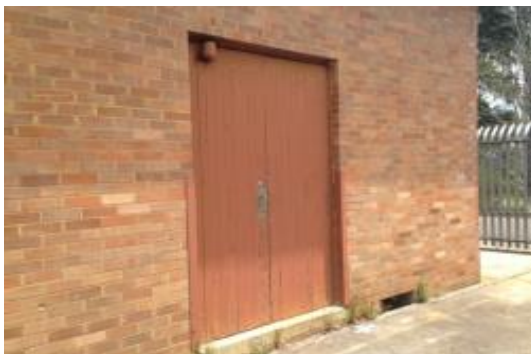
.2.8.8	Doors - LVAC Building	Timber access doors with paint finish.	In fair to good overall condition.	Allow to replace doors in the short term due to lifecycle expiry and rot in select areas.	CAP	2		\$	6,000.00		\$	6,000.00

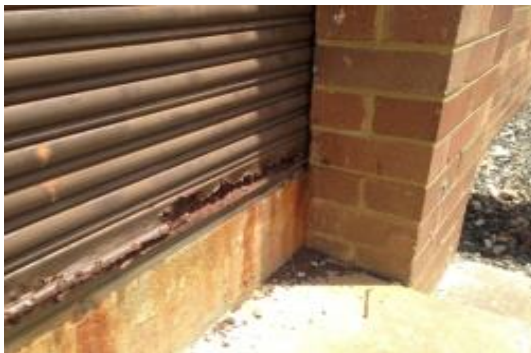
.2.8.9	Doors - Roller Shutter Doors - LVAC Building	Metal roller shutter doors.	In poor overall condition.	Allow to replace roller shutter in the immediate term.	CAP	1	\$	5,000.00			\$	5,000.00

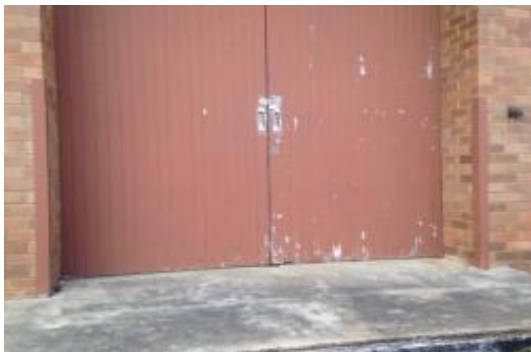
.2.8.10	Doors - Fire Pump House	Timber access doors with paint finish.	In fair overall condition.	Allow to replace doors in the short term due to lifecycle expiry.	CAP	2		\$	4,500.00		\$	4,500.00

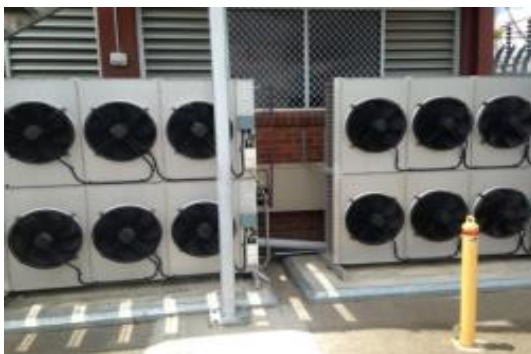
1.2.9	Fixtures & Fittings																
.2.9.1	Fixtures & Fittings - Control Building	Wall mounted security lighting.	N/A	Little or no security lighting. Allow for short term installation.	CAP	2		\$	3,500.00			\$	3,500.00				
.2.9.2	Fixtures & Fittings - Control Building	Split System A/C units located to elevations.	In fair to good overall condition.	Allow for replacement / upgrade of large units in the medium term.	CAP	3			\$	14,000.00		\$	14,000.00

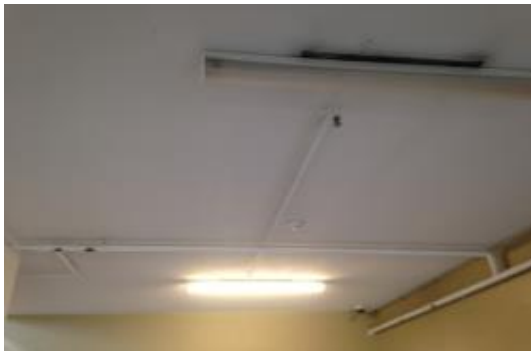
1.2.9.4	Fixtures & Fittings	CCTV with cameras externally and internally mounted.	In fair to good overall condition.	CCTV appears to only cover minimal areas of the building. Allow for medium term review and overhaul of CCTV throughout the building.	CAP	3			\$	20,000.00	\$	20,000.00

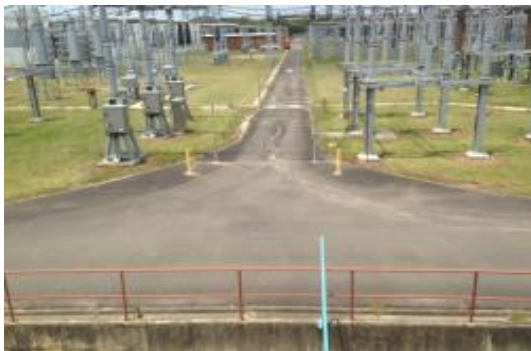
1.3 External Areas																
1.3.1 External Surfaces																
1.3.1.1	Parking & Switchyard	Combination of reinforced concrete hard stand areas and on-grade tarmacadam road surfaces.	In fair overall condition.	Allow for ongoing repairs to potholes, edge kerbing, hardstand jointing and grated steel drainage coverings throughout.	R&M	3		\$	45,000.00	\$	35,000.00	\$	35,000.00	\$	115,000.00

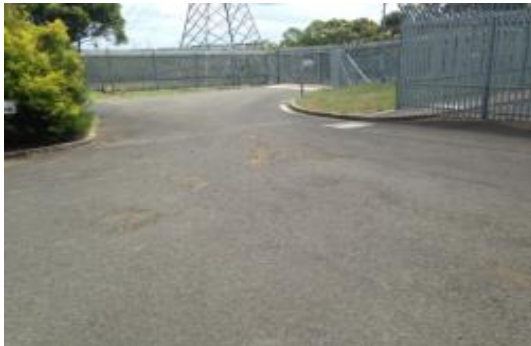
1.3.2.2	Entry Gates	Mechanically operated sliding metal entry gate.	In good overall condition.	No action required, ongoing maintenance as normal.	CAP	4						\$	-

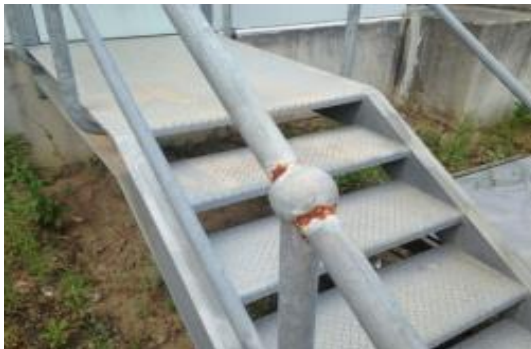
1.3.3 External Ancillary Buildings															
.3.3.1	Water tanks	Circular concrete water storage tank.	In fair overall condition.	Allow for lifecycle replacement in the long term.	CAP	4				\$	60,000.00	\$ 60,000.00	 		
.3.3.2	Bunding	A number of areas of bunding have been sealed with a waterproof membrane whereas other areas are fairfaced concrete and a small area of low level brickwork.	In fair overall condition.	A number of areas of joint degradation were observed. Allow to seal banded areas with waterproof membrane to the transformer and reactor areas over the reporting period.	R&M	2		\$	65,000.00	\$	65,000.00	\$	65,000.00	\$ 195,000.00	 
.3.3.3	Bunding Access Stairs	Steel access steps and balustrades/handrails.	In fair overall condition.	Allow to treat corrosion to select areas in the short term. A number of areas have already been repaired recently.	R&M	2		\$	3,400.00			\$	3,400.00

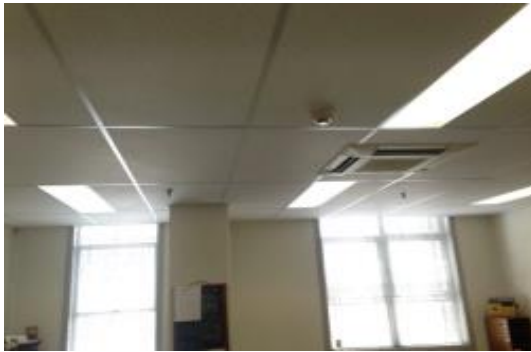
2.1	Control Building - Ground Floor - Kitchen / Lunch											
2.1.1	Ceilings	Suspended ceiling with exposed grid and lay-in tiles.	In good overall condition.	No action required.	CAP	4					\$ -

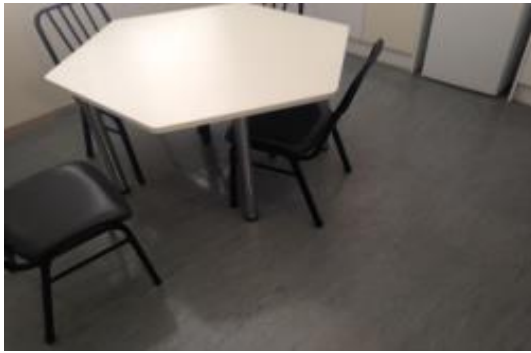
2.1.3	Floors	Vinyl sheet.	In fair to good overall condition.	Allow to replace vinyl sheet in the medium term.	CAP	2			\$ 1,050.00		\$ 1,050.00

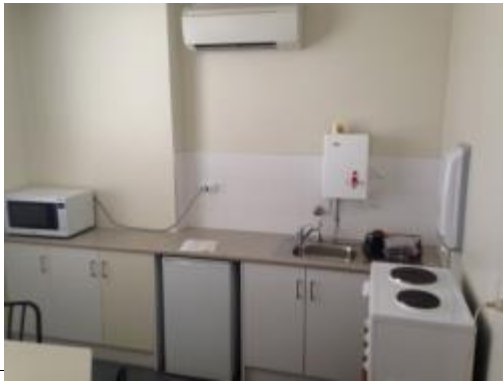
2.1.4	Joinery- Kitchen	Laminated base units, stainless steel sink and drainer.	In fair to good overall condition.	Allow to replace kitchen units throughout.	CAP	3			\$ 10,000.00		\$ 10,000.00

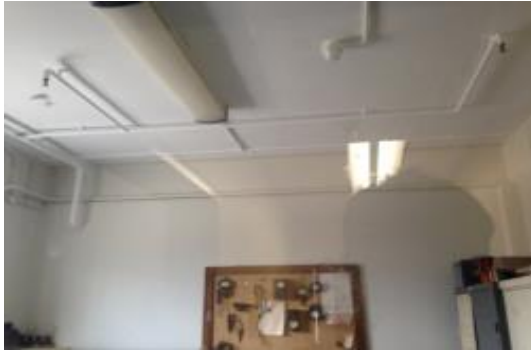
2.2	Control Building - Ground Floor - Workshop & Store											
2.2.1	Ceilings	Suspended plasterboard ceiling with paint finish.	In good overall condition.	Allow to repaint surfaces.	R&M	3			\$ 360.00		\$ 360.00

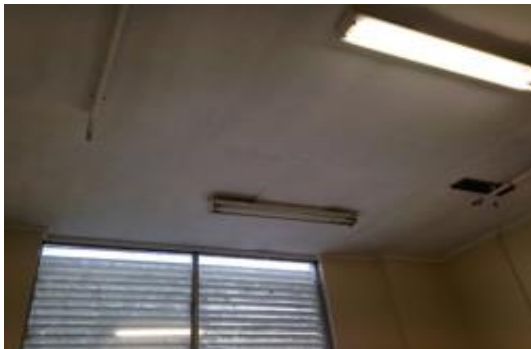
2.12	Control Building - First Floor - Kitchen / Lunch												
2.12.1	Ceilings	Suspended plasterboard ceiling with paint finish.	In fair overall condition.	Allow to repaint surfaces.	R&M	3		\$	480.00		\$	480.00

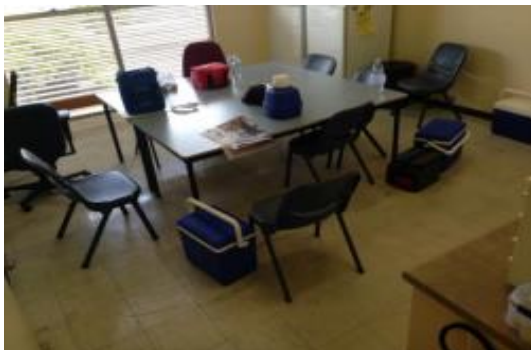
2.12.2	Walls	Painted plasterboard walls and partitions.	In fair to good overall condition.	Allow to repaint wall surfaces.	R&M	3		\$	1,200.00		\$	1,200.00

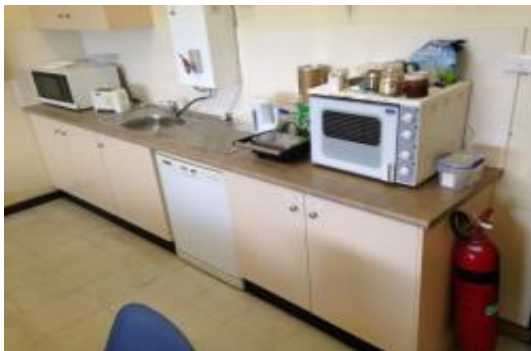
2.12.3	Floors	Vinyl sheet.	In fair to good overall condition.	Allow to replace vinyl sheet in the medium term.	CAP	2		\$	1,680.00		\$	1,680.00	
2.12.4	Joinery- Kitchen	Laminated base units, stainless steel sink and drainer.	In fair to good overall condition.	Allow to replace kitchen units throughout.	CAP	3		\$	10,000.00		\$	10,000.00

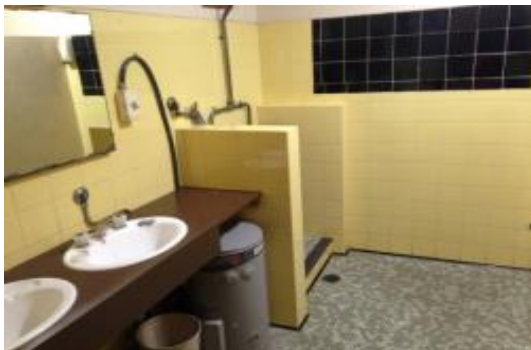
2.13.2	Walls	Tiled wall surfaces, half height.	In poor to fair overall condition.	No action required.	CAP	2		\$	6,120.00		\$	6,120.00

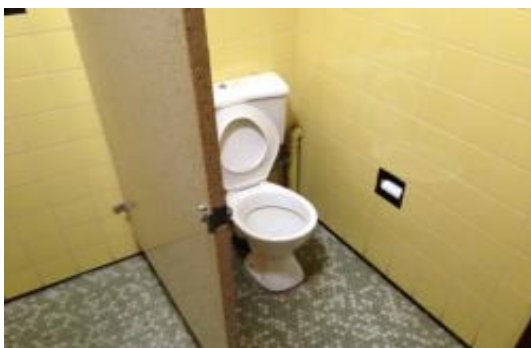
2.13.4	Floors	Ceramic tiled floor surfaces.	In poor to fair overall condition.	Allow for replacement in the short term.	CAP	2		\$	1,440.00		\$	1,440.00

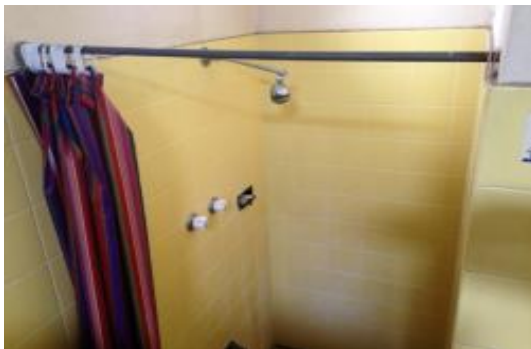
2.13.7	Fixtures and Fittings	Vitreous china WHB's, WCs, small urinal and showers.	In poor to fair overall condition.	Allow for short term replacement.	CAP	2		\$	13,500.00		\$	13,500.00

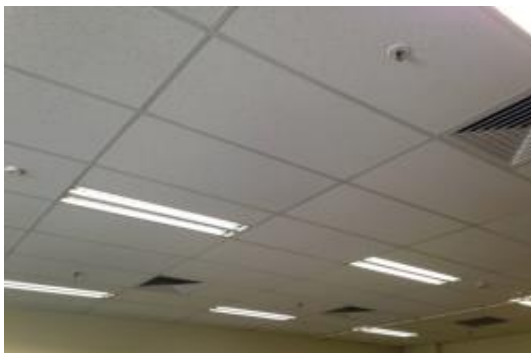
2.14.5	Lighting	Recessed strip light fittings with diffusers.	In fair overall condition.	Allow for short term replacement.	CAP	2		\$	4,000.00		\$	4,000.00

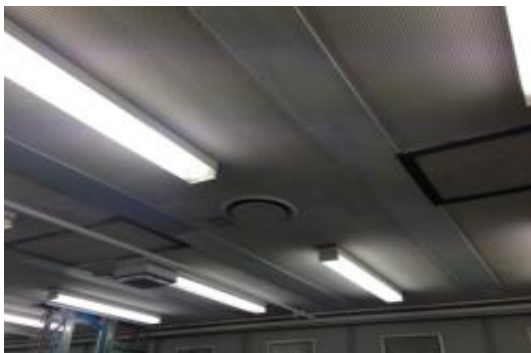
2.17.1	Ceilings	Proprietary ceiling finishes.	In good overall condition.	Allow to replace with new system in the long term.	CAP	4				\$	12,600.00	\$	12,600.00

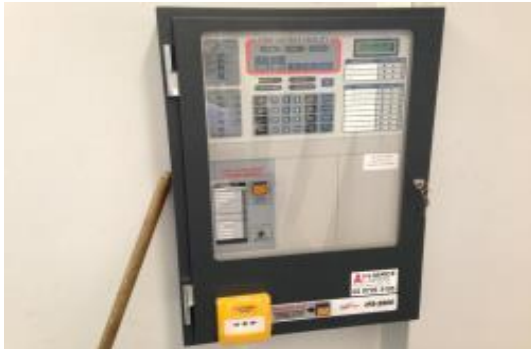
3.5	Building Services Generally	VESDA system.	In good overall condition.	We don't envisage any major replacement works in the reporting period. Maintain annually.	R&M	2	\$	5,000.00	\$	10,000.00	\$	15,000.00	\$	25,000.00	\$	55,000.00
