Powercor – Wood Pole Management

Sustainable Wood Pole Safety Management approach

Detailed Technical report

December 2019

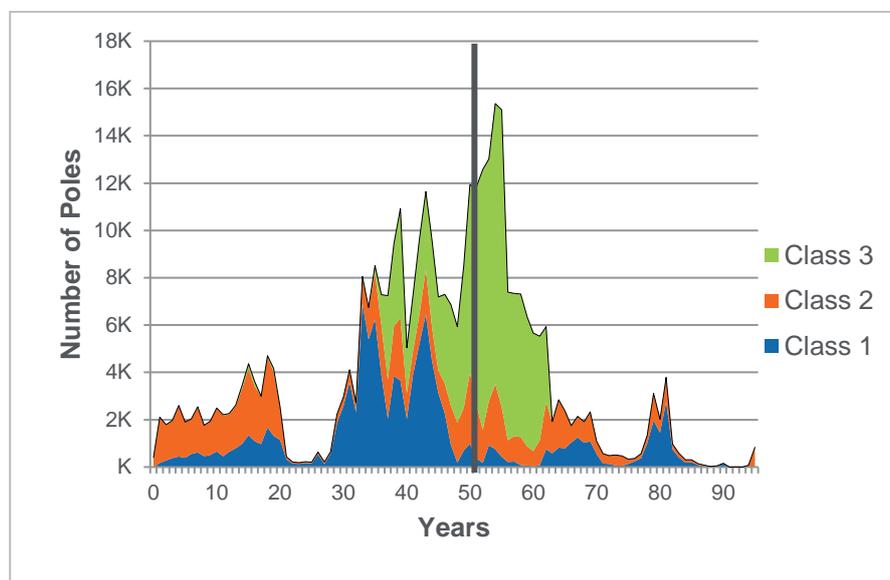
Figure 3: ESV's wood pole age profile

As shown in the Figure 3 below, Powercor has over 365,000 wood poles, with over 158,000 poles (42 per cent) over 50 years old. Approximately 100,000 poles over 50 years old are (lower) durability class 3 poles. The average age of the pole population is 44 years and the average age of poles that fail is 51 years. This large number of wood poles approaching their end-of-life is a challenge for Powercor's wood pole management system.

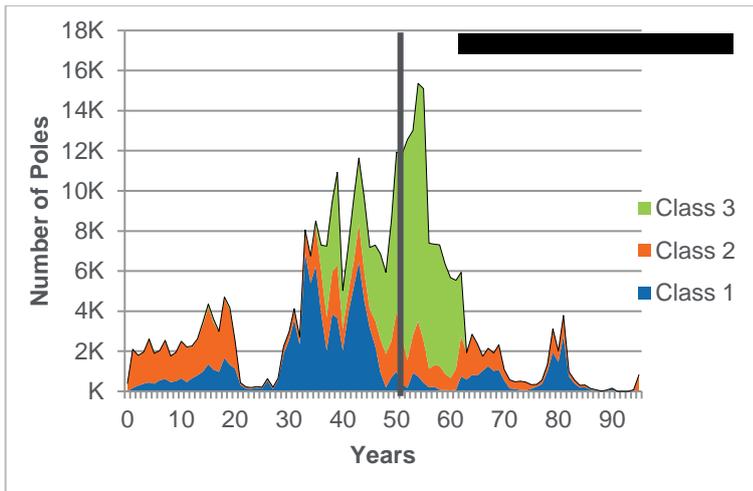
Figure 14: Age profile of All Powercor Wood pole by class³²

Powercor’s wood poles age profile is shown in Figure 14, and indicates that most of the electricity network was constructed 40 to 60 years ago. It reflects a snapshot of the network after years of installation and decommissioning activities through changes in policy and business practice. Approximately 158,000 poles (43 per cent of the total wood pole population) are over 50 years of age, with:

Age Metric	Average Age
In-Service	44
Replacement	53
Unassisted Failure	51

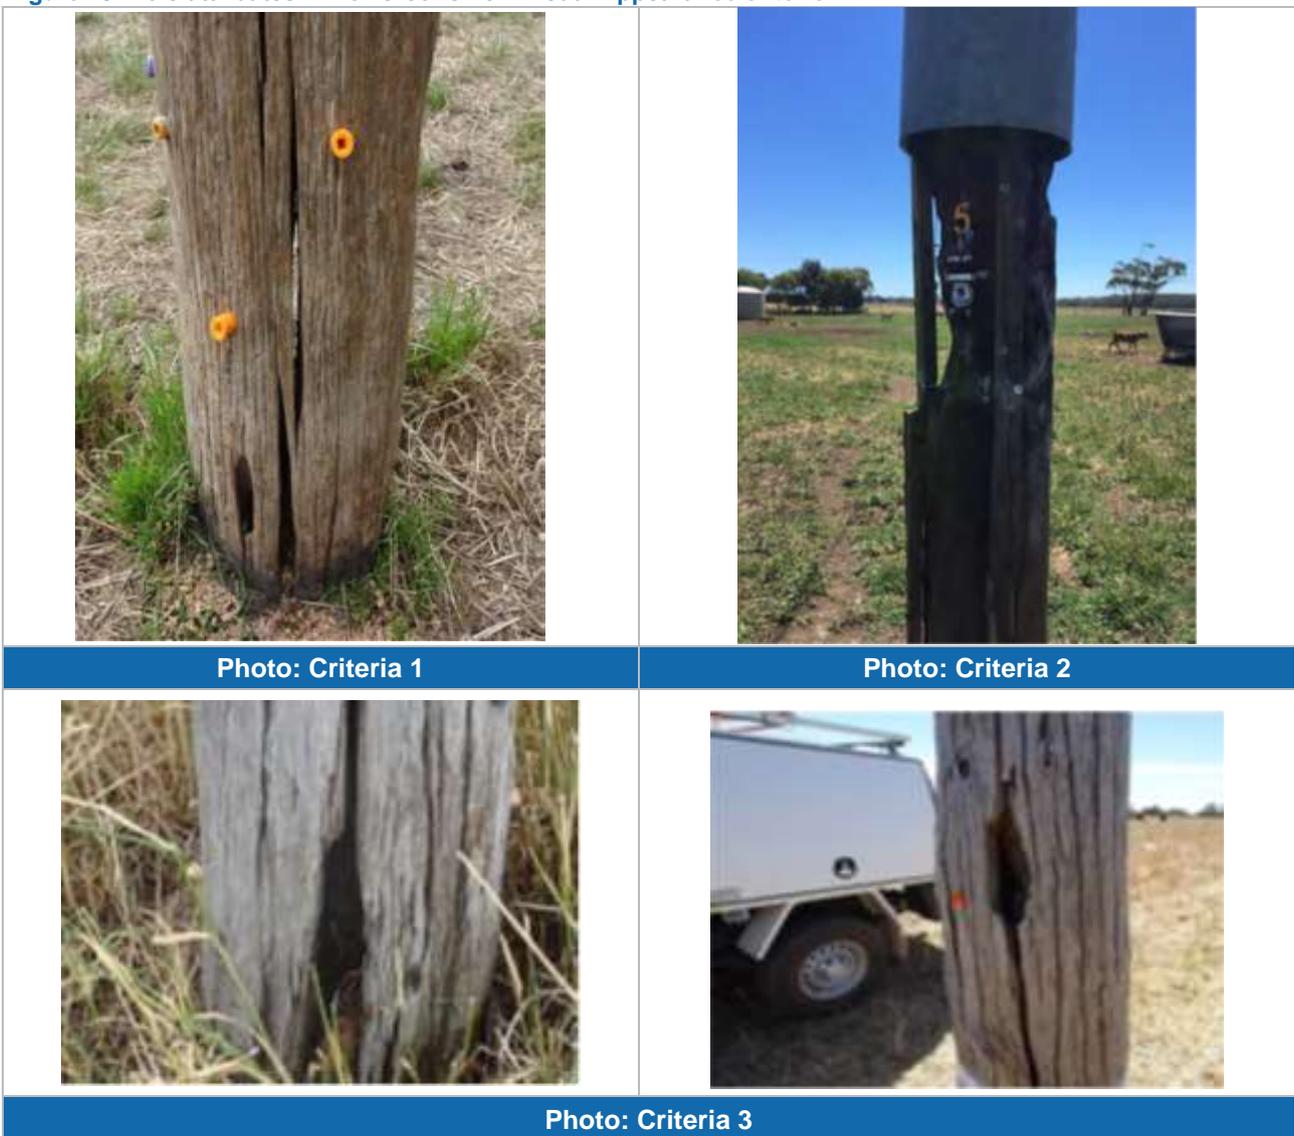
Figure 19: Pole attributes in Powercor’s new Visual Appearance criterion⁶⁷

Figure 19 shows the three pole attributes which Powercor apply to classifying an AC Serviceable or Serviceable pole as Unserviceable P2, noting that the Visual Assessment criterion is applied after the other inspection techniques.⁶⁶

- see-through split greater than 10mm in width.
- deterioration of pole cross-section greater than 25 per cent
- 100mm or greater void or loss of wood (knot hole or damage) including staked poles with no timber above ground level.

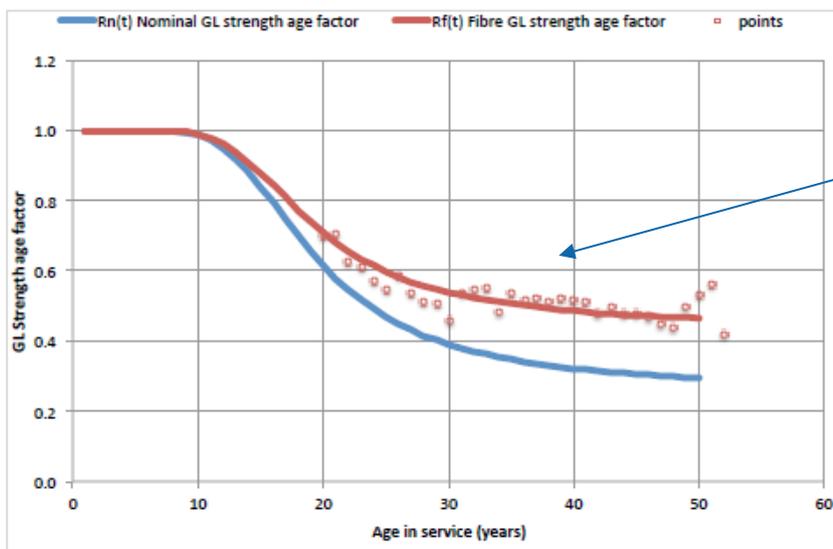
Figure 26: Fibre strength age factor¹³⁵

The greatest decline in strength occurs during the 10-20 years old period, but by 45 years of pole age, residual strength has declined to less than 50% of its initial strength.

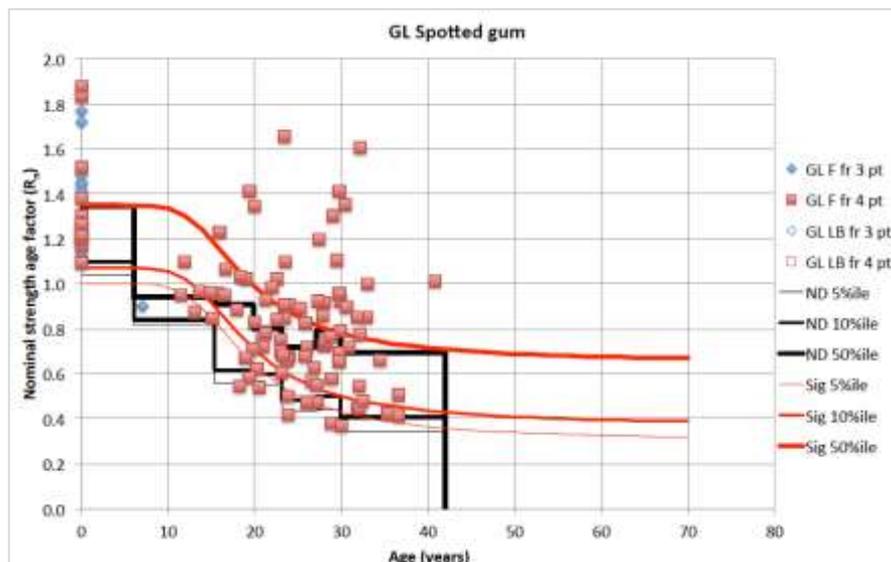
Figure 28: Strength versus age curves (GL) for spotted gum from ENA research¹³⁷

Based on the example in Figure 28 below from the ENA research, there is a large variation in strength versus age even within a single species. The 5th percentile curve is clearly much more conservative than the 50th percentile curve because of the large variation in residual strength between poles of the same age and species. A conservative approach would be to adopt the 5th percentile, but as discussed below, this is likely to be overly conservative, generating a very high number of false positive results (i.e. classifying low risk poles as Unserviceable).

ESV consider that Powercor's application of the ENA research is reasonable to help calibrate its SI calculations and, by extension, its serviceability criteria.

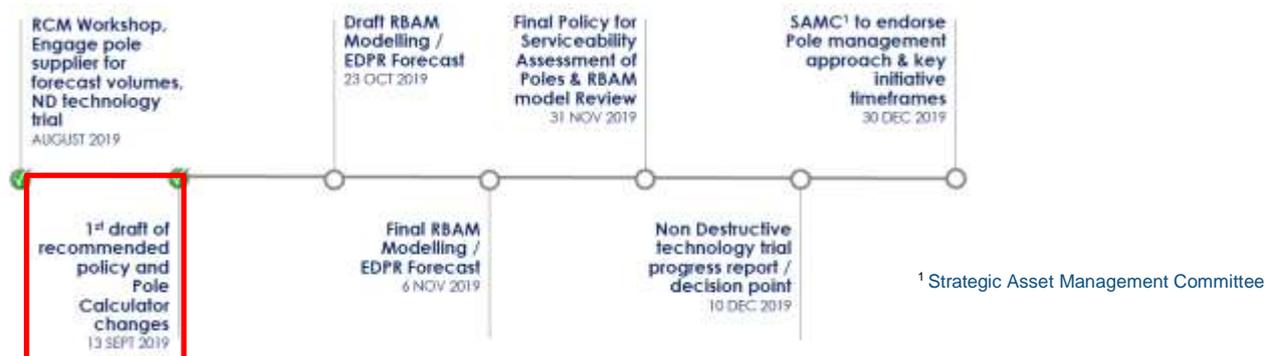
Figure 30: Powercor's draft 2020-2021 wood pole management improvement timeline¹⁴⁴

Figure 31 and Figure 30 show Powercor’s latest draft wood pole management improvement timelines for 2019 and 2020. The improvement steps related to serviceability assessment are highlighted.

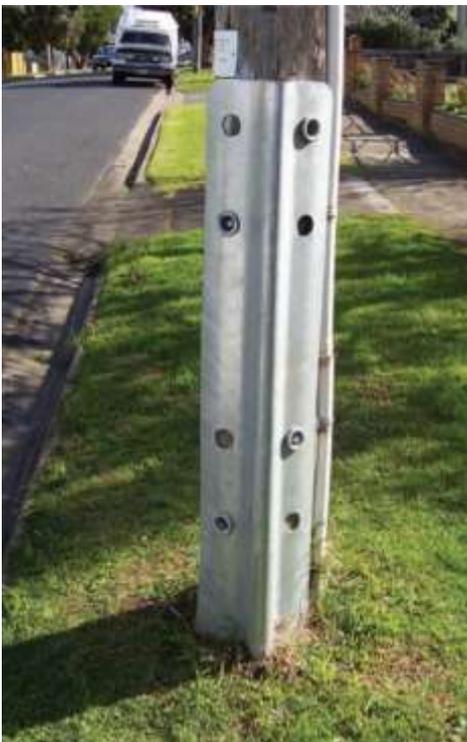
Figure 36: example of [REDACTED] RFD Pole Reinstatement¹⁸²

[REDACTED] designs and installs the pole reinforcements for Powercor

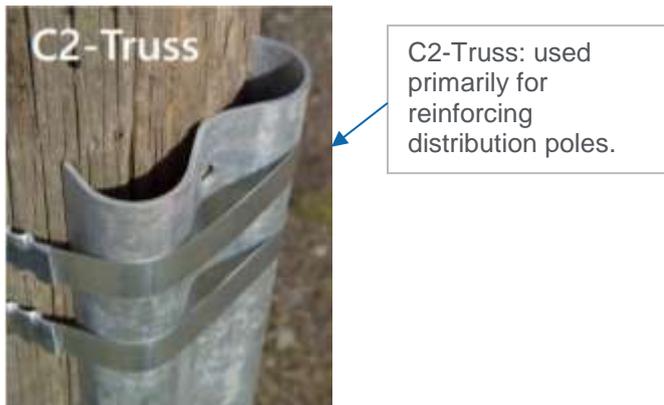
Figure 38: Example of an [REDACTED] pole restoration system¹⁸⁸

Powercor commenced exploring alternatives to the [REDACTED] RFD system in mid-2018. It plans to initiate a project in 2020 to investigate and trial an alternative pole reinforcement system(s) with intent to review the suitability for use on the network. Figure 38 below shows, an example of one new reinforcement system (which Powercor may evaluate), that does not involve drilling into the pole, instead it uses welded bands to provide the supporting strength from the steel stake(s).

Powercor advises that it expects that [REDACTED] system will be retained: *'We believe that adequate controls (recently enhanced with wood scanning technology) are being applied to manage [REDACTED] system installed on the network and the ability to utilise multiple suppliers will assist in delivering our increased forecast.'*¹⁸⁹

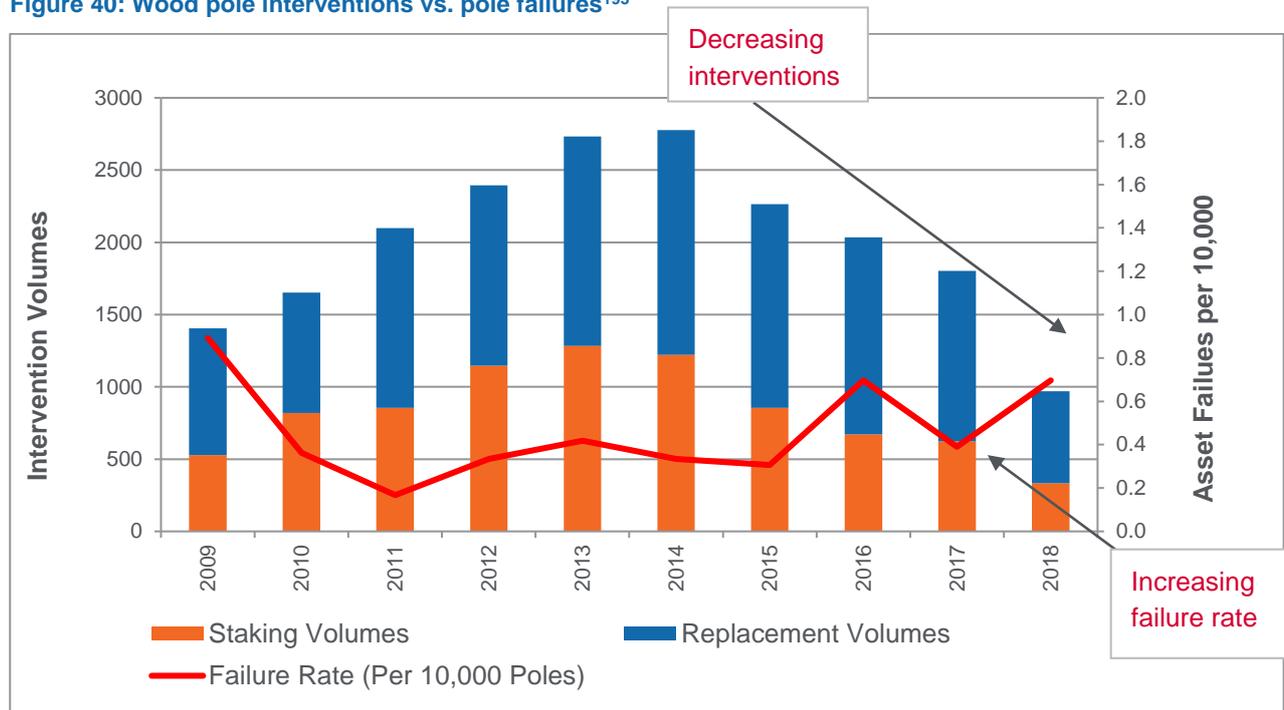
Figure 40: Wood pole interventions vs. pole failures¹⁹³

As discussed in section 6 (Serviceability assessment) and section 7 (Pole Interventions), ESV consider that the major contributors to the declining intervention rate are the changes in inspection practices and optimistic serviceability criteria (specifically the Safety Factor/good wood criteria).

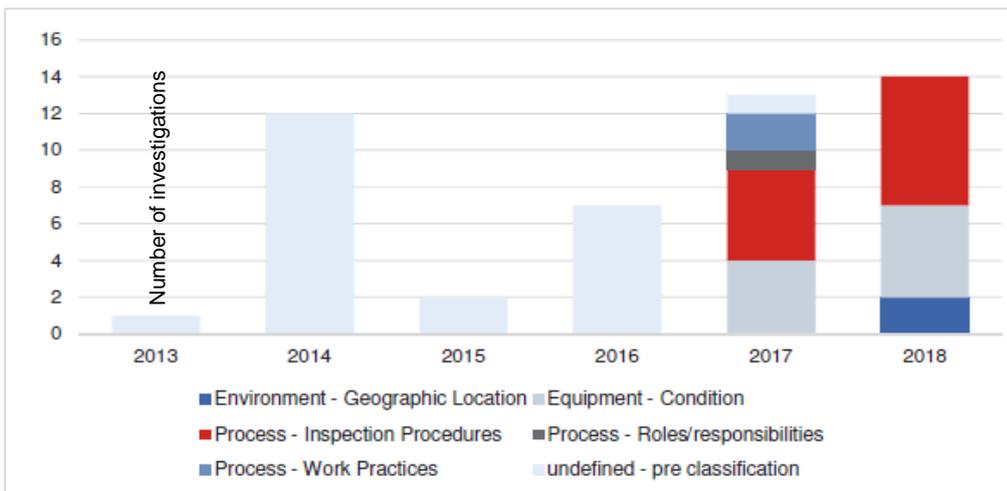
Figure 42: Powercor’s pole failure investigation root cause classifications²⁰²

Figure 42 below is from Powercor's Asset Class Strategy document for poles and towers, and provides a summary of its investigation of pole failure root causes. There is little explanation of the results in the strategy document, however ESV infers from the descriptions and accompanying text that:

Powercor’s Asset Class Strategy identifies that the majority of these failures occurred in the northern region of Powercor’s supply territory, with failures of poles classified as Serviceable and AC Serviceable.²⁰³ This indicates that either termites for wood poles, or rust in steel poles, are the primary reasons for pole failures in the statistics provided. However, only two Unserviceable poles failed in last 7-years, due to termite attacks.

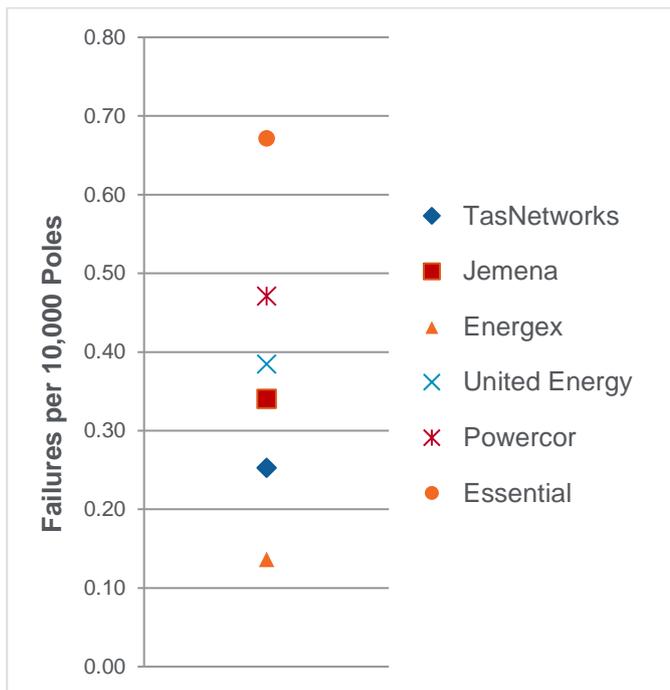
Figure 44: 10-year average Wood pole failure comparison to other distribution businesses²⁰⁶

Powercor’s 10-year average pole failure is above the median results of the six sample DNSPs (refer to Figure 44), at 0.47 unassisted failures per 10,000 poles and the second highest of the six utilities in the sample. However, Powercor’s 10-year average normalised pole failure levels are less than half of the unofficial industry benchmark of 1.0 failure per 10,000 poles.

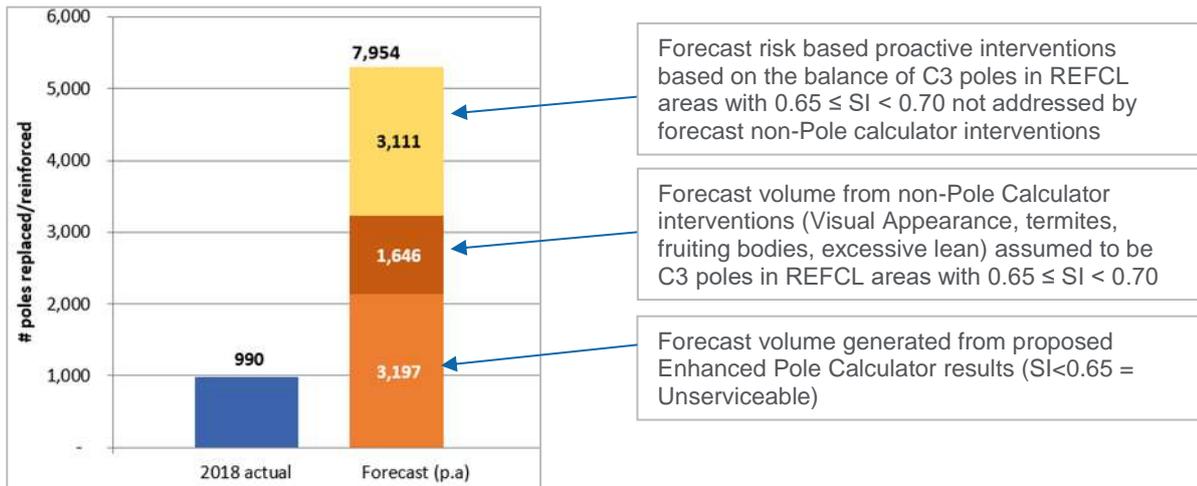
Figure 47: Powercor’s forecast average annual pole reinforcement and replacements (next RCP)

All poles in categories C1 and C2 in Table 27 are forecast to be replaced or reinforced. Poles classified as C3 will either be treated via non-Pole calculator interventions, by proactive risk-based intervention, or by increased inspection frequency.

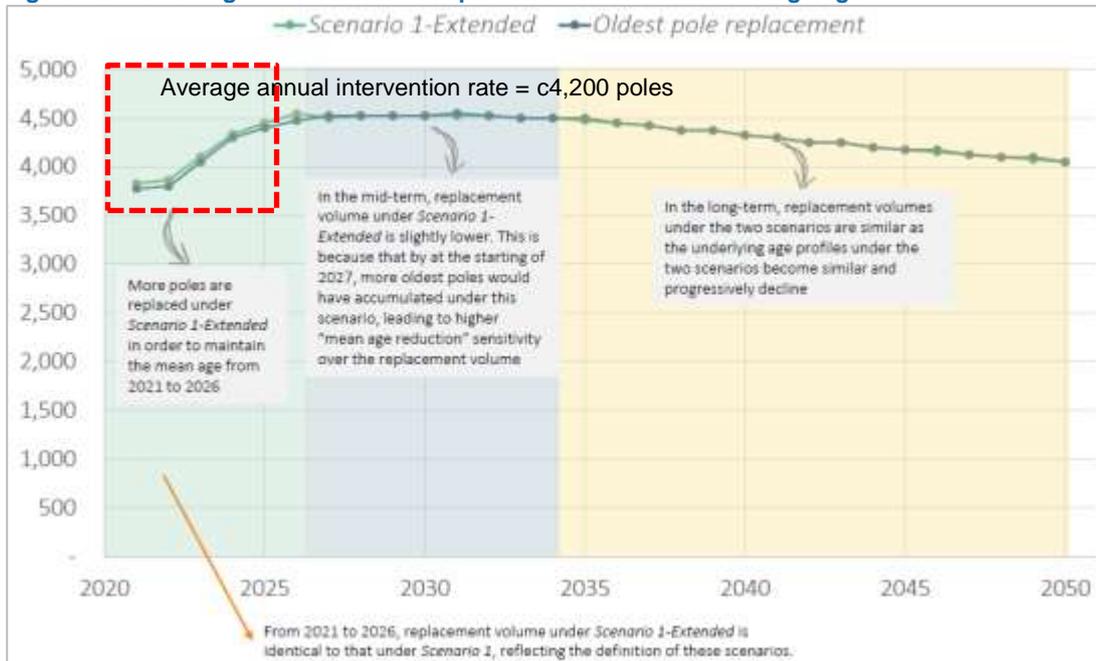
Figure 49: Actioning Powercor’s oldest poles to maintain 2020 average age²³²

Powercor has provided the results of a forecasting scenario analysis in which the oldest poles in its network are assumed to be replaced in priority order to maintain the mean wood pole population age at 44 years, as illustrated in Figure 49 below. The resulting average annual intervention volume of about 4,200 poles in the 2021 to 2026 period is:

As Powercor points out,²³¹ the scenario is likely to represent a lower band of what will be required because it will not replace or reinforce poles based on their condition, which are likely to be other than the oldest poles. Nonetheless, ESV expects that the majority of the poles identified based on condition for intervention will be older poles (i.e. greater than 50 years of age).
