Unmodelled repex: Business cases for “other” repex

Reactive Asset Replacement Program

Reactive Asset Replacement Program 2015/16 - 2019/20

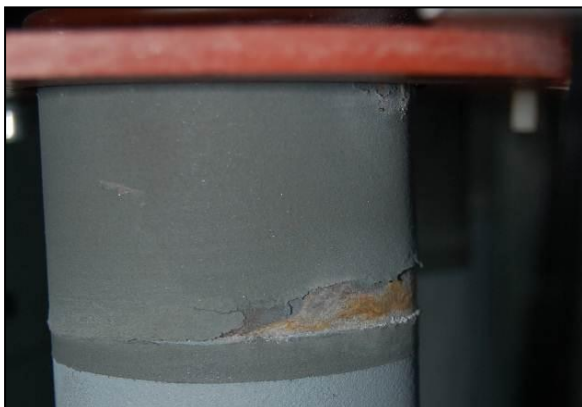
SSMGL CB1022 badly detached screen

However, in 2012 two panels were found at a substation (SSMGL) to be in very bad condition such that if not rectified immediately failure would have been very likely to fail. Further inspections and tests have shown that PD activity and associated degradation has been found in more than one aspect of the design albeit in very small quantities. To understand the extent of the problem, Energex initiated an on-line PD scanning program of all Eclipse CB panels across the network.

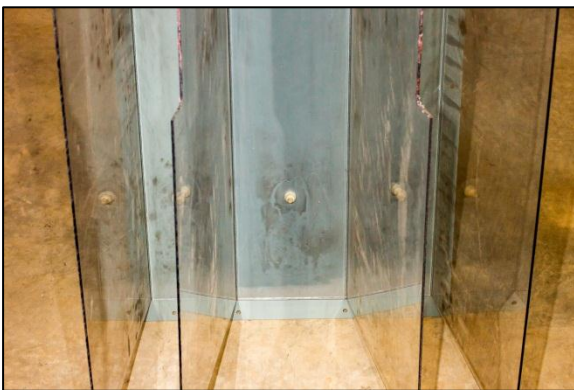
PD on nylon screws SSLYT CB1022

PD has been linked to catastrophic insulation failure in other in Eclipse switchgear. As the occurrence of PD can be very dependent on the environment, it cannot always be detected at the time of asset inspection thus leading to risk of dielectric failure at some later time. The impact of such a catastrophic failure will depend on the fault level and duration and may lead to the complete destruction of one or more complete CB panels and adjacent equipment. A number of photographs are included from several sites where defective insulation has been discovered.

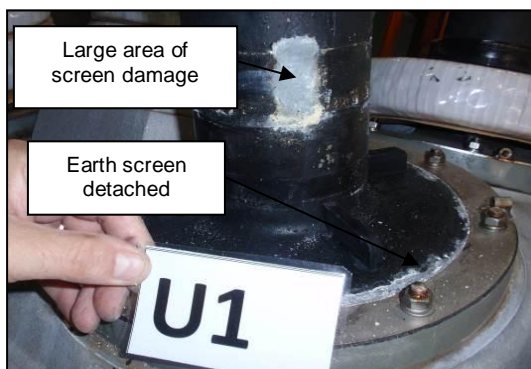
Energex conducted a survey (in 2013) which detected PD activity in 16 CBs on the Energex network, from which 2 have been inspected and serious HV insulation degradation was found. Such degradation may ultimately lead to either CT or catastrophic insulation failure. Photos of the two inspected units are shown below

SSDRA CB3T22 screen degradation

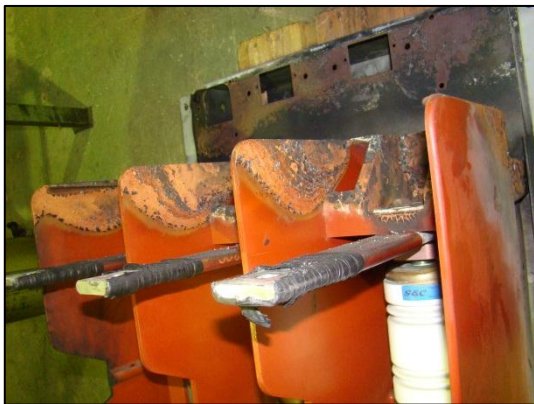
SSLYT [REDACTED] CB flashover

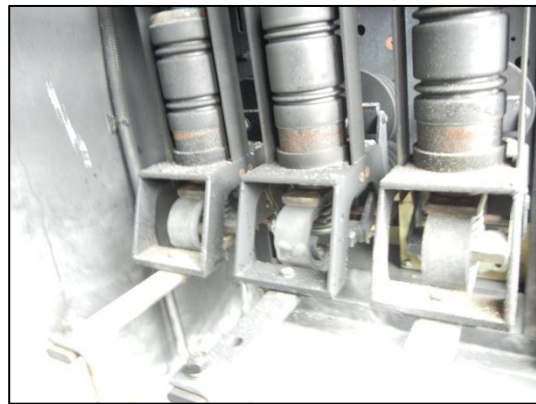
SSRLB [REDACTED] flashover

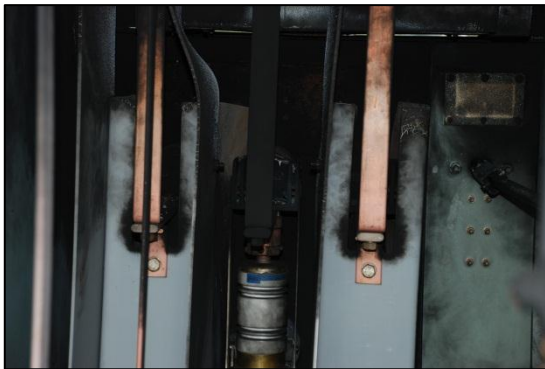
SSTPT [REDACTED] CB flashover

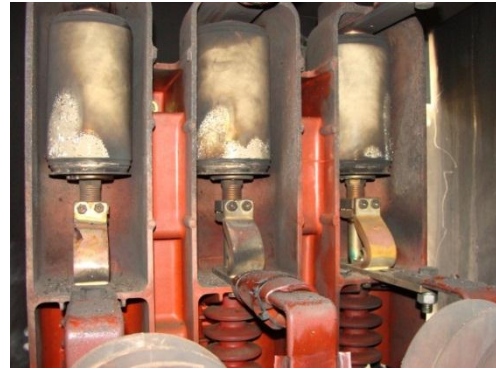
SSCLM [REDACTED] vacuum bottle failure

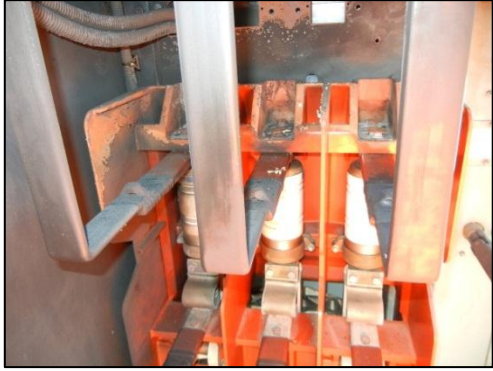
SSBDT [redacted] CB flashover

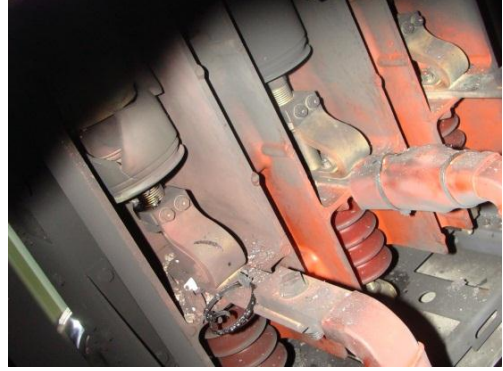
SSKBN [redacted] vacuum bottle failure

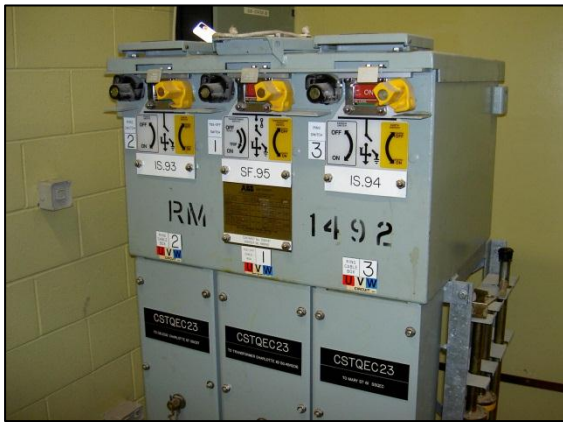
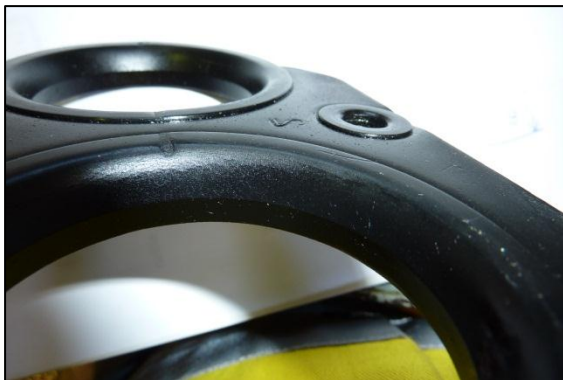
An issue has been found with [REDACTED] series oil RMUs in which the tank may leak oil, usually after invasive maintenance. This problem was brought to the attention of Energex after several leaking units were discovered by Ergon Energy. Energex has conducted checks and has found some leaks from a small quantity of RMUs. Investigations have suggested that the leak only occurs in later models in which a change of gasket design with less fixings is not providing an effective seal. Evidence has shown that the unit may be more susceptible to leaking after switching operations during maintenance without oil in the tank. The practice of switching without oil has been ceased but it is not known how many units may leak in the future as a result of these conditions.

As the leak is usually from the bottom of the unit, inside the HV cable boxes, it is not easy to check for this leak other than checking the oil level on the sight glass. Operating restrictions are in place to manage this and prevent energised operation without oil. Once a leaking unit is discovered, it cannot be repaired either onsite or economically in the workshop and the only viable action is to replace the unit with a new SF₆ insulated RMU. At this time there is no accurate data to forecast the numbers affected or the likely locations.

For the above RMU, inspection programs and restrictions have been implemented to alert operators to this risk. The variables that cause the RMU to leak have no geographical pattern and hence potential failures cannot be predicted on this basis. The replacement program is driven by identifying affected units as found during inspection or by operators performing routine switching.

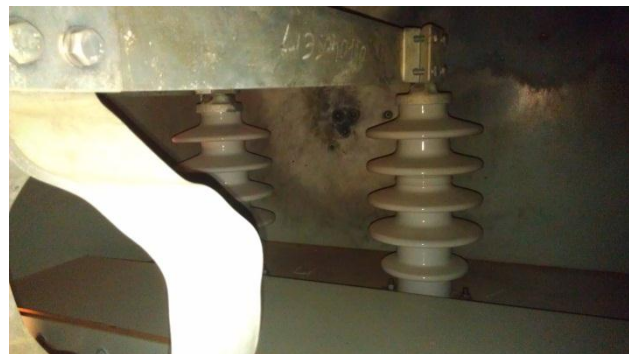
SSRVW Late restrikes on [redacted]

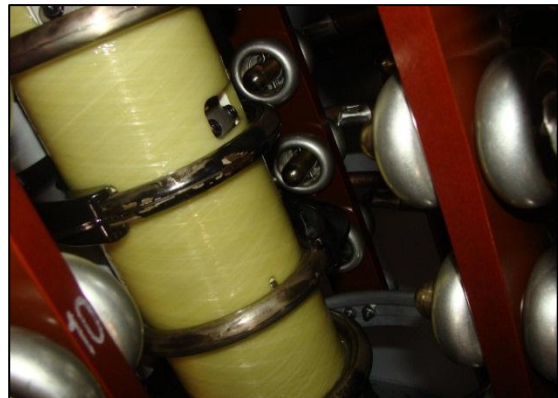
SSCMA silver sulphide deposits

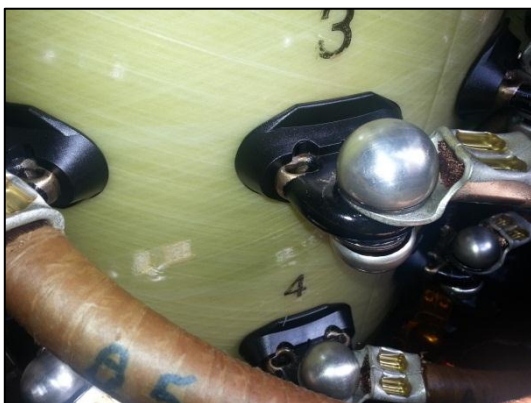
A detail investigation of power transformers at AFD-Archerfield, VPK-Victoria Park and LBS-Lytton Bulk Supply Substations have shown significant evidence of corrosive sulphur in the transformer oil and are at a high risk of failure.

Silver sulphide deposits SSVPK

Corroborative evidence was sought by checking similar transformers and samples were taken on all transformers. The presence of silver sulphide was confirmed by analysis on transformers manufactured between 1998 and 2007. Energex has embarked on a program of oil passivation, prioritised by higher rated power transformers. Of this program, 34 off 110 kV transformers and 108 off 33 kV transformers are scheduled for completion in 2014/15 with the remaining 142 off 33 kV transformers programmed for completion in 2015/16. Energex will also be completing internal inspections, cleaning and refilling oil in 9 power transformers each year until 2019/20 in units where oil passivation alone is not sufficient to manage the risk.

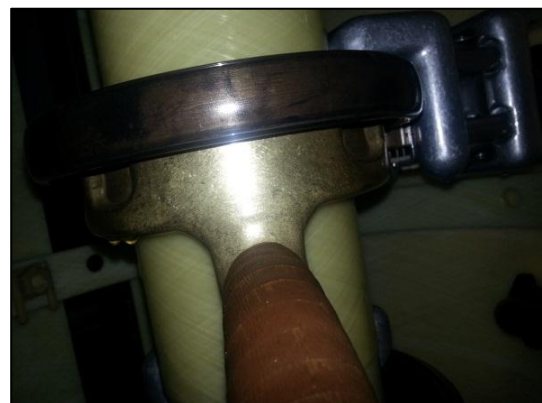
Silver sulphide deposits SSVPK

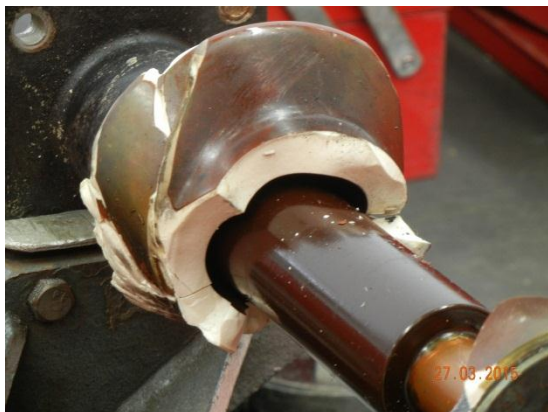
Such failure of a porcelain bushing is very violent and in each case porcelain shards are ejected several metres across the substation yard thereby presenting a serious safety risk to operators and the public. For short term operator safety all ██████████ CB have been fitted with plywood barriers to reduce the impact of a catastrophic failure.

SSLTN shattered bushing

Taking into account the age of the CB (44-47 yrs.) and the fault rating of 13.1kA is less than the typical fault levels on the network, it is not economically viable to repair the bushings. The only safe course of action is to replace with the new CBs.

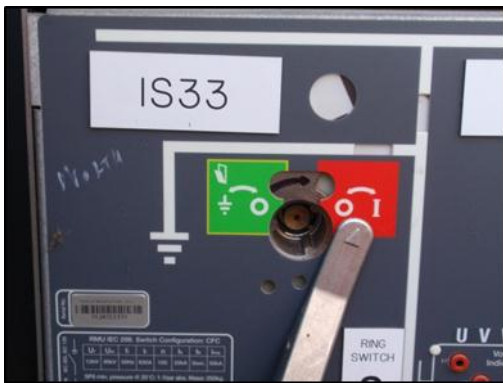
Energex operates a population of approximately 8,500 11kV RMUs. On several occasions, a design fault on a mechanical switch allowed the contacts to overtravel into an indeterminate position between OFF & Earth, which initiated an internal arcing fault. This situation is dangerous to operators and also destroys the asset. To rectify this, a large high risk batch was rectified (1,000) and the entire population, which can still fail are required to be operated with an overtravel arresting device (mounted on the front panel). This objective of the device is to limit travel of the mechanical switch and this will allow the unit to survive, and can be repaired.

Overtravel resulting in indeterminate position

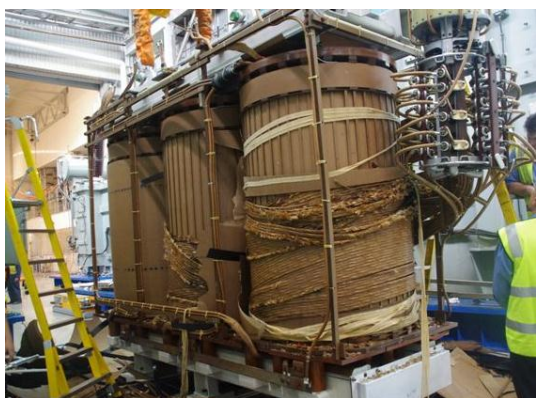
In 2012 there was an a transformer fault initiated in the on load tap changer of a 110kV/33kV transformer. This fault was detected and isolated from all sources by the protection scheme in approximately 120ms. Despite the fast clearing time there was still damage caused to the winding of the transformer. However as the damage was limited and the auxiliaries of the transformer were still intact, allowing the transformer to be re-wound at a lower cost than being replaced. Arguably, had the protection not isolated the fault as quickly as it had, there could have been more damage sustained to the transformer. If there been a reliance on a load encroachment blocking scheme under this fault the consequences could have greater.

Figure 14: 110/33kV Transformer winding damage after a fault and corresponding waveform capture from the protection relay disconnecting the fault in 120ms.
